# Preliminary Ecological Appraisal and Roost Assessment

Home Farm, Shaw Hill, Shaw, Wiltshire, SN12 8EW

22<sup>nd</sup> August 2024

‘The erection of 2no. dwellings with associated soft landscaping’.

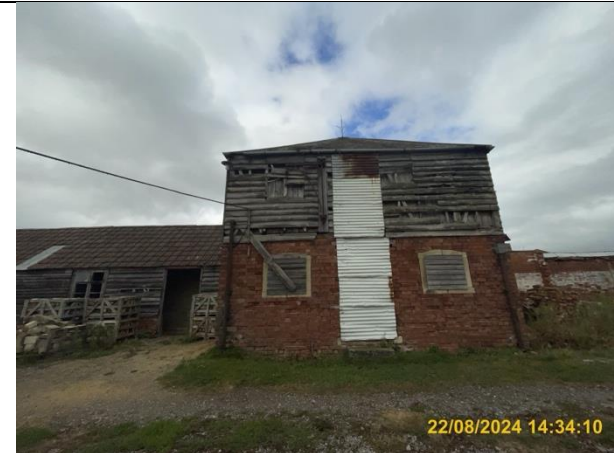
B1 is a three-storey farm building in poor condition, with two sections (B1a, B1b) connected internally by a corridor. The roof is clay and slate tiled and walls consist of timber clad, brickwork and breeze block. All structures contain suitable bat roosting and access features for both crevice and void-dwelling bats. These include crevices and gaps under/in timber boards, eaves, roof tiles, brickwork and window frames. Moreover, there are areas of unrestricted access in the form of entrances without doors. There are three internal voids (B1a, B1b-first and second storey) and one loft void (B1b – third storey) in which evidence (bat droppings and discarded insect wings) of bats using the interior was found. No evidence was found on external walls, however, this couldn't be used to indicate a likely absence of crevice dwelling bats. This is because bats such as pipistrelles can be found roosting behind hanging tiles, soffit and barge or eaves boarding, between roofing felt and roof tiles or in cavity walls, and all internal evidence is trapped within these crevices. Moreover, any external evidence would be quickly weathered away. The building has **high roosting habitat value**.

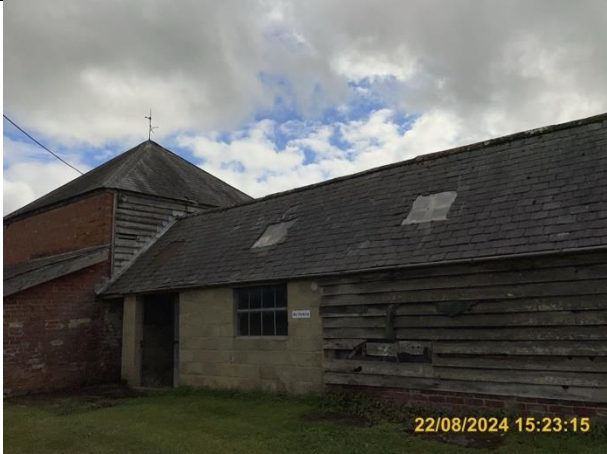
| Window/doors frames and lintels B1a | Timber | <p><b>Condition/description</b><br/>Timber doors with small gaps along the frame, broken window with metal sheet behind on the southern elevation and opening without barrier on the northern and southern elevation, and well-sealed window on the northern elevation.</p> <p><b>Suitability/access</b><br/>Small gaps between door frame and doors provide access into internal void. Metal sheet behind the broken window on the southern elevation limits access into internal void, but the unrestricted openings on the southern and northern elevation provide access into the interior.</p> | | |

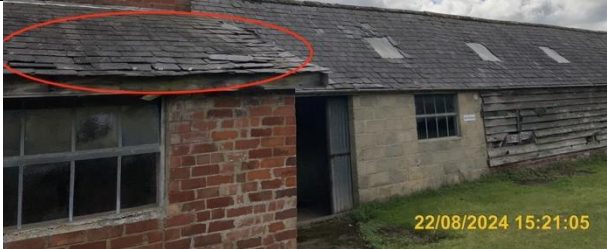
| Roof B1b | Clad in slate tiles and metal roofing sheets | <p><b>Condition/description</b></p> <p>The main roof of B1b is hipped and clad in slate tiles, and two adjacent lean-on roofs on the northern elevation have metal roofing sheet and slate tiles clad. Both the main roof and lean-on roof clad in slate tiles have broken, dislodged or missing tiles, revealing gaps, and there is exposed lead flashing on all elevations of the main roof.</p> <p><b>Suitability/access</b></p> <p>The numerous gaps in roofs clad in slate tiles create crevices in which bats could roost or gain access into the interior void and loft void.</p> | |

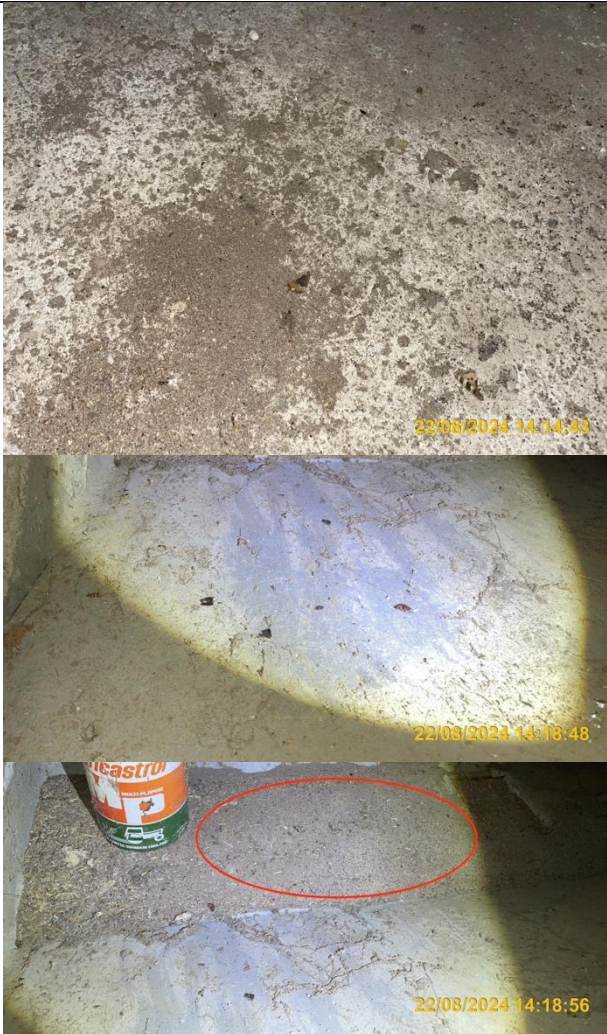
| Internal voids<br>B1b | Timber<br>rafters and<br>ridge beam.<br>Open floor to<br>ridge.<br>Mortise and<br>tenon joints. | <p><b>Condition/description</b></p> <p>First storey can be accessed through opening into the corridor between B1a and B1b. The interior was dark with low levels of natural light spill through gaps in window frames and brickwork. Second storey is accessed by a ladder and contains two dark enclosed spaces, running along eastern elevation and western elevation of the building. Both spaces don't have a barrier in their opening, allowing full access. The second storey has some natural light spill through the gaps between timber cladding and metal sheets which were used to board up windows and door.</p> <p><b>Suitability/access/evidence of bats</b></p> <p>First storey had a low number (&lt;5) of discarded moths and butterfly wings. A large number of bat droppings (~50) with mixture of colours and discarded moths and butterfly wings (~20) were seen within both two dark enclosed spaces on the second storey. Samples were collected for DNA analysis. There is a mixture of colours which shows different ages of droppings, with darkest droppings indicating more recent activity. Size and shape of droppings indicate a large bat, such as serotine or horseshoe.</p> | |

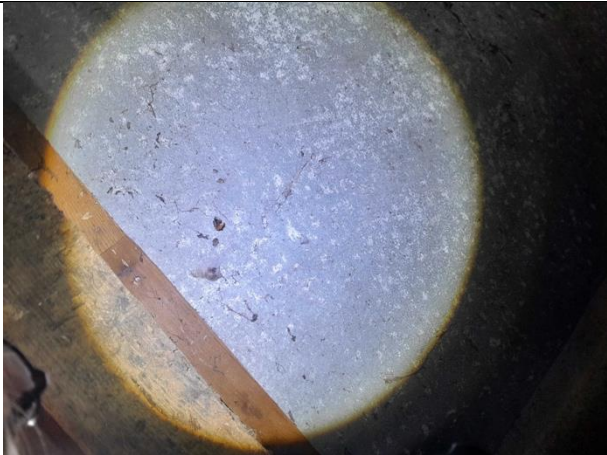
| Loft void B1b | Timber rafters and ridge beam. Open floor to ridge. | <p><b>Condition/description</b></p> <p>Loft void is on the third storey of the building, it has timber rafters and ridge beam in good condition, and it is 2 m high and 4 m wide in diameter. The loft roof is not lined, with exposed slate tiles. 2 dead birds, presumably pigeons, 4 pigeon nests and rodent droppings were seen. The loft void couldn't be fully accessed and surveyed due to safety reasons as the loft joists were unstable.</p> <p><b>Suitability/access/evidence of bats</b></p> <p>Bats can access the loft void through crevices in slate tiles, eaves and opening leading to the second storey. ~10 bat droppings and discarded moth and butterfly wings were found, however due to safety reasons it was not possible to inspect the whole area of loft void and therefore more evidence of bats might have been missed. Samples were collected for DNA analysis. The loft is suitable for roof-void dwelling bats, which require gaps from as small as the width of our thumb to access the roost and need timber joists or beams on which to roost.</p> | |

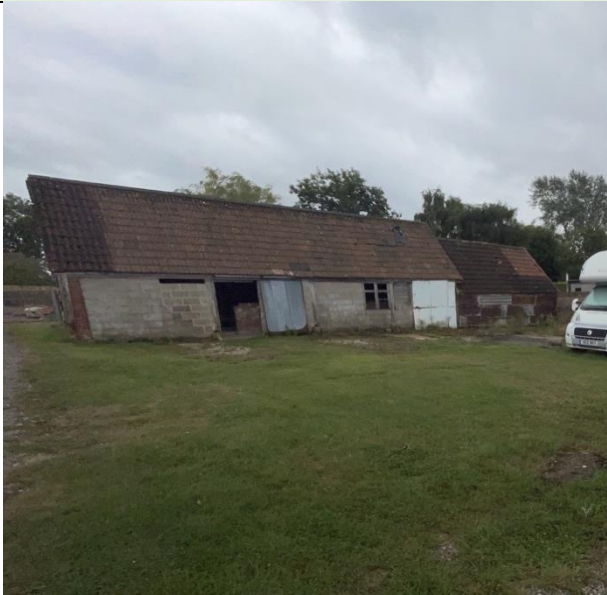
| | | | | |
|---|--|--|---|--|
| <p><i>Summary</i></p> <p>B2 is a one-storey farm building in poor condition, with two sections (B2a, B2b) connected internally by an unrestricted opening. The roof is clay tiled and walls consist of timber clad, brickwork and breeze block. All structures contain suitable bat roosting and access features for crevice and void-dwelling bats. These include crevices and gaps under/in timber boards, eaves, roof tiles, brickwork and barge board. Moreover, there are areas of unrestricted access in form of open area of B2b which leads to the exterior. There are two internal voids. Within the internal void of B2a evidence (bat droppings and discarded insect wings) of bats using the interior was found. No evidence was found on external walls, however, this couldn't be used to indicate a likely absence of crevice dwelling bats. This is because bats such as pipistrelles can be found roosting behind hanging tiles, soffit and barge or eaves boarding, between roofing felt and roof tiles or in cavity walls, and all internal evidence is trapped within these crevices. Moreover, any</p> | | | | |

| external evidence would be quickly weathered away. The building has <b>high roosting habitat value</b> . | | | |

| <i>Recommendations</i> | <p><b>Roosting habitat [B1+B2]</b><br/>Three bat emergence/re-entry surveys are required on B1 and B2 during the active bat season (May – September) to confirm presence/likely-absence of bats roosting in or on the building.<br/>These survey visits should be completed during the optimal survey period mid-May to August inclusive. The survey visits should be at least three weeks apart. Sub-optimal: early May and September. Would require greater justification of timing e.g., weather conditions, known local bat activity.<br/>Six surveyors are required to provide full coverage of the building's elevations to look for emerging/re-entering bats. An infrared camera should also be employed as part of the survey to see where any specific roost locations are located.<br/>Lighting mitigation may be required based on the outcome of the night bat surveys. An EPSL application to Natural England will be required. The EPSL application requires that all surveys have been undertaken within the most recent active bat season and planning permission must have been granted and all relevant wildlife-related conditions have been discharged prior to submission.</p> <p><b>Foraging and commuting habitat</b><br/>No activity surveys are required, however foraging and commuting behaviour will be observed and recorded during the night time of bat emergence surveys.</p> <p><b>Artificial lighting</b></p> |

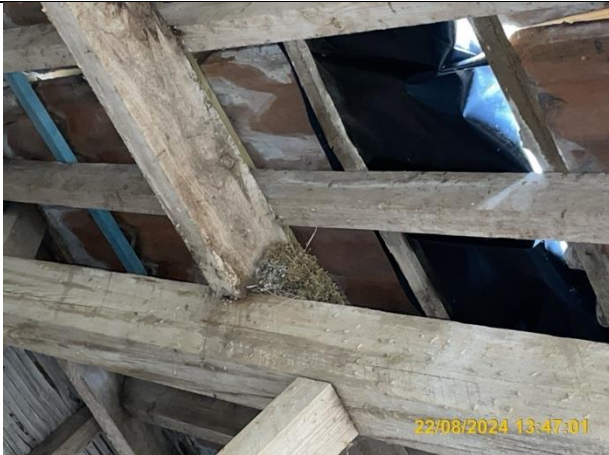
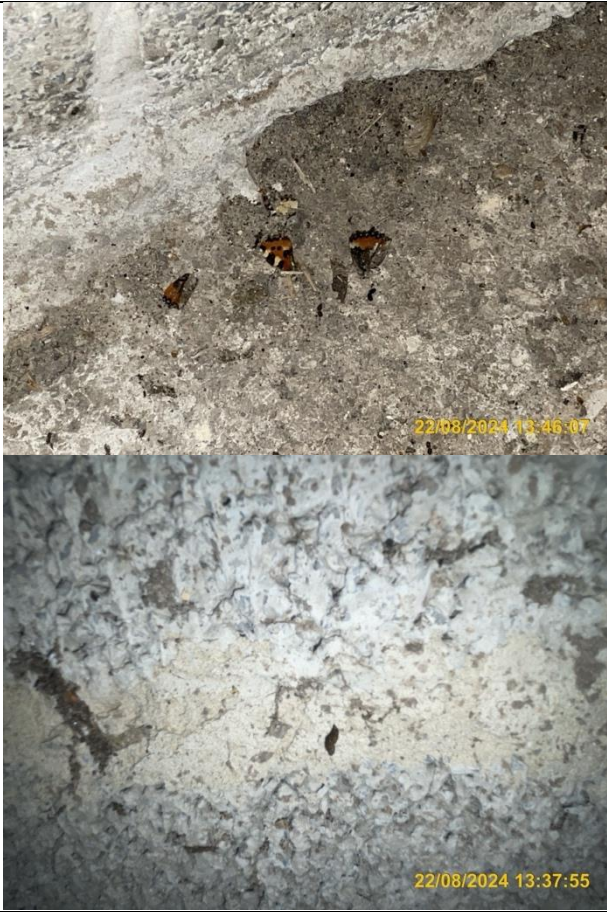
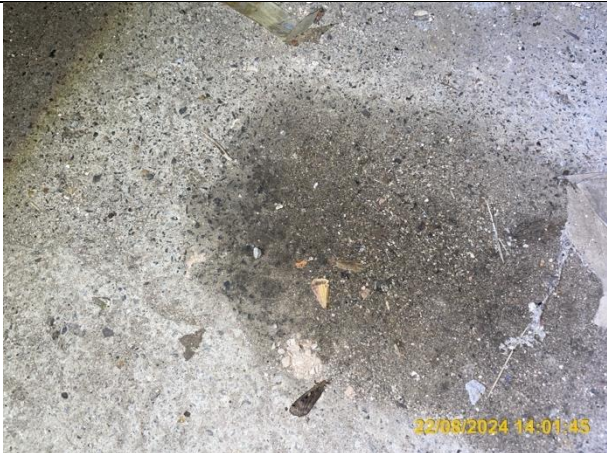
| Internal voids<br>B2a | Timber rafters and ridge beam. Open floor to ridge. Mortise and tenon joints. | <p><b>Condition/description</b></p> <p>Internal space measures approx. 11.5 m long, 4.5 m wide, floor to ridge height approx. 5 m. The internal timbers appear to be original with traditional mortise and tenon joints. There is timber lining under clay tiles and some areas with plastic and metal sheets on eastern elevation and no lining on western elevation. Gaps in timber cladding, metal and plastic sheets and roof tiles are present, especially on the northern and western elevation. The void has a large amount of natural light entering the space through gaps in timber cladding, clay tiles, missing breeze blocks, window and opening into B2b. There were four old bird nests on the intersection of timber beams.</p> <p><b>Suitability/access/evidence of bats</b></p> <p>Between 20 - 59 bat droppings and ~20 moth and butterfly wings were found on the floor. Samples were collected for DNA analysis. Size and shape of droppings indicate a large bat species. There is a mixture of colours which shows different ages of droppings, with darkest droppings indicating more recent activity. This, along with the volume found eliminates a one-off exploratory visit. High level of natural light internally is indicative of this space not being used as a day or maternity roost, and therefore the void is most likely used as a feeding roost.</p> | |

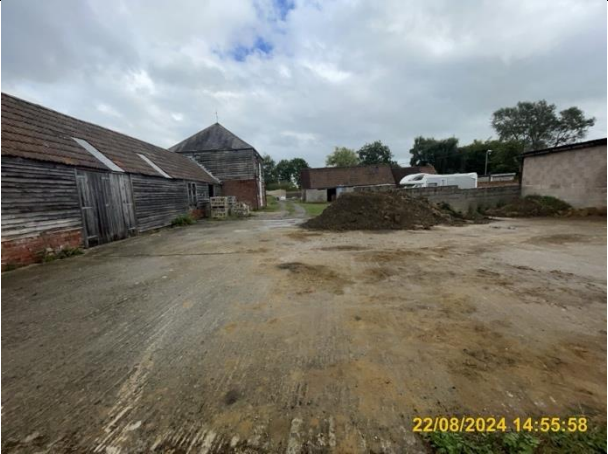
| <b>Ecological Survey Factor</b><br><br><b>Conclusion, Impact or Recommendations</b> | <b>Detailed using desk study and site survey. Any specific limitations noted within relevant section. This table may include further work you will need to commission (if any) to obtain planning permission or comply with legislation for other consent. All clients are expected to read and understand this section, or to contact the lead surveyor for advice.</b> |
|---|---|
| <i>Summary of Survey Findings</i><br><br><i>(UKHab codes used)</i> | <p>The site contains native hedgerow with trees which is listed as a habitat of principal importance under Section 41 of the Natural Environment and Rural Communities (NERC) Act (2006). The site also contains fruiting trees which are of good quality and could be of value to local wildlife populations (as detailed in subsequent sections of this table). Other habitats within the site are common and widespread and have low ecological value. Deciduous woodlands, traditional orchards, and woodpasture and parklands, which are notable habitats are present within 2 km radius of the site.</p> <p><b>On-site habitats</b></p> <p><u>Buildings (u1b5)</u><br/>There are two buildings on-site that will be impacted by the development works - Building 1 (B1) and Building 2 (B2) which comprise four sections (B1a, B1b, B2a, B2b). A third building is found centrally in the site and is to be retained. A full preliminary roost assessment was undertaken of B1-B2, this can be found in the section on bats of this report. Condition assessment N/A.</p> <p><u>Developed land/sealed surface (u1b)</u><br/>Areas of hardstanding are surrounding the two buildings (Figure 1). Condition assessment N/A.</p> |

| <b>Developed land; sealed surface</b> | |
|---|---|
| | <p>Figure 1: Area of developed land; sealed surface adjacent to the southern elevation of B1a</p> |

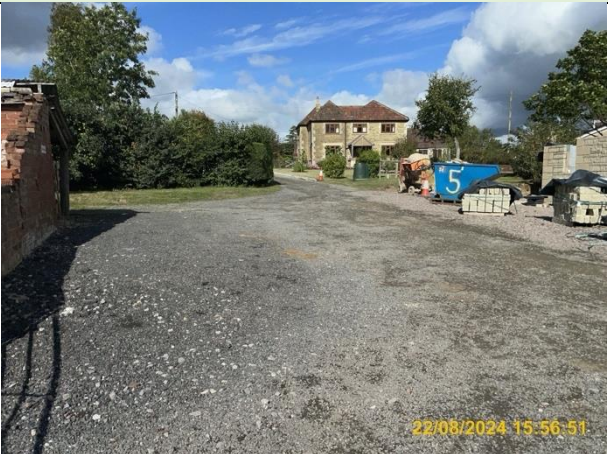
| | <p><u>Artificial unvegetated, unsealed surface (u1c)</u><br/>Area of artificial unvegetated, unsealed surface comprises the driveway and is adjacent to northern area of modified grassland and north-eastern site boundary (Figure 2). Condition assessment N/A.</p> <p><u>Artificial unsealed surface with ruderals (u1c-81)</u><br/>Area of artificial unsealed surface with ruderal vegetation is adjacent to the southern elevation of B1 (Figure 3). The species assemblage of the ruderal vegetation includes ribwort plantain <i>Plantago lanceolata</i>, dandelion <i>Taraxacum officinale agg.</i>, white clover <i>Trifolium repens</i>, wood cranesbill <i>Geranium sylvaticum</i>, creeping thistle <i>Cirsium</i>. Condition assessment N/A.</p> <p><u>Bare ground (u1-510)</u><br/>Area of bare ground is adjacent to the southern and western site boundary along native hedgerow with trees and north-western area of modified grassland (Figure 4). The area of bare ground appears to have been tilled recently, with no vegetation present. The condition assessment is as follows: a) The habitat doesn't have a varied vegetation structure; b) The habitat parcel doesn't contain different plant species; c) No invasive non-native plant species were detected. The habitat's condition is assessed as poor.</p> <p><u>Modified grassland (g4-510)</u><br/>There are three areas of modified grassland (Figure 5). The first area is adjacent to the eastern elevation of B2, and the species assemblage includes common bent <i>Agrostis capillaris</i> (D), white clover <i>Trifolium repens</i> (A), perennial rye-grass <i>Lolium perenne</i> (O), creeping buttercup <i>Ranunculus repens</i> (O), dandelion <i>Taraxacum officinale agg.</i> (O), ribwort plantain <i>Plantago lanceolata</i> (R), Yorkshire fog <i>Holcus lanatus</i> (R). The condition assessment for this area of the habitat is as follows: a) There are 5 vascular plant species per m2 present; b) The sward height is &lt;7 cm; c) Cover of scrub is less than 20%; d) Physical damage accounts for more than 5% of total area; e) The cover of bare ground is between 1% and 10%; f) The cover of bracken is less than 20%; g) No invasive non-native species were detected on survey. The habitat's condition is assessed as poor.</p> <p>The second area is adjacent to the north-western site boundary and bare ground habitat, and the species assemblage includes common bent <i>Agrostis capillaris</i> (D), white clover <i>Trifolium repens</i> (A), perennial rye-grass <i>Lolium perenne</i> (O), creeping buttercup <i>Ranunculus repens</i> (O), dandelion <i>Taraxacum officinale agg.</i> (O), ribwort plantain <i>Plantago lanceolata</i> (R), Yorkshire fog <i>Holcus lanatus</i> (R), ivy <i>Hedera helix</i> (R). The condition assessment for this area of the habitat is as follows: a) There are 5 vascular plant species per m2 present; b) The sward height is &lt;7 cm; c) Cover of scrub is less than 20%; d) Physical damage accounts for less than 5% of total area; e) The cover of bare ground is less than 1%; f) The cover of bracken is less than 20%; g) no invasive non-native species were detected on survey. The habitat's condition is assessed as poor.</p> <p>The third area is adjacent to the northern site boundary, and the species assemblage includes common bent <i>Agrostis capillaris</i> (D), white clover <i>Trifolium repens</i> (A), perennial rye-grass <i>Lolium perenne</i> (O), creeping buttercup <i>Ranunculus repens</i> (O), dandelion <i>Taraxacum officinale agg.</i> (O), ribwort plantain <i>Plantago lanceolata</i> (R), Yorkshire fog <i>Holcus lanatus</i> (R), ivy <i>Hedera helix</i> (R). The condition assessment for this area of the habitat is as follows: a) There are 5 vascular plant</p> |

| <b>Developed land; sealed surface</b> | |
|---|---|
| | <p>Figure 2: Artificial unvegetated, unsealed surface comprising driveway (adjacent to northern area of modified grassland)</p> |
