Drawing : **Detail Specifications for repair works to:**

**Fireplace - G.08**

**1306.D.18**

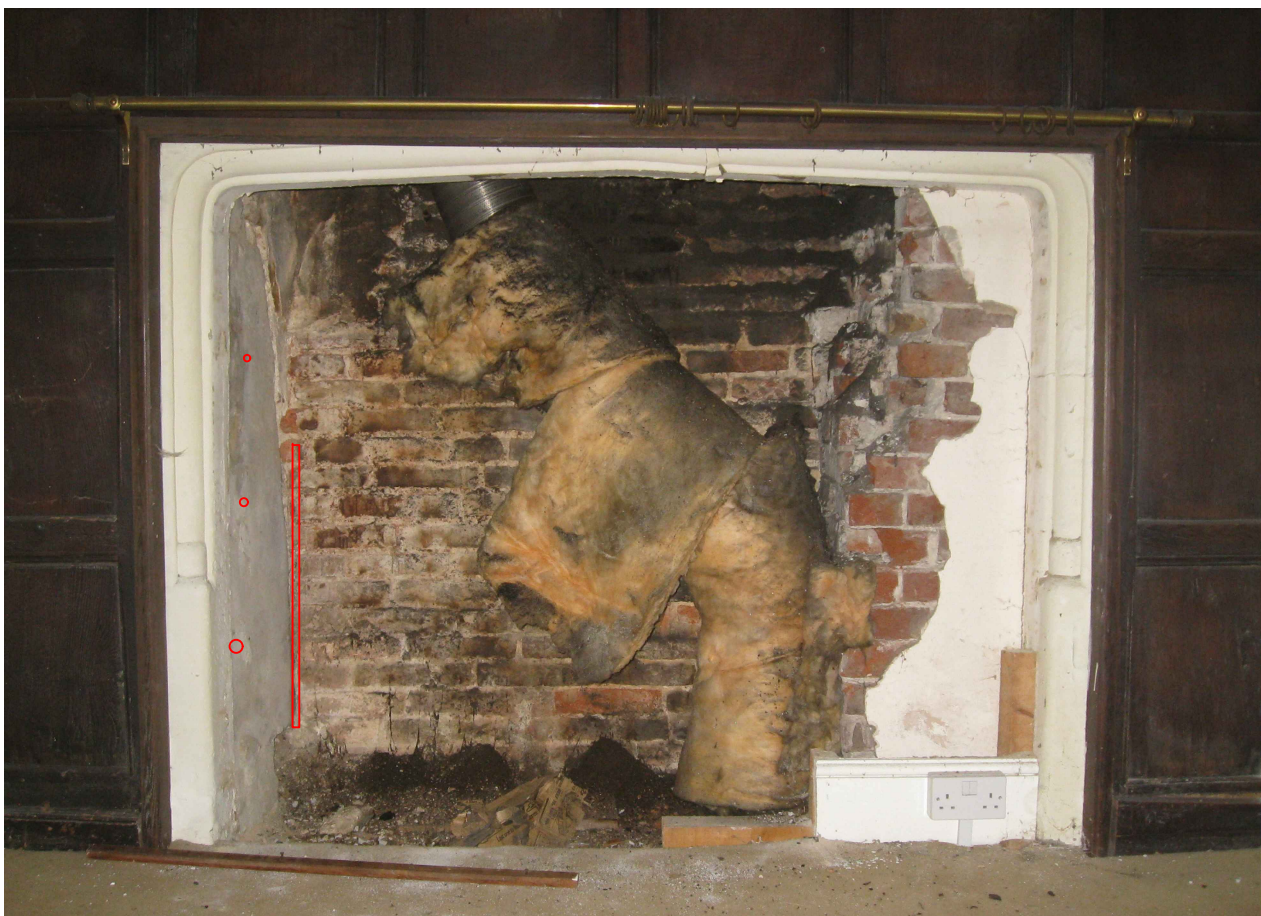
### G08 Fireplace.

C17 plain bolecion mouded surround, part covered by C17th oak panelling.

A substantial crack in the joint between the C 17th back brick lining and the stone surround as indicated by a red line.

An insulated steel flue pipe from the cellar fireplace passes through the hearth and lines the chimney.

To the right is a part infill of brickwork and plaster, complete with the remains of a modern section of skirting.

Remove insulation and flue pipe.

Support over and remove the right hand brick infill.

Clean off soot and tar deposits in accordance with the specification on drawing D.15.

Make good any loose brickwork to match.

Re-construct the hearth with a soft red clay brick set in 1:3 NHL 3.5:sand in a herringbone pattern.

Use 3 no.stainless steel 8mm pins to relocate the stone mantle with the surrounding brickwork.The locations are indicate by a red circle.
