Title : 17 Cathedral Close Salisbury SP1 2EB

Drawing : Detail Specifications for repair works to:

Mantle Surround - Room G02

1306.D.14

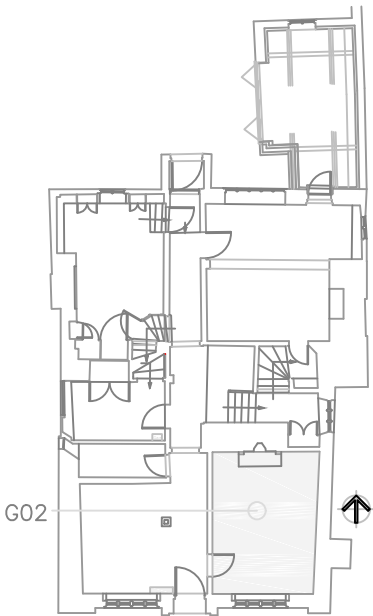
G02 – Fireplace

The hearth is of ceramic-clad concrete.

The fire place is defined with a red clay tile trim, separating the fire bricks from the decorative tile surround.

The mantle is butted against painted wood panelling

Mantle is painted stonework.

There is outward movement by the pilasters from the joints with the entablature base at circled areas.

To prevent any further movement between the pilasters and entablature it is suggested that stainless steel pins are drilled in and resin anchored with the holes plugged with a lime mortar and matching lime-based paint.

C18 fireplace to be retained and repaired.

Fire brick linings to be replaced to match existing.

Brickwork to be cleaned and re-pointed with lime-based mortar and flush jointed.

Flue to be cleaned and lined, if it is to used as an open fire.
