## Off Mains Drainage Survey Report Prepared For:

Dairy Cottage, North Newnton, Pewsey, Wiltshire SN9 6LA

**Date of Survey:** 30/05/2025

## Drainage Survey Standard Report:

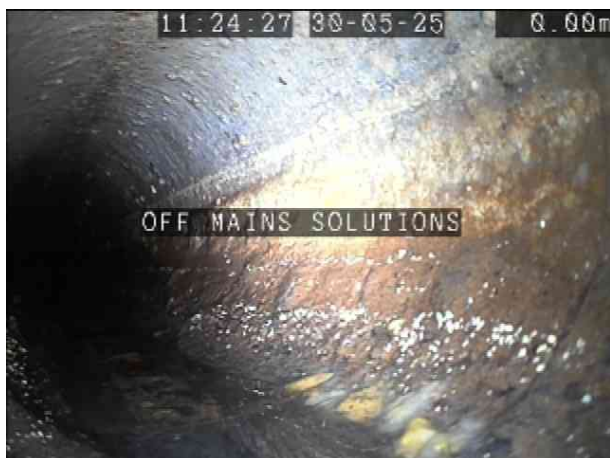
W.C.X\_eaa3eb21-041d-444a-95fb-eb485c41235c\_20250604\_130650\_605.jpg, 00:00:00, 0.00 m  
Start node, manhole, reference: IC1

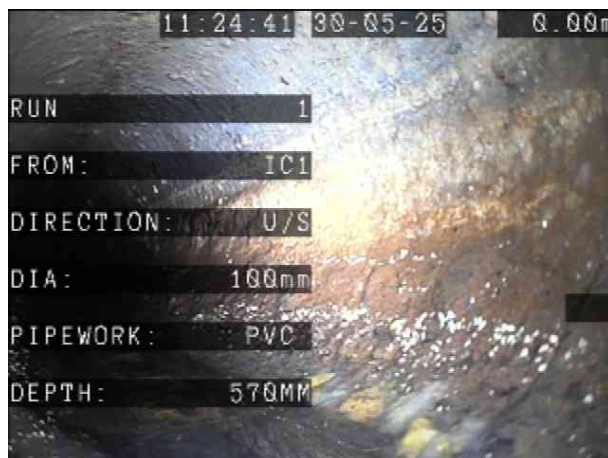
W.C.X\_86f5473a-15ae-4514-9074-cabb1a888ccc\_20250604\_130658\_383.jpg, 00:00:00, 0.00 m  
Start node, manhole, reference: IC1

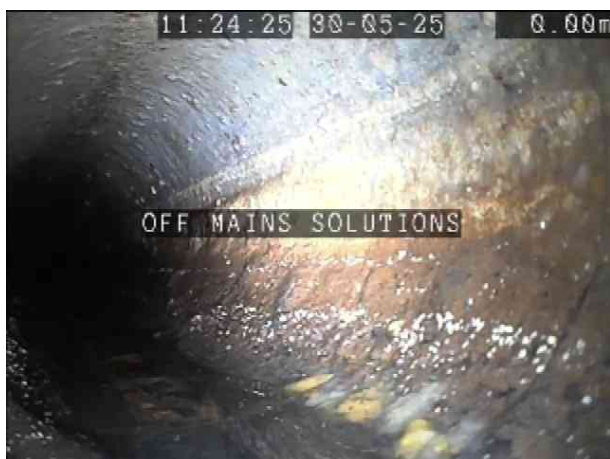
W.C.X\_a1dd3d71-662b-4fc3-926e-369a7f08aa7c\_20250604\_130948\_383.jpg, 00:00:00, 3.66 m  
Finish node, other special chamber, reference: W.C., W.C.

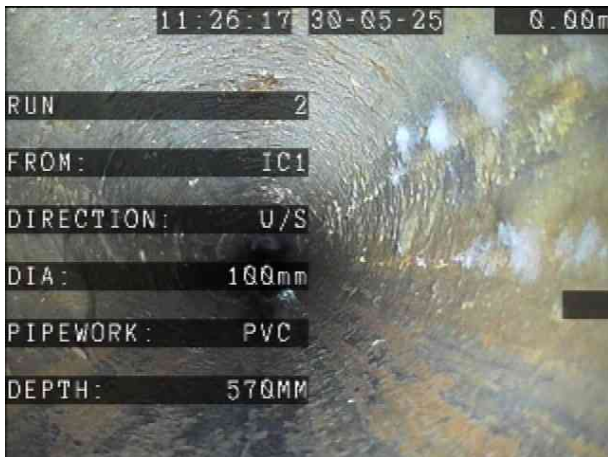
InternalX\_eb514271-c333-4e0a-9e8a-d3de86de49fa\_20250604\_131243\_093.jpg, 00:00:00, 0.00 m  
Start node, inspection chamber, reference: IC1

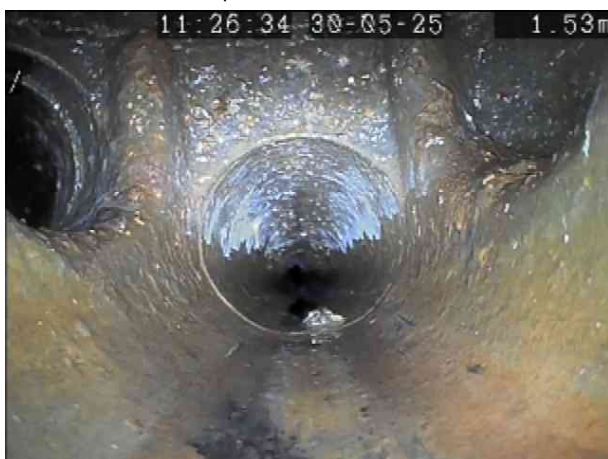
InternalX\_39948847-9a4e-4a4f-99de-aa58adeb660c\_20250604\_131352\_621.jpg, 00:00:07, 1.53 m  
General remark, IC2

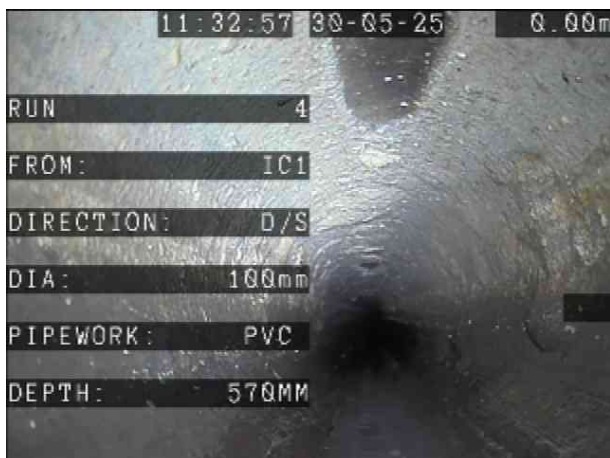
IC1X\_f7ceb95d-6b64-4267-92fc-e8498fba9d09\_20250604\_13  
2627\_447.jpg, 00:00:00, 0.00 m  
Start node, inspection chamber, reference: IC1

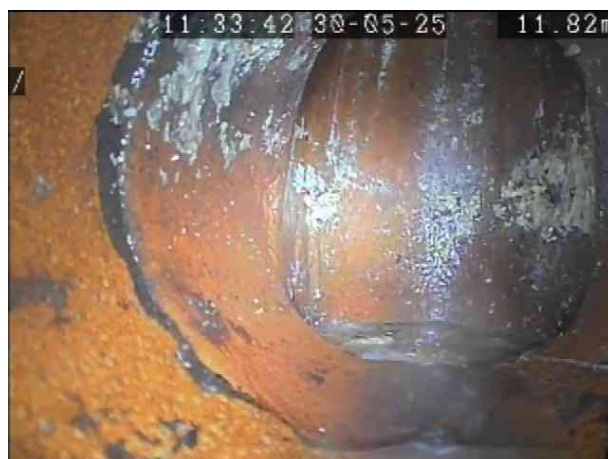
IC1X\_4f8c3061-1447-415c-b93c-235797a514f6\_20250604\_13  
2827\_211.jpg, 00:00:44, 11.82 m  
Finish node, catchpit, reference: Septic Tk
