# **3 Northgate Street, Devizes**

**A Historic Buildings Statement**

**February/March 2026**

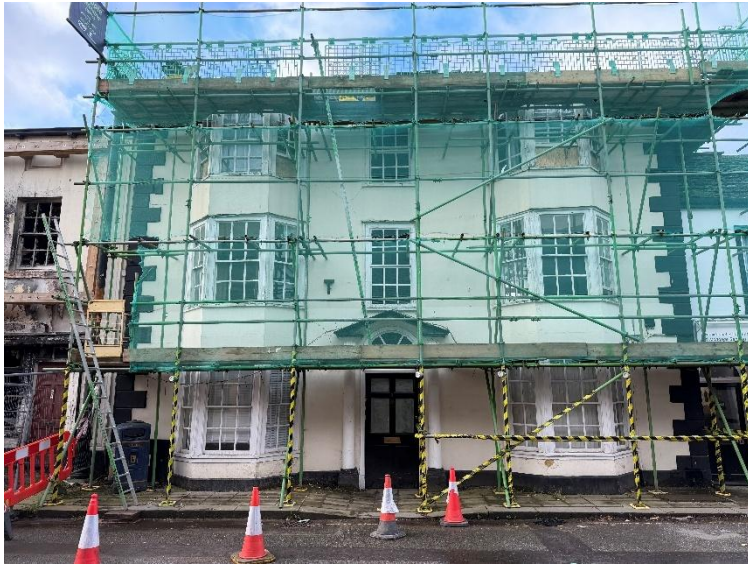
***Fig.15 Main east elevation***

The imposing rendered front is of 3 storeys with full-height canted bay windows on either side of the central entrance with an open triangular pediment and engaged pillars (**fig.15**). Projecting rendered quoins. The entrance hall has a false painted fanlight over the door (**fig.17**), and above that a false 6x6 sash with an architrave surround (**fig.16**). 6x6 sash windows with 4x4 side-sashes, some with original thick moulded glazing bars, some 20<sup>th</sup> century repairs. The engaged pillars are painted, but indications are that they are stone.

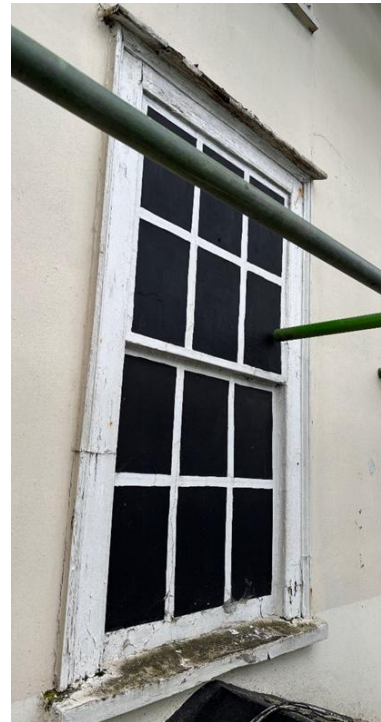
***Fig.16 False sash over central entrance***

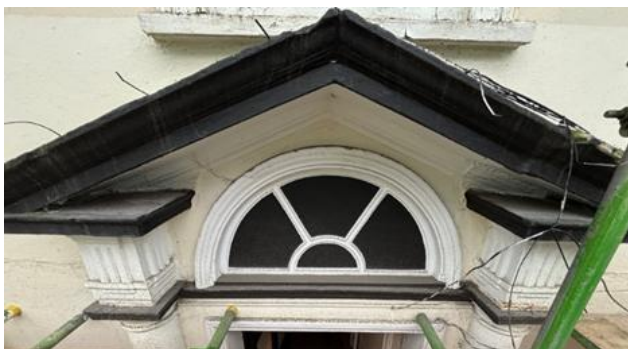
***Fig.17 Semi-circular false fanlight in open pediment***

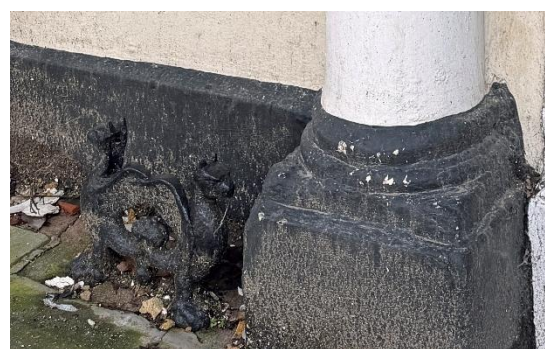
***Fig.18 Rendered base of wall with one of two bootscrapers still extant***

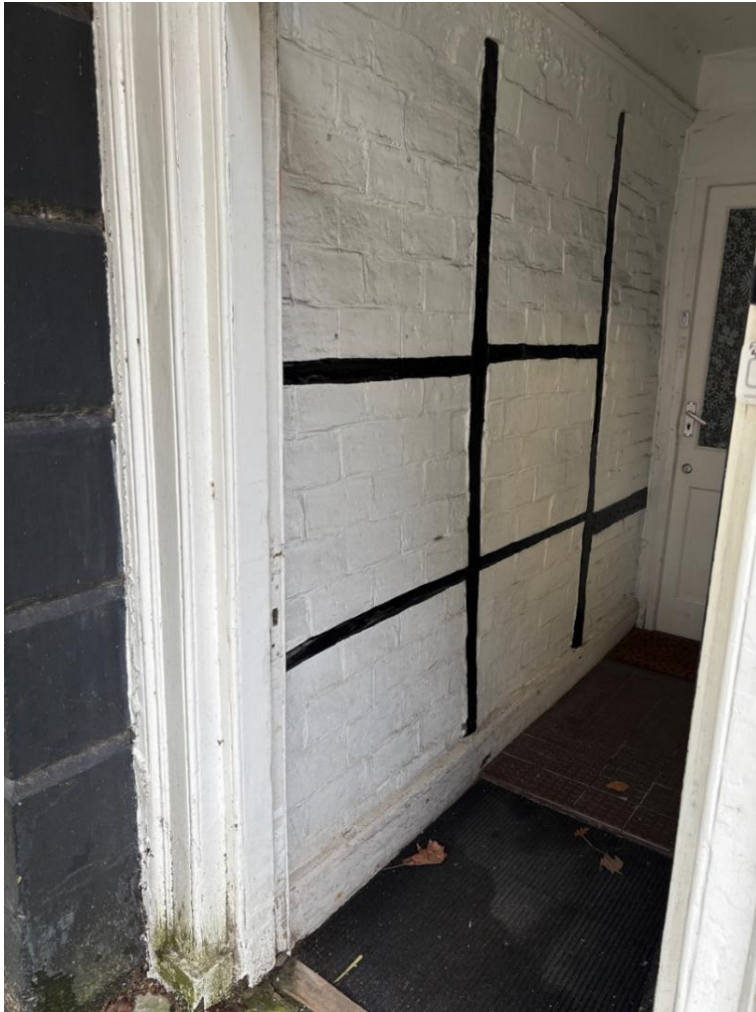
***Fig.19 Light timber-framing of c1800 with edge-set brickwork panels forming the north return***

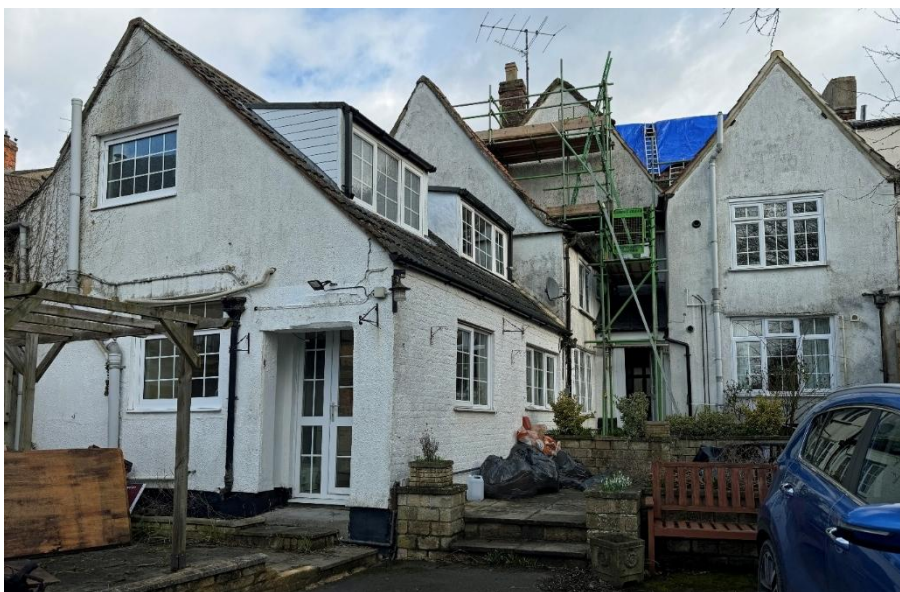
**Fig.22 Rear ranges**

The rear elevation comprises gabled ranges at right angles of differing heights. All the gables appear to have cement rendering applied at different times, the central gable with a roughcast cement render and plain clay tiles (**fig.22**).

All windows on this rear elevation are modern Upvc casements. The rainwater goods are mostly plastic, with one cast iron downpipe with rainwater head to the right-hand gable.

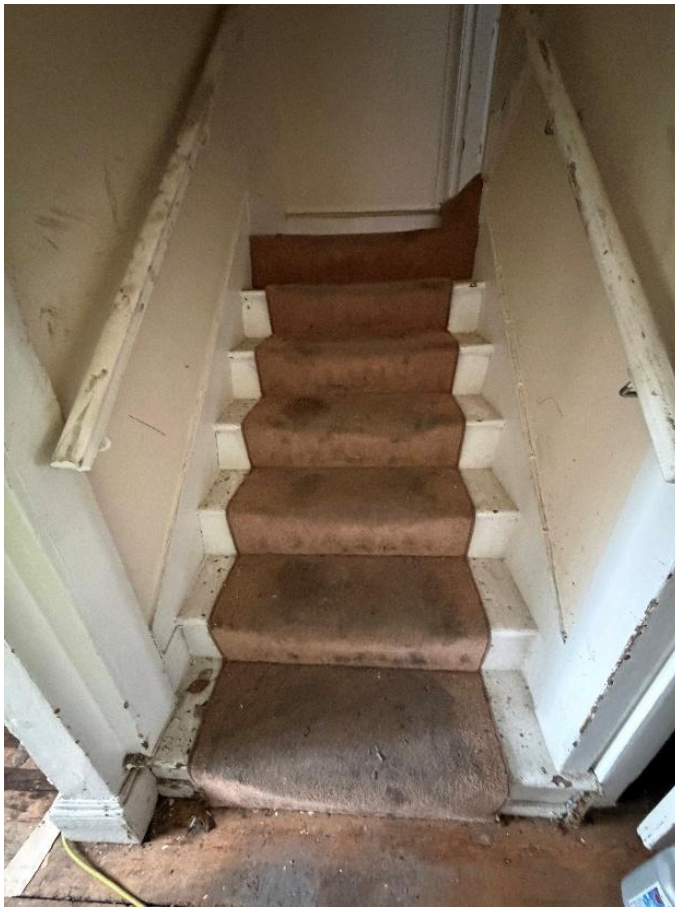
**Fig.23 Lower enclosed flight**

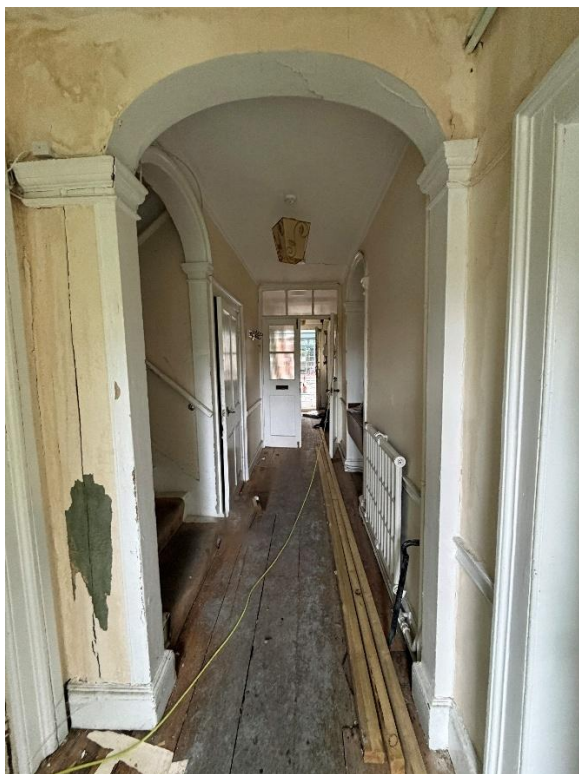
This narrow hall runs from the front to back doors (**fig.24**). Before c1800 the back door was in line with the exterior wall on the west side of the stair position. After c1800 this had been extended in the remodelling under a lean-to to cover the entrance to the rear wing, which had become the kitchen for the house. Much of the decorative detail in the architrave surrounds, softwood floorboards and dado rail appears to date from this phase (**fig.26**). Alteration has taken place in the room access. Kitchen 1 had a secondary access made from the small lobby opposite the stair.

***Fig.24 Hall looking towards front door. Note the stilted segmental arches with moulded imposts. The closest arch may have lost its moulded architrave surround. The glazed double doors with overlight is circa 1900***

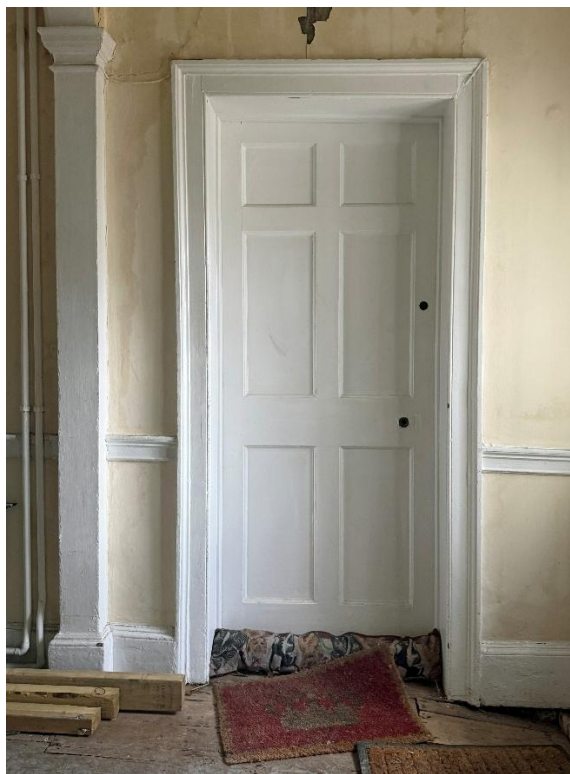
***Fig.25 Good 6-panel door to Bedroom G1, with original skirting board***

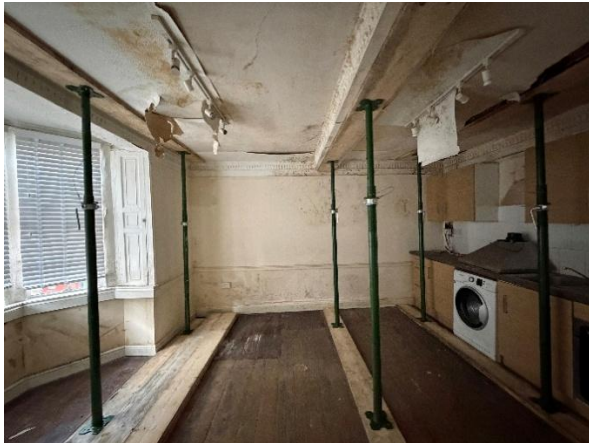
Formerly the drawing room in c1800. This has a contemporary residual decorative scheme of moulded plastered beam, cornice, dado, skirting boards and canted bay window with fielded panelled shutters (**fig.30**). The fireplace on the back wall is obscured by late 20<sup>th</sup> century kitchen cabinets and tiling. This room has a good cornice of stylized acanthus leaves with a frieze of what appears to be Lincrusta (**fig.28**). This also runs along the lath and plastered beam (**fig.29**). The picture rail is likely to be later.

**Fig.27 Kitchen 1 looking south**

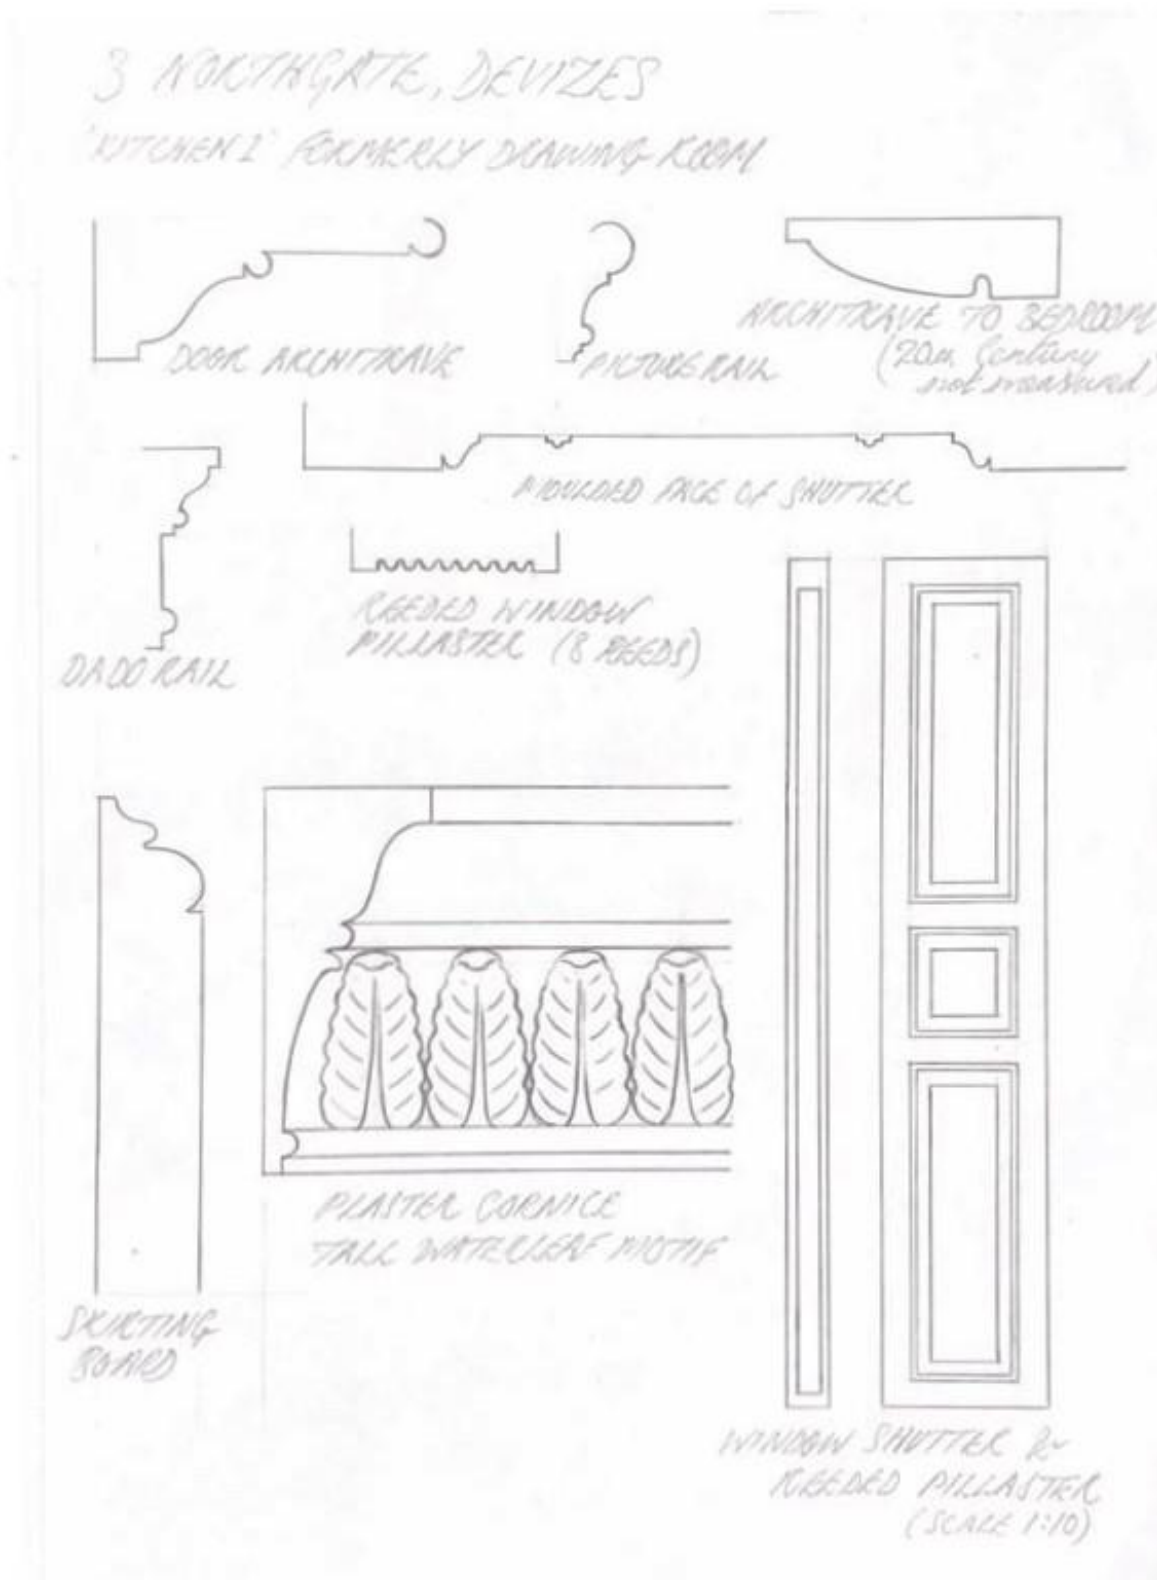
**Fig.30 Kitchen 1 details**

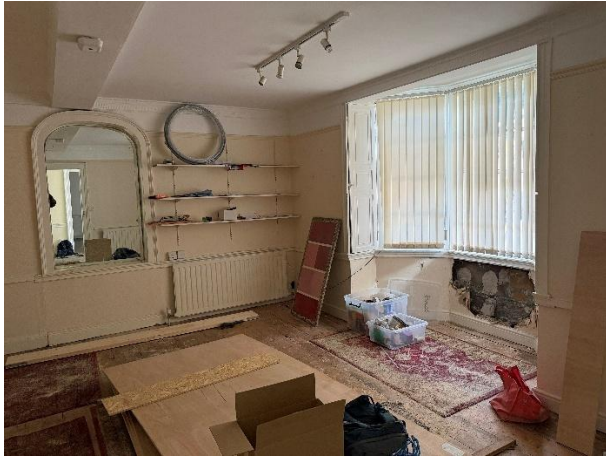
running band of acanthus leaves makes up the top of the cornice and along the beam, with a ribbed frieze and picture rail. Is this frieze present in Kitchen 1 under the Lincrusta? A recess in the north wall has a stilted arched architrave surround, as seen throughout the house (**fig.31**). A small en-suite kitchen (kitchen 2) has been partitioned off in the south-west corner of the room. Accommodation has been made in the west wall in the kitchen to house a handbasin for the WC created under the stair.

**Fig.31 Family room looking north**

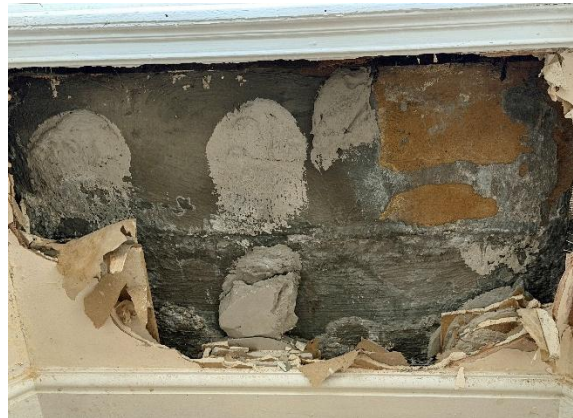
Designated as a dining room in c1800. A mirror image of Kitchen 1 (former drawing room) but with more restrained plasterwork (**fig.36**). Part of the plasterwork has been removed from inside the bay window, revealing ashlar stone beneath (**fig.32**). The same

**Fig.32 Ashlar stonework inside bay**

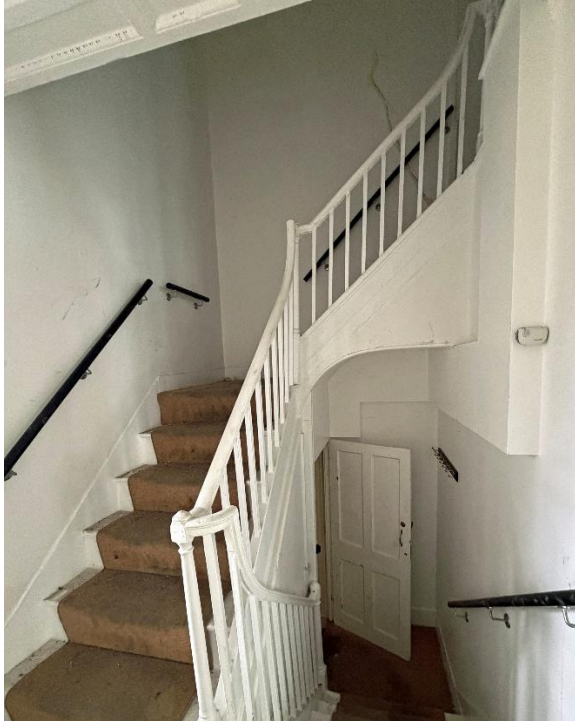
**Fig.42 Stair from ground floor**

The stairs are of c1800 date with typical stick balusters and turned newel and knee-and-ramp stages to each flight. The east wall has a boxed projection where the upper flight attaches, and this is presumably a modification of existing fabric, or a support to the attachment to it (**fig.42**). The staircase has been evidently created in the angle between the front and rear ranges, necessitating this intervention.

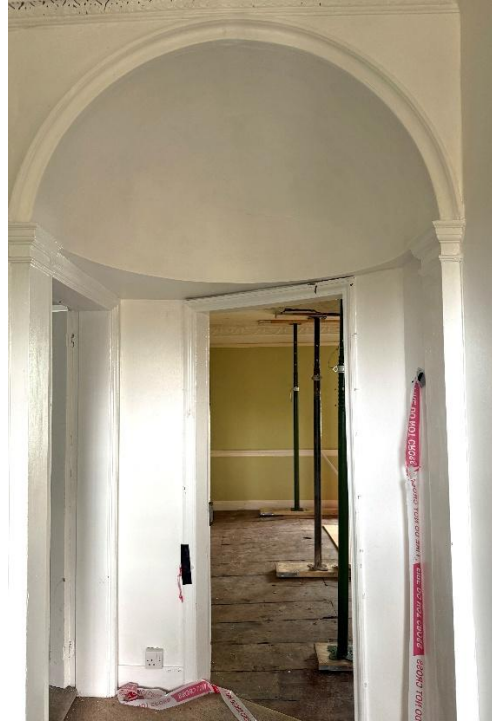
**Fig.43 Half dome over lobby to front bedrooms**

A domed lobby area between the front rooms is presumably an accommodation of the c1800 rebuild imposed on the late 16<sup>th</sup> or 17<sup>th</sup> century fabric (**fig.43**). This dome is supported on either side by shallow pilasters. The skirting on either side of the pilasters is plain, and does not continue the mouldings, which may suggest a phased scheme.

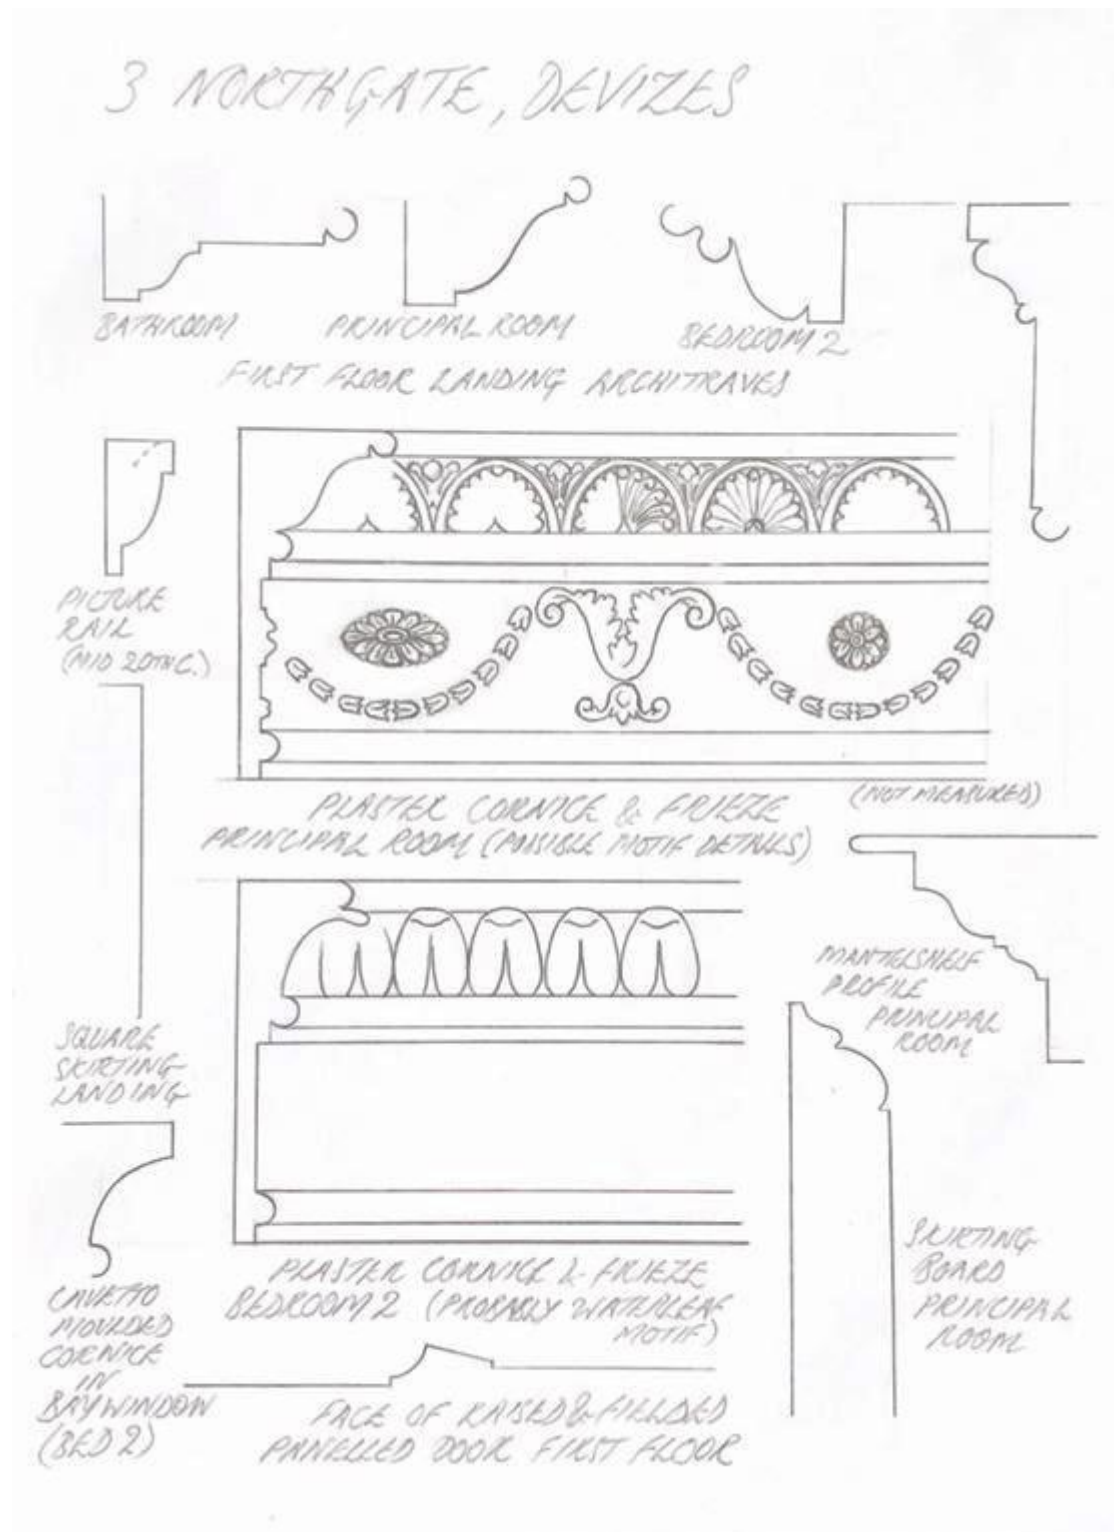
Carpeted bedroom. Lath and plastered ceiling with plastered transverse beam. Later picture rail. Acanthus leaf cornice much overpainted with consequent loss of detail (**figs.46 & 49**). Exterior walls dry-lined with plain skirtings. Bay window with thick 1½" (4.5cm) moulded glazing bars, some repairs (**fig.47**). Floor covered with fitted carpet, so boards beneath not seen.

**Fig.49 Bedroom 2 Details**

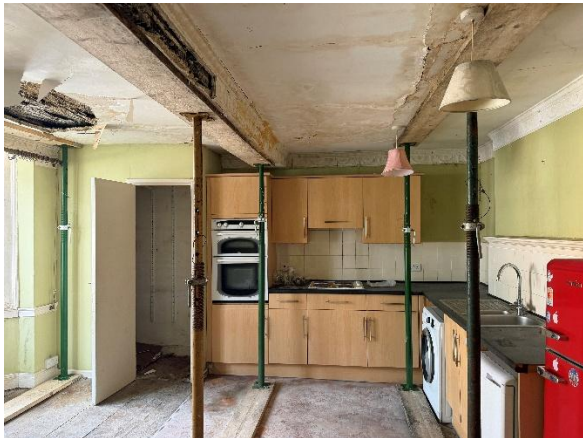
**Fig.50 Kitchen 4 from doorway**

This room was not safe to enter, so observations and photographs were made from the doorway (**fig.50**). Used as a kitchen, the fittings are similar to those in the flat below (kitchen 1).

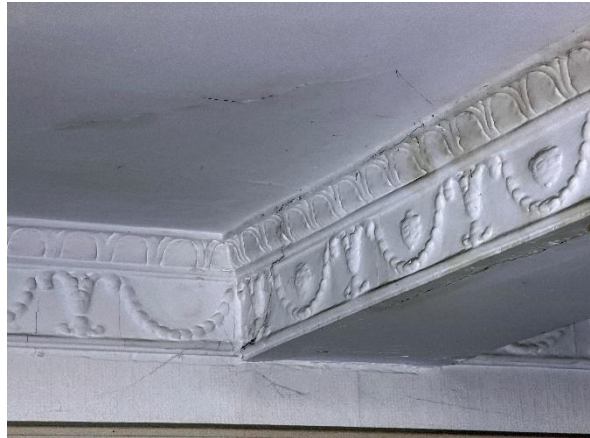
**Fig.51 Detail of egg-and-dart moulding, with swagged frieze**

The ceiling and beam are lath and plastered with more complex mouldings than in all the other rooms. It is likely that this was a principal reception room as well as bed chamber at the front of the house (**fig.51**). Where the plasterwork has fallen away, the beam beneath appears to be constructed of two separate sections. Original riven laths are visible where the plaster has fallen from the ceiling (**fig.53**). The historic floorboards are of wide oak and possibly the originals (**fig.52**).

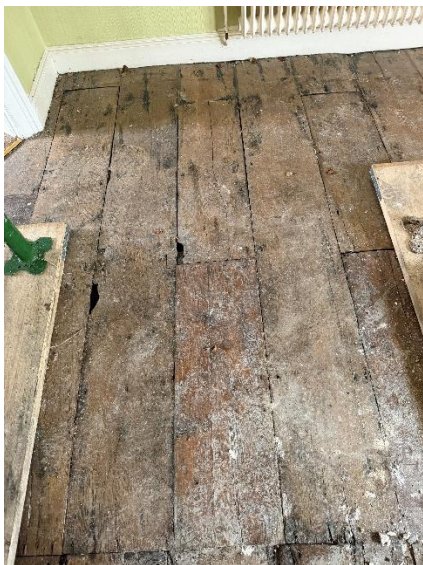
**Fig.52 Historic floorboards**

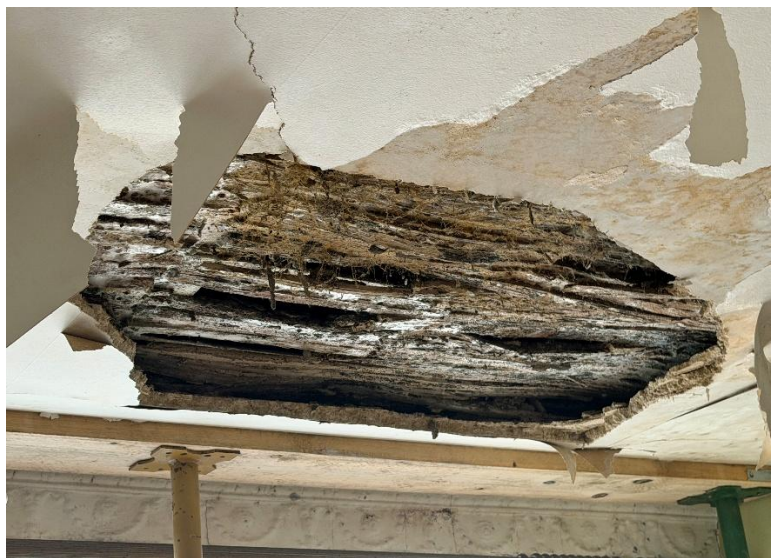
**Fig.53 Laths exposed in ceiling**

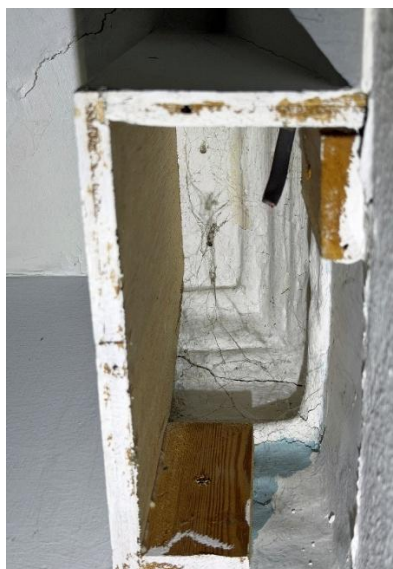
This chamber converted to a bathroom, possibly fitted out in 2013 when permission was given to allow the ground floor rooms to be used as flats<sup>4</sup>. Most of the linings to walls and floor are modern, but a small section of the original cornice is retained within boxing next to the entrance (**fig.57**). The ceiling retains a historic plastered beam (**fig.54**) and 4-panelled doors (**fig.55**). The door to the closet appears to have been added later, and the original entrance to this closet was from the front room (kitchen 4).

**Fig.57 Part of original cornice seen inside boxing**

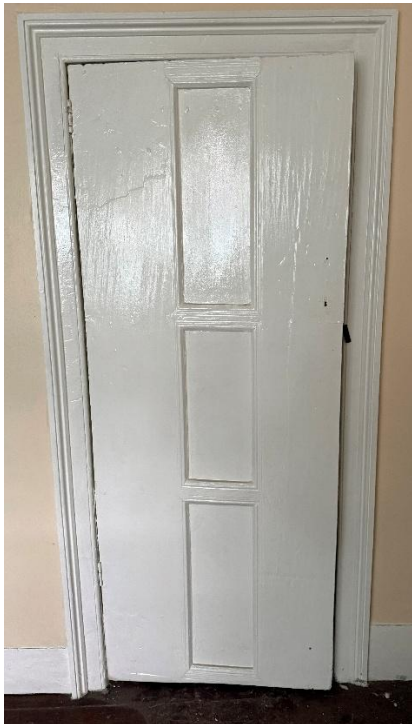
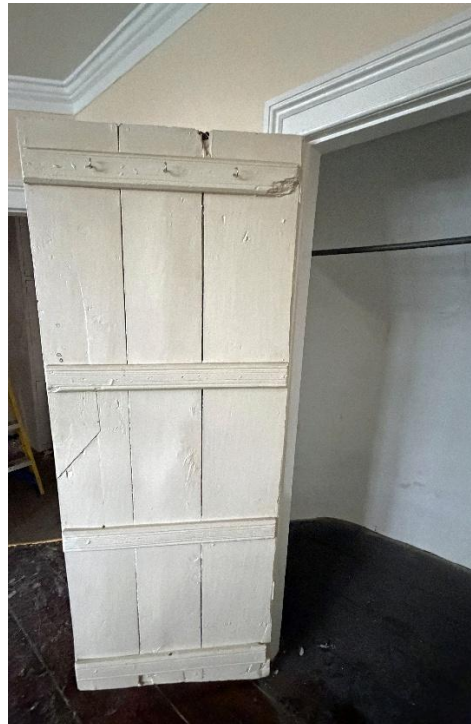
Cupboard formed with lath and plaster stud partition against chimney stack with good 3-plank 18<sup>th</sup> century door (**figs.61 & 62**), formerly on strap hinges from evidence of witness marks, now on slot-headed screws. A lath and plaster lining.

***Figs.61 & 62 Outer and inner skins of later 17<sup>th</sup> century door***

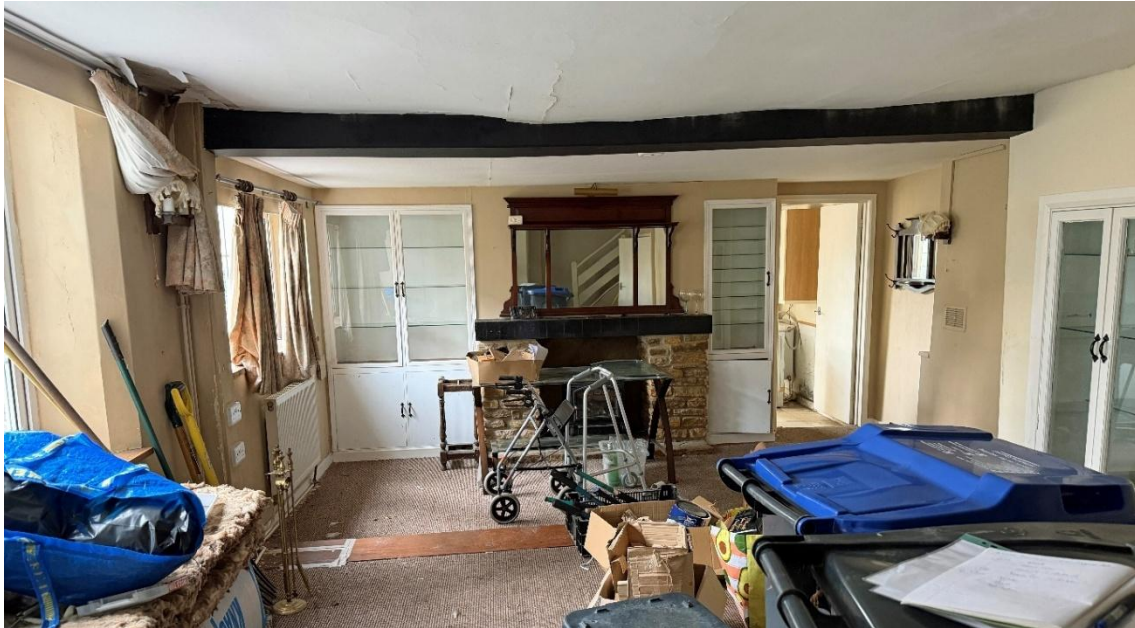
**Fig.64 Sitting Room looking west to false fireplace. A partition wall was at the step down and the beam above may be a boxed steel**

This is a separate, self-contained unit, and does not communicate with the front of the house at first floor level. It comprises a main, large living room with smaller kitchen to the rear. There is a step down to a lower floor half-way through the room, level with the wall between the windows (**fig.64**). A plan of c1800 shows this room was originally divided into a main kitchen at the front, with a back kitchen or scullery behind, housing a water pump. A second door led to a small pantry within the back kitchen. The floors here are solid.

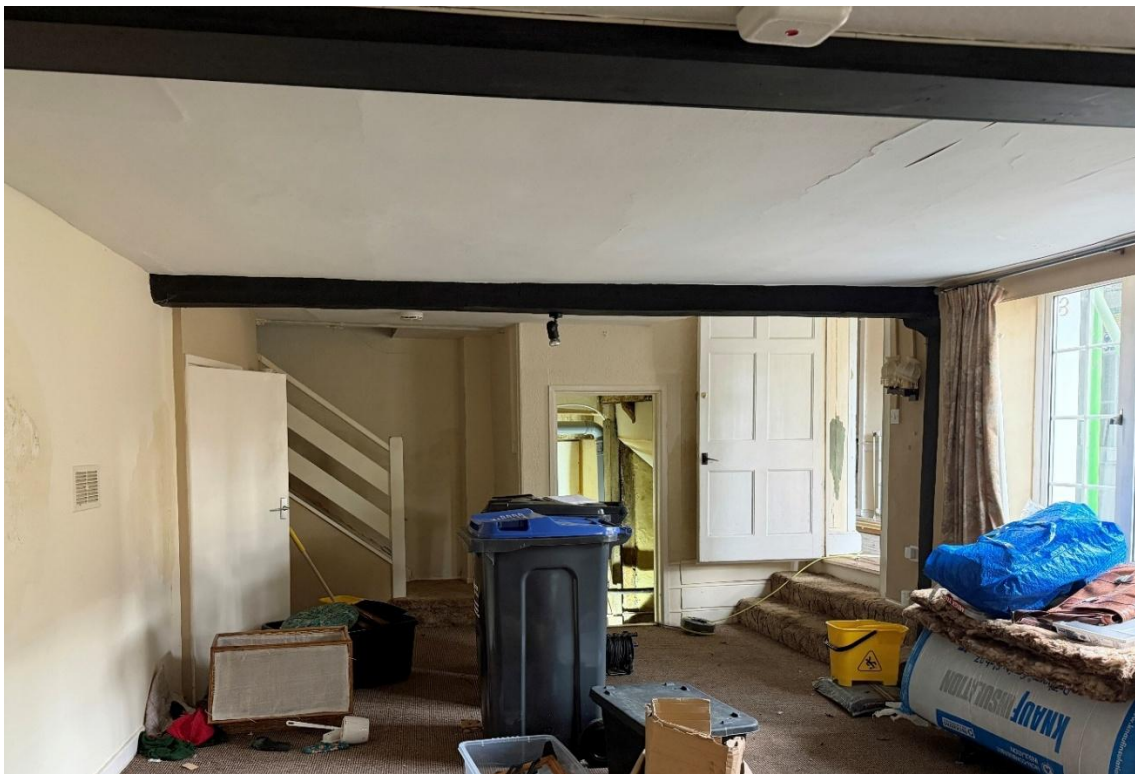
**Fig.65 Blocked kitchen fireplace (left), c1960 stair, cellar entrance and 6-panel door on HL hinges**

Entrance to the wing inside the back door involves 3 steps down. A domed cut-away facilitates the inwards door-swing, and mirrors the same arrangement on the first floor. The door is of 6 panels and hung on HL hinges (**fig.65**). The only example of this hinge type in the house, excepting the others being of 19<sup>th</sup> century date or later. The ceiling here is likewise stepped, with the eastern, upper part lath and plastered, the lower part at the west end being 49lasterboarded. One older reused beam has been identified, partly resting on a curved bracket and shallow pilaster at the south end. The beam has a wide chamfer indicating at least an early 17<sup>th</sup> century date. At the south end there is evidence that the decorative chamfer stops – apparently bars – have been cut away, perhaps to disguise it as a reuse from an older structure (**fig.66**).

A modern stair has been inserted at the east end of this room (**fig.65**). A pencilled note on the underside of the stair gives the names of painters working on the house in 1961 (**fig.69**)

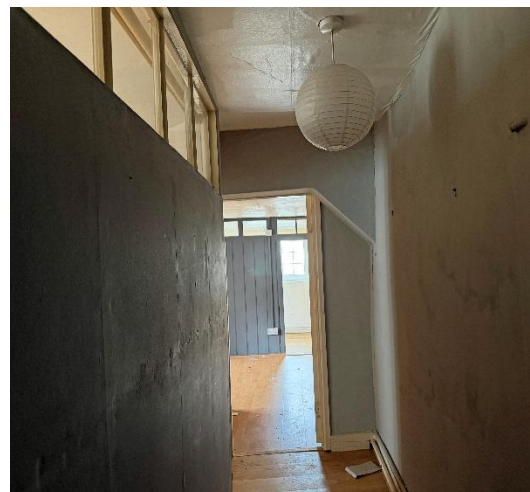
The **corridor** is of hardboard with borrowed lights over. This appears modern, but it is possible that only the linings are modern and there is an older stud frame perhaps of the c1900 – a typical feature at that time (**figs.73 & 74**). A 4-panel door is still in situ in this corridor partition. Similarly, a c1900 tongue and grooved plank partition to end bathroom 3 has a borrowed light over, and a 4-panel door (**fig.76**).

**Fig.73 Corridor partition**

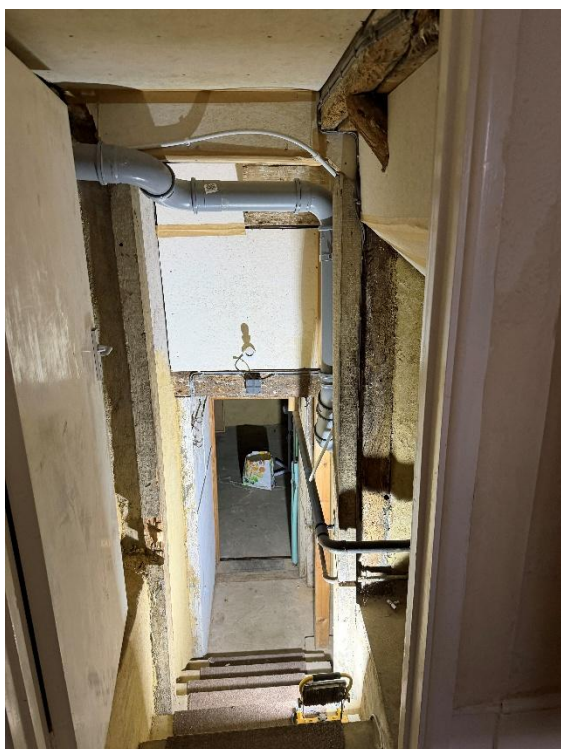
**Fig.78** Entrance to cellar from rear range    **Fig.79** Part of undercarriage for stair

Reached by 8 concrete steps and through a high doorway with one old jamb (**fig.78**). Further modern studwork encloses the cellar lobby with a flush panel door. The interior is mostly tanked with concrete floors (**fig.81**), though the north/south beam is visible

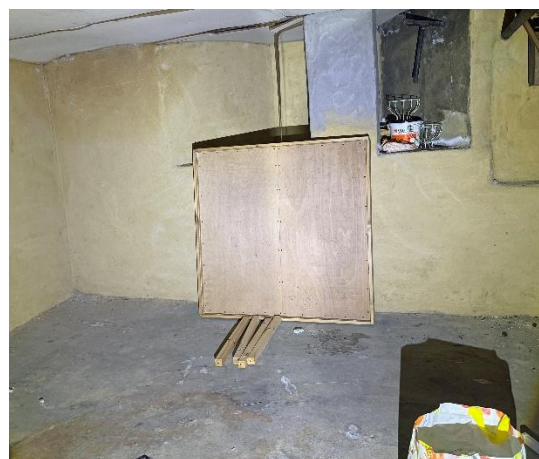
**Fig.81** Cellar interior looking towards blocked-in cellar window

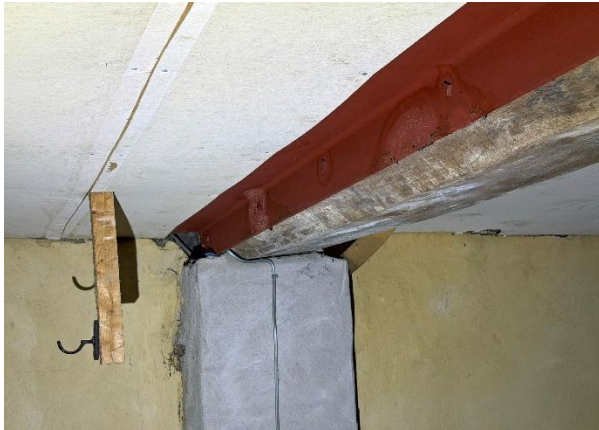
with well-formed chamfers supported by plastered brick piers at either end and an additional modern steel (**fig.82**). Either side of the beam the ceiling is covered with hardboard, once lath and plastered.

***Fig.82 Reused 17<sup>th</sup> century beam in cellar***

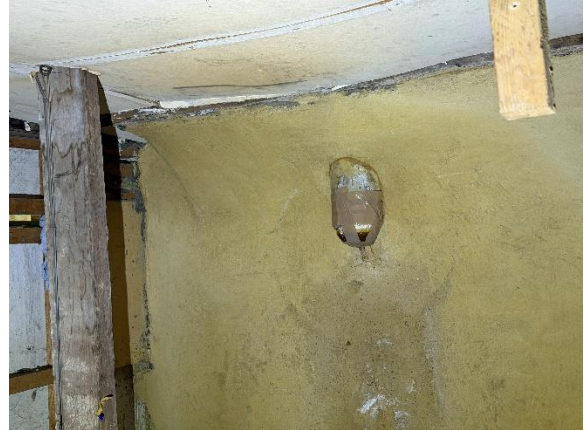
Against the rear wall is coving associated with the support for the fireplace hearth above in the family room (**fig.83**).

***Fig.83 Coving for hearth above in family room***

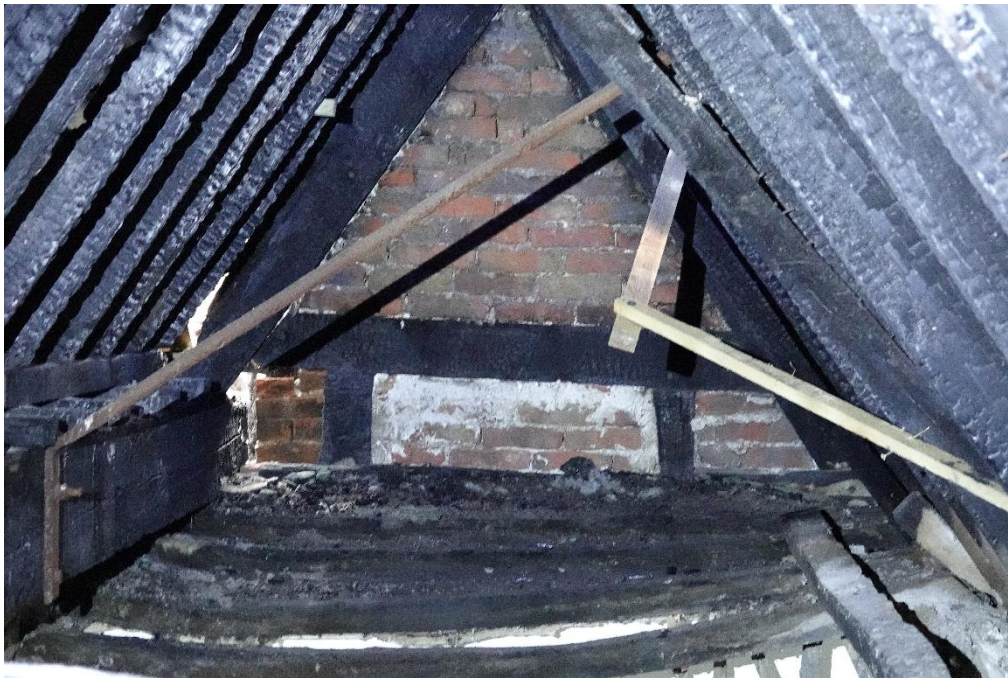
**Truss T1** at the SE end has been affected by the recent fire spreading from the adjacent building which has charred the common rafters and destroyed many of the ceiling joists to the bedroom below. As seen from the loft hatch (**fig. 84**) the truss has principal rafters and a collar, with two heavy studs beneath, each single-pegged. The frame infilling is brick. The apex is bridled and single-pegged, with no yoke (on this NW side at least)

**Fig.84. Truss T1 as seen from the loft hatch**

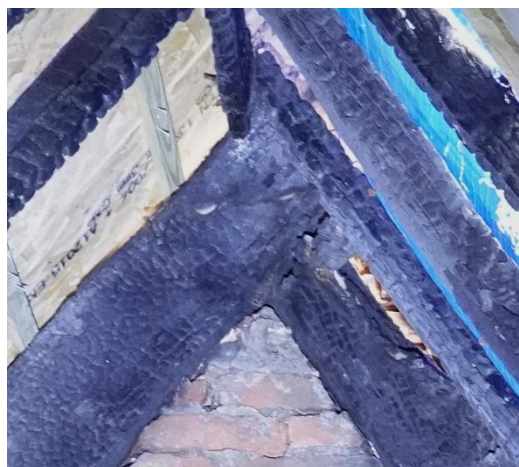
(fig.85). The ridge is a thin plank (fig.85). The inserted ceiling of the bedroom below now cuts across the roof space about 500mm below the collar.

**Fig. 85. The apex of Truss T1**

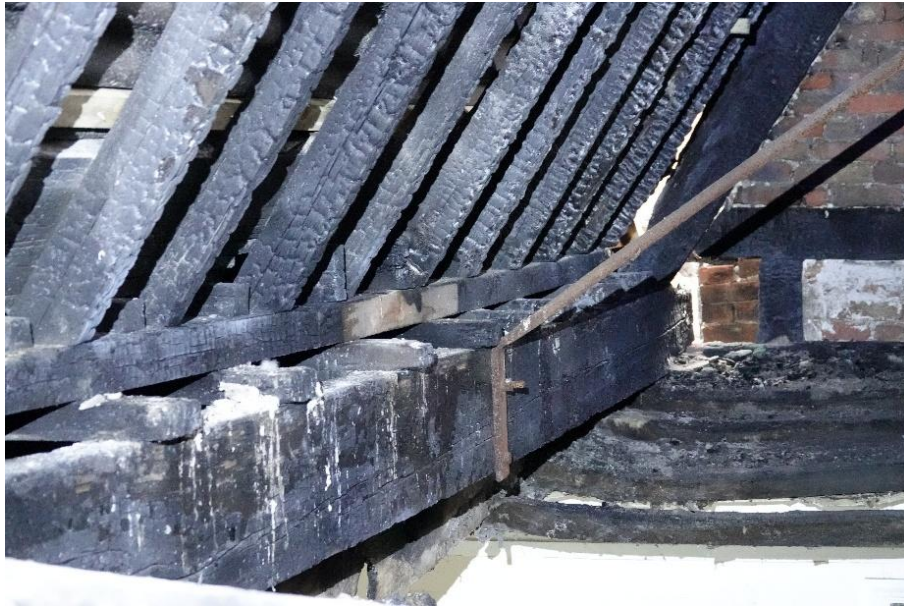
**Bay T1-T2** has no visible purlins. On the rear slope the common rafters probably extend down below the present second floor ceiling level and it is possible that a purlin survives here, embedded in the partition wall thickness below. On the front slope, the common rafters terminate at a large horizontal plate set upright; this is not a true purlin and is clearly not from the primary build. It runs the length of both bays (**figs. 86 and 87**). Indeed, the common rafters, at least on the front slope, are replacements and are carried by a thin joists and struts loading to the horizontal plate.

***Fig. 86. The horizontal plate in bay T1-T2***

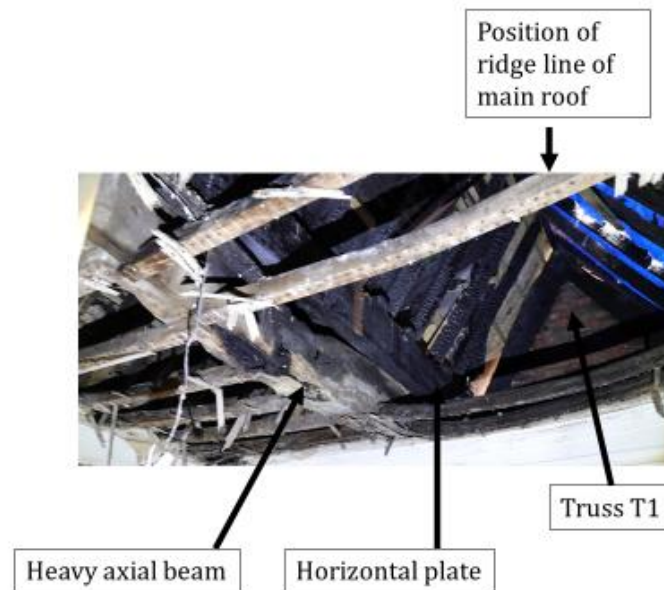
**Fig. 88. Bay T1-T2 as seen from the room below, with annotations**

To the NE of the main roof structure is a **subsidiary pitched roof**, producing overall an M-shaped roof (**figs. 88 and 89**). This subsidiary roof is much smaller than the surviving roof of the main range, although this is not apparent from the street where the roof appears to be a simple single ridge. No inspection was possible of its internal construction details beyond noting that the aforementioned inserted horizontal plate carries the common rafters from this subsidiary roof and valley. Like the main roof range, this subsidiary roof has stone tiles except where re-tiled in red clay triple-roll pantiles.

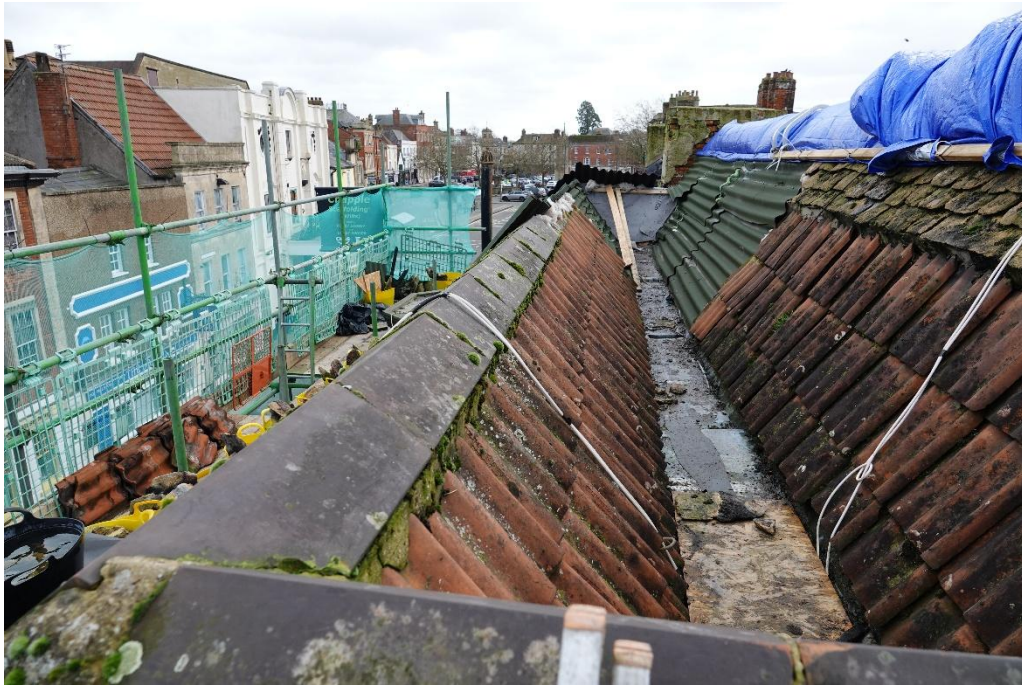
**Fig. 89. View looking SE showing the subsidiary front roof**

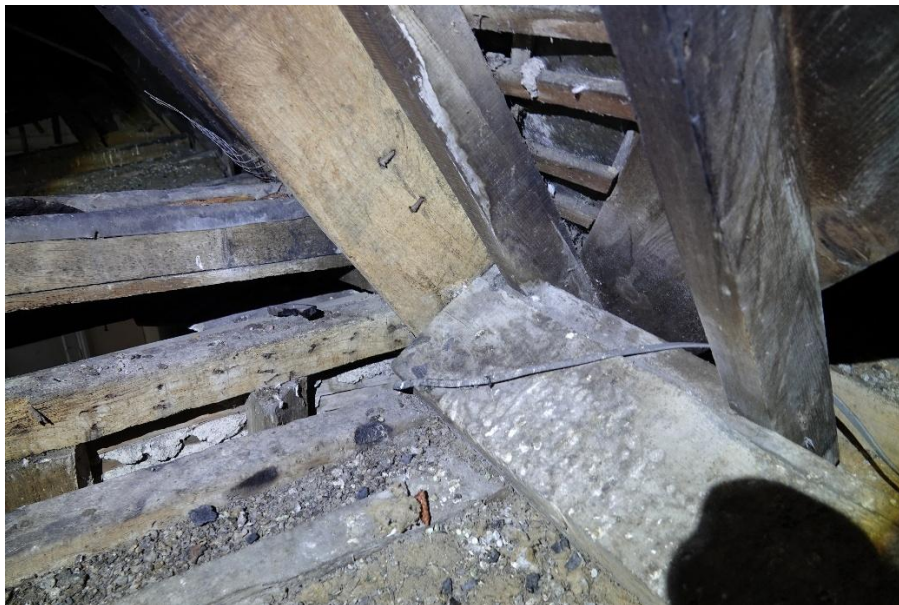
Returning to the main roof range, **Truss T2** is charred from the fire but otherwise survives. The whole truss cannot be shown in a single photograph but its individual elements are shown in **figs. 90-94** below. The principal rafter on the front slope is possibly a replacement, perhaps when the horizontal plate was added, and it is

possible the truss is a composite made from re-used elements from the primary build. However, the rear slope does still retain its primary principal rafter, 150 x 200mm in section, and this timber has some interesting features. There is an unusual carpenter's mark in the form of a chiselled double "V", see **fig. 10**. The truss apex detail is shown in **fig. 9**, and is a heavy yoke plate over a bridled joint, apparently primary, with a housing for a heavy diamond ridge piece, now replaced by a thin plank ridge.

***Fig. 92. Truss T2, showing the principal rafter on the rear slope***

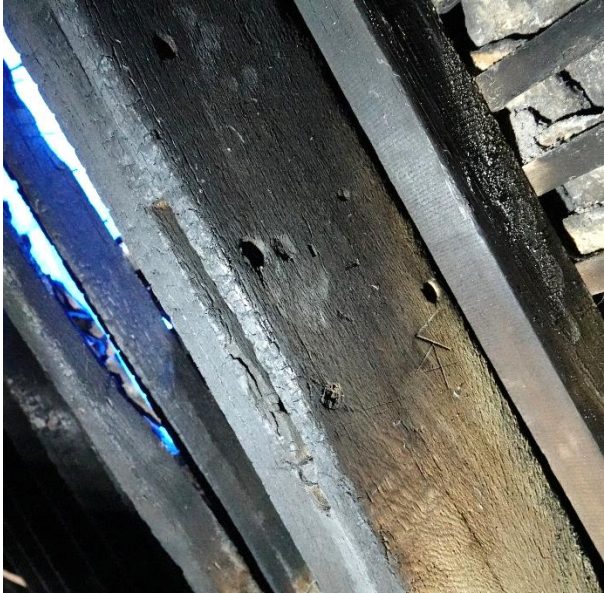
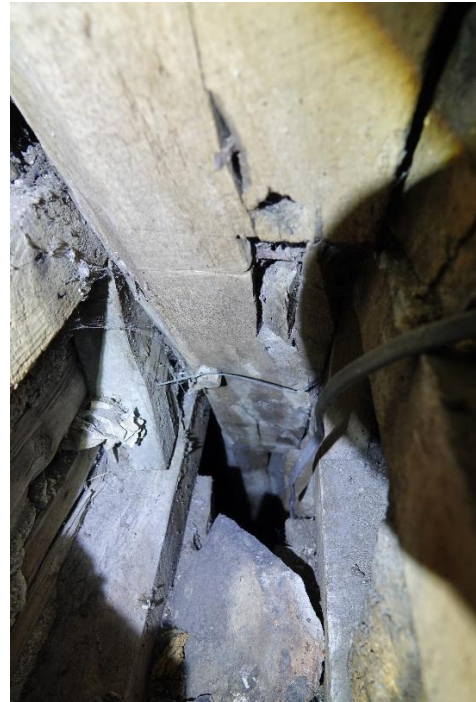
The inner face of the principal has a vacant mortise for a collar, with two vacant peg holes (**fig. 95**). This collar would have matched that still present at T1 and T3. Further down the inner face of the principal (**fig. 96**) are possibly two further vacant mortises at levels now below the ceiling line and glimpsed only down the open cavity within the lath-and-plaster partition. One of these may be from a lost lower collar or a raking rafter strut (or just possibly a lost brace or arch-brace). The other probably relates to a lost tiebeam – the roof now has no apparent tiebeams at all. Here in its lower part below the ceiling level the inner face of the principal also appears curved suggesting this is a knee principal (a “principal with a curved foot”). A chamfer appears present on lower NE

edge of the principal, (ie facing into bay T1-T2), but not on the matching SW edge (**fig. 96**).

***Figs. 95 & 96. Truss T2, showing (left) the mortise for a lost collar; (right) further vacant mortises glimpsed inside the lath-and-plaster partition***

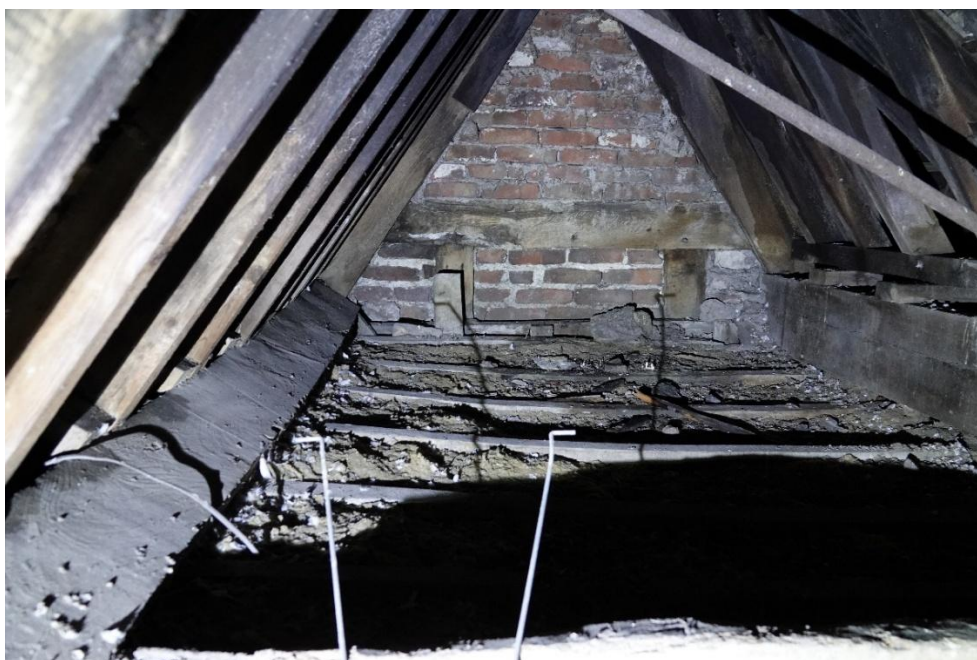
**Fig. 98. A general view of bay T2-T3 and Truss T3**

**Bay T2-T3 and Truss T3** have similar details to those already noted, the only significant difference being the presence on the rear slope of a purlin-like timber at the level of the inserted ceiling (to the left in **fig. 98**). This probably is a purlin now partly obscured by a plate affixed above it to carry the roof of the large gable wing which abuts the main range in this bay (described below). In the equivalent position on the front slope is the horizontal plate noted already. The apex of T3 is shown in **fig. 99** and is a heavy yoke plate applied over a bridled joint. As with T1 and T2, the ridge here is a lightweight plank evidently replacing an earlier heavy diamond ridge. On this truss the yoke can be seen to be pegged though to the principals.
