# **3 Northgate Street, Devizes**

**A Historic Buildings Statement**

**February/March 2026**

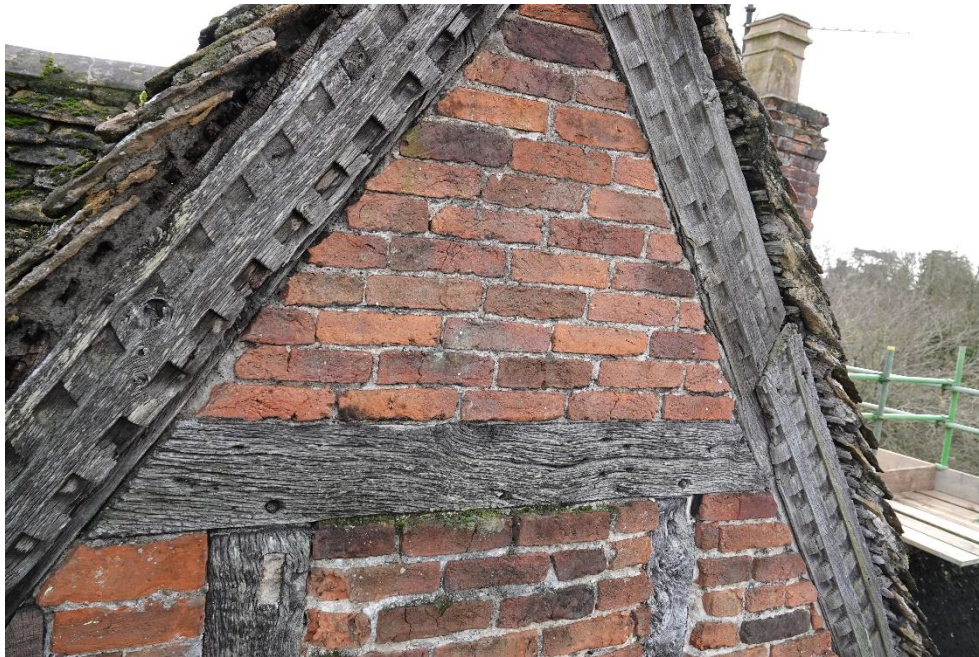
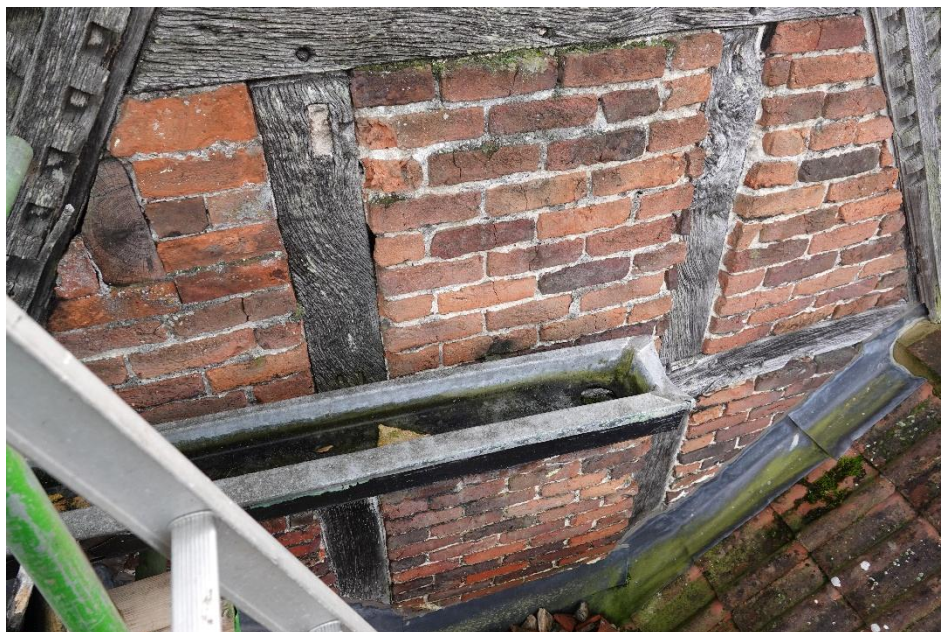
The framing visible on T3 matches that of T1 and T2, i.e. a collar with two heavy studs below it, single-pegged. This framing is also readily visible externally (**figs. 100 and 101**), where it is apparent that there was originally a central stud below the collar, matching the two surviving, and suggesting a lost gable window here. Externally the gable has decorative dentillated bargeboards. Although these boards are applied, they are probably primary.

**Fig. 100. Truss T3 and the timber-framing of the end wall**

**Fig. 101. Truss T3 and the timber-framing of the end wall, lower part**

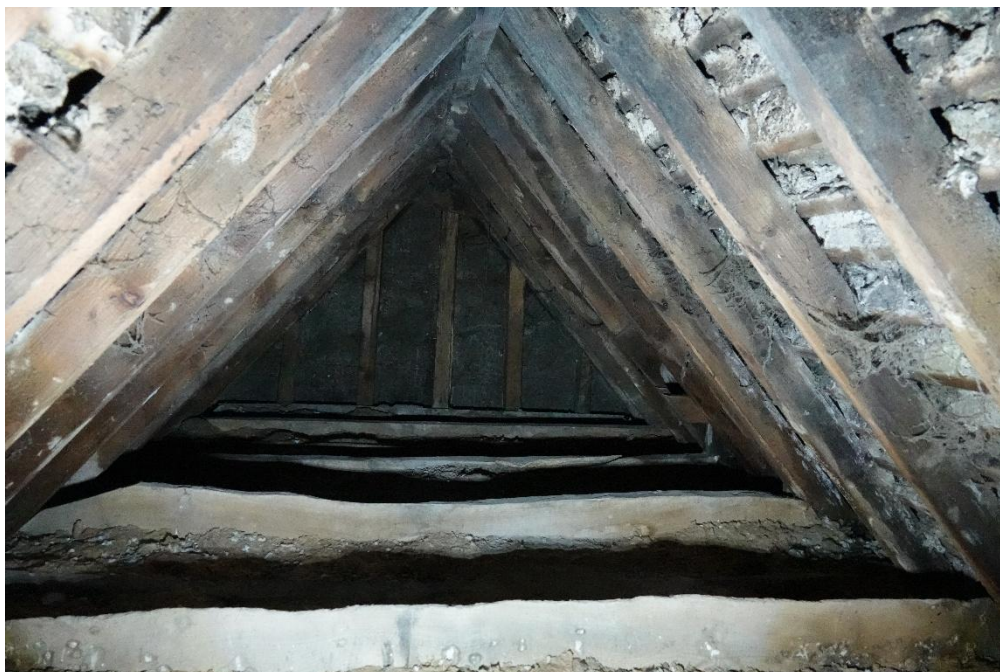
From the evidence of the roof timbers of the rear range gable seen from the main roof, this is a short extension to the main range of c1800, and no earlier (**fig.103**).

***Fig. 103. The roof of the rear wing (bedroom 2)***

The roof is without any truss and is constructed from simple common rafter pairs up to a plank ridge piece, with every other pair held by a collar which acts as the ceiling joist. It is clearly not primary to the main range.
