# ASBESTOS 2GO LIMITED

On behalf of:  
The Ramsbury Manor Foundation

Asbestos Refurbishment and Demolition Survey  
To Specific Locations Only

@  
Ramsbury Manor  
Ramsbury  
Marlborough  
Wiltshire  
SN8 2RG

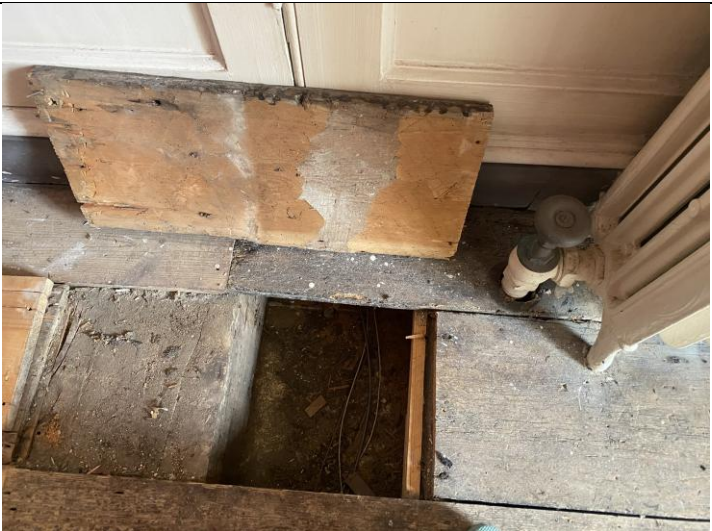
| <b>Sample Location:</b> | Ground Floor<br>North Hall | | |

| <b>Other Recommended Action:</b> | Asbestos has been found within the floor voids at all levels within the building, these materials were found during a restricted access inspection; leaving much of the floor voids uninspected. Further ACM's may be present & widespread within the uninspected parts of the floor voids.<br>We recommend to restrict all access into the floor voids, pending licensed asbestos removal works to decontaminate the voids. | | |

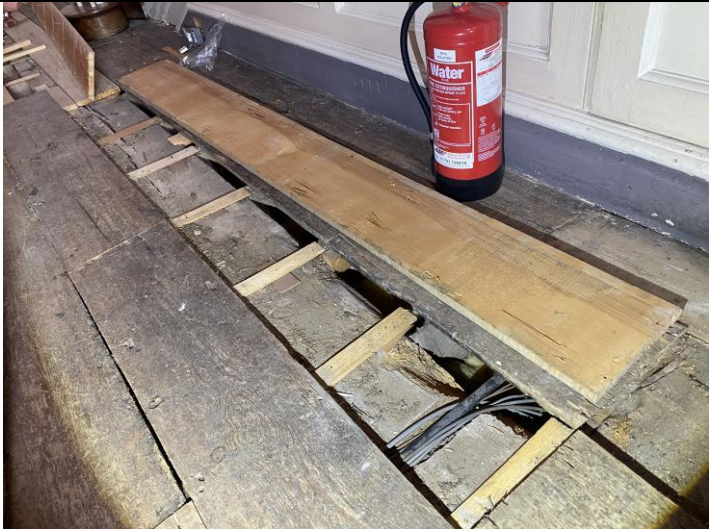
| <b>Sample Location:</b> | Ground Floor<br>North Hall | | |

| <b>Other Recommended Action:</b> | Asbestos has been found within the floor voids at all levels within the building, these materials were found during a restricted access inspection; leaving much of the floor voids uninspected. Further ACM's may be present & widespread within the uninspected parts of the floor voids.<br>We recommend to restrict all access into the floor voids, pending licensed asbestos removal works to decontaminate the voids. | | |

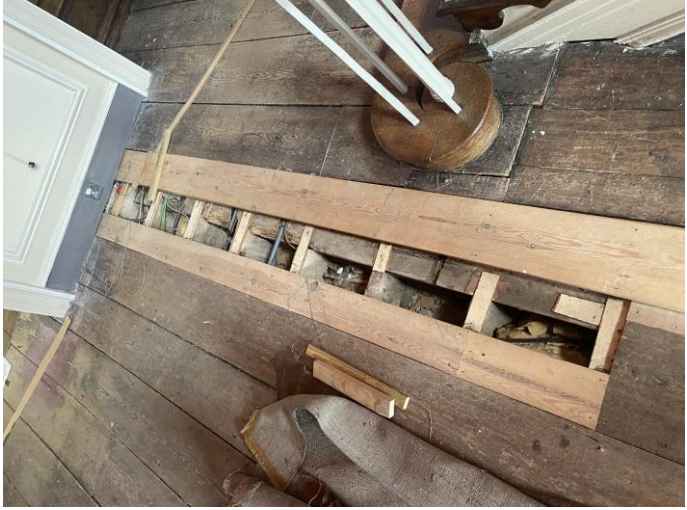
| <b>Sample Location:</b> | Ground Floor<br>North Hall | | |

| <b>Other Recommended Action:</b> | Asbestos has been found within the floor voids at all levels within the building, these materials were found during a restricted access inspection; leaving much of the floor voids uninspected. Further ACM's may be present & widespread within the uninspected parts of the floor voids.<br>We recommend to restrict all access into the floor voids, pending licensed asbestos removal works to decontaminate the voids. | | |

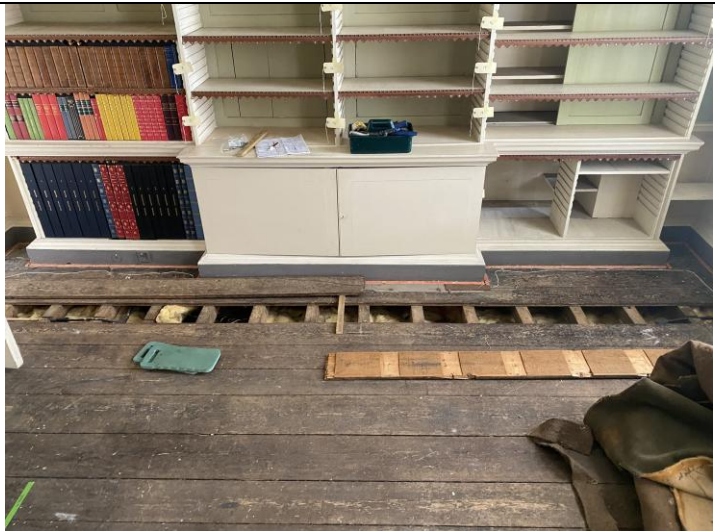
| <b>Sample Location:</b> | Ground Floor Library | | |

| <b>Other Recommended Action:</b> | Asbestos has been found within the floor voids at all levels within the building, these materials were found during a restricted access inspection; leaving much of the floor voids uninspected. Further ACM's may be present & widespread within the uninspected parts of the floor voids.<br>We recommend to restrict all access into the floor voids, pending licensed asbestos removal works to decontaminate the voids. | | |

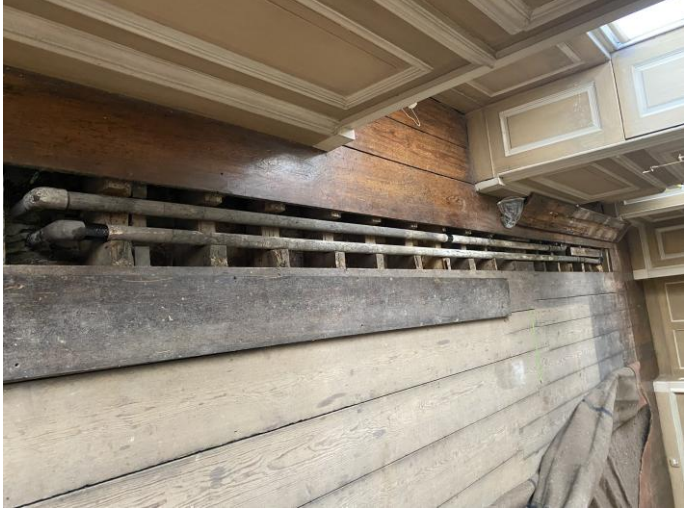
| <b>Sample Location:</b> | Ground Floor<br>Large Dining Room | | | | | |

| <b>Other Recommended Action:</b> | Asbestos has been found within the floor voids at all levels within the building, these materials were found during a restricted access inspection; leaving much of the floor voids uninspected. Further ACM's may be present & widespread within the uninspected parts of the floor voids.<br>We recommend to restrict all access into the floor voids, pending licensed asbestos removal works to decontaminate the voids. | | | | | |

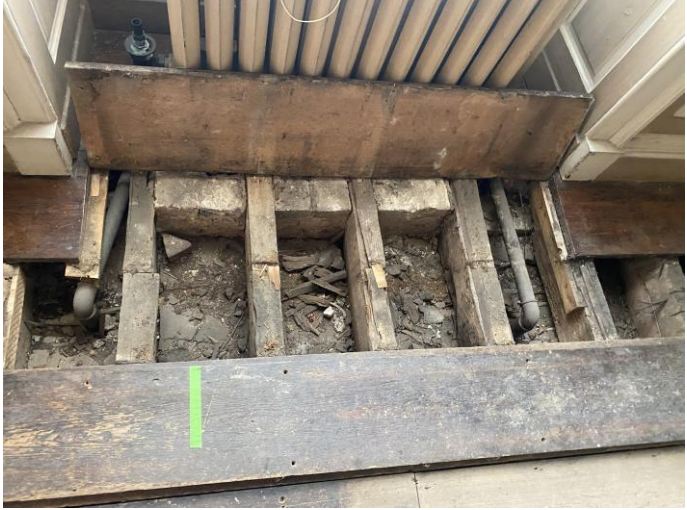
| <b>Sample Location:</b> | Ground Floor<br>Large Dining Room | | | |

| <b>Other Recommended Action:</b> | Asbestos has been found within the floor voids at all levels within the building, these materials were found during a restricted access inspection; leaving much of the floor voids uninspected. Further ACM's may be present & widespread within the uninspected parts of the floor voids.<br>We recommend to restrict all access into the floor voids, pending licensed asbestos removal works to decontaminate the voids. | | | |

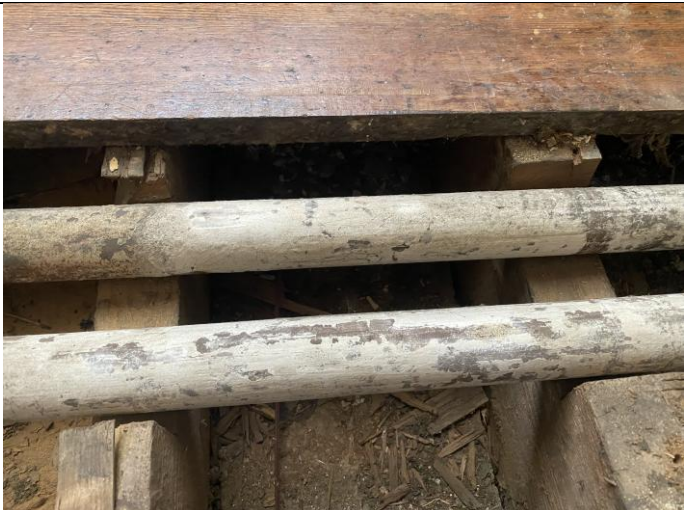
| <b>Sample Location:</b> | Ground Floor<br>Large Dining Room | | |

| <b>Other Recommended Action:</b> | Asbestos has been found within the floor voids at all levels within the building, these materials were found during a restricted access inspection; leaving much of the floor voids uninspected. Further ACM's may be present & widespread within the uninspected parts of the floor voids.<br>We recommend to restrict all access into the floor voids, pending licensed asbestos removal works to decontaminate the voids. | | |

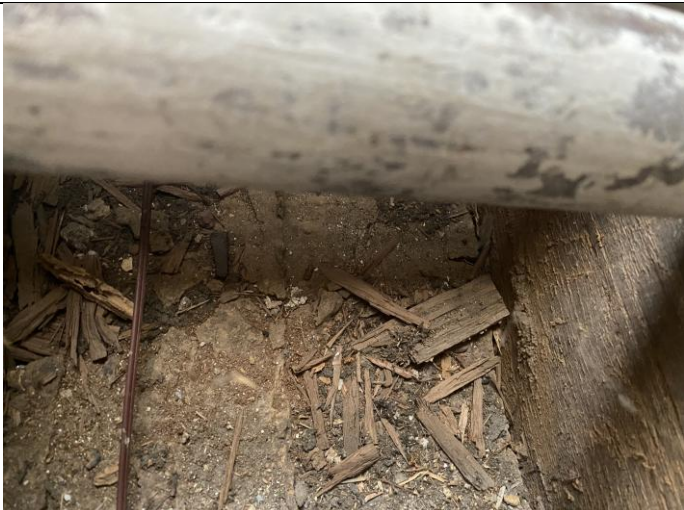
| <b>Sample Location:</b> | Ground Floor<br>Large Dining Room | | | |

| <b>Other Recommended Action:</b> | Asbestos has been found within the floor voids at all levels within the building, these materials were found during a restricted access inspection; leaving much of the floor voids uninspected. Further ACM's may be present & widespread within the uninspected parts of the floor voids.<br>We recommend to restrict all access into the floor voids, pending licensed asbestos removal works to decontaminate the voids. | | | |

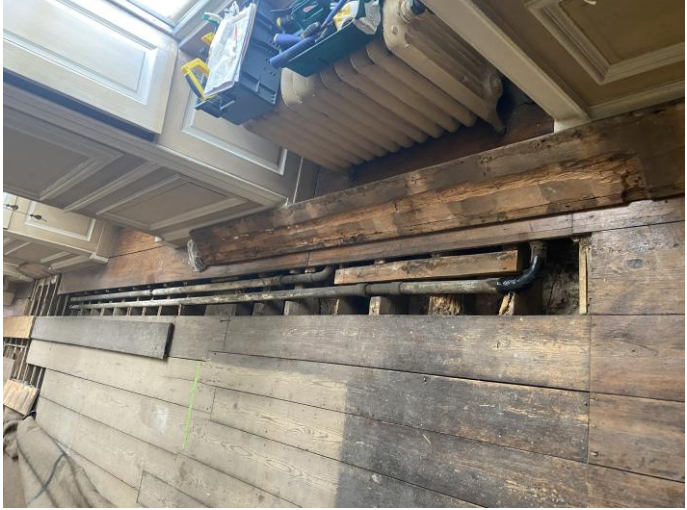
| <b>Sample Location:</b> | Ground Floor<br>Large Dining Room | | | | | |

| <b>Other Recommended Action:</b> | Asbestos has been found within the floor voids at all levels within the building, these materials were found during a restricted access inspection; leaving much of the floor voids uninspected. Further ACM's may be present & widespread within the uninspected parts of the floor voids.<br>We recommend to restrict all access into the floor voids, pending licensed asbestos removal works to decontaminate the voids. | | | | | |

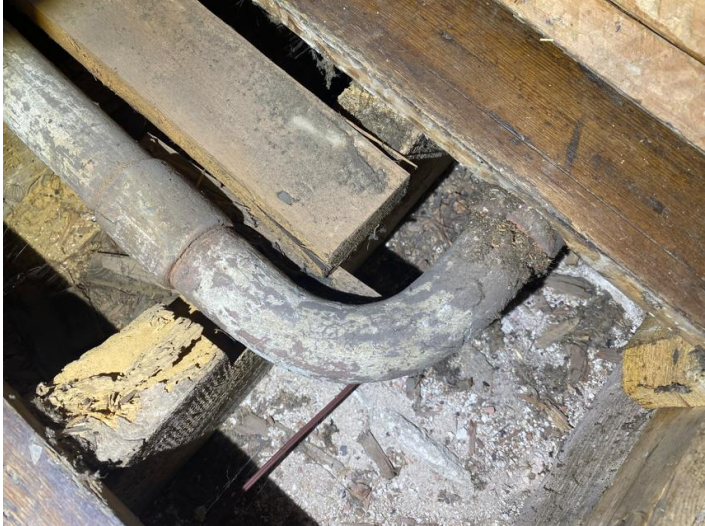
| <b><u>Sample Location:</u></b> | Ground Floor<br>Large Dining Room | | | | |

| <b><u>Other Recommended Action:</u></b> | Asbestos has been found within the floor voids at all levels within the building, these materials were found during a restricted access inspection; leaving much of the floor voids uninspected. Further ACM's may be present & widespread within the uninspected parts of the floor voids.<br>We recommend to restrict all access into the floor voids, pending licensed asbestos removal works to decontaminate the voids. | | | | |

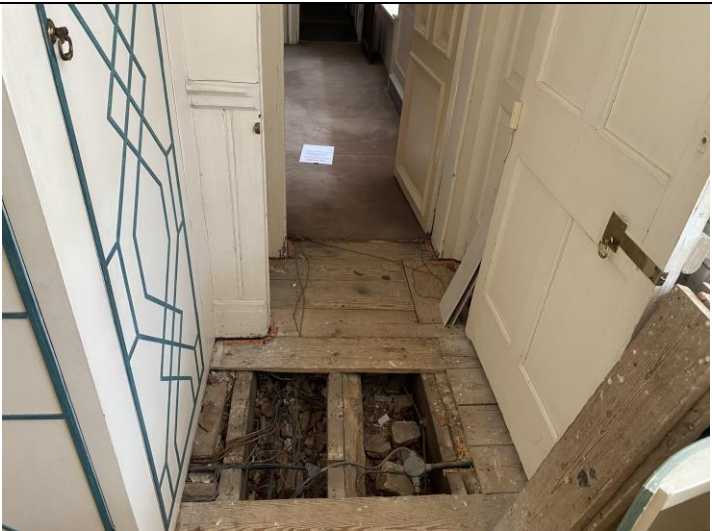
| <b>Sample Location:</b> | First Floor Mrs Hyams Dressing Room | | | | | |

| <b>Other Recommended Action:</b> | Asbestos has been found within the floor voids at all levels within the building, these materials were found during a restricted access inspection; leaving much of the floor voids uninspected. Further ACM's may be present & widespread within the uninspected parts of the floor voids.<br>We recommend to restrict all access into the floor voids, pending licensed asbestos removal works to decontaminate the voids. | | | | | |

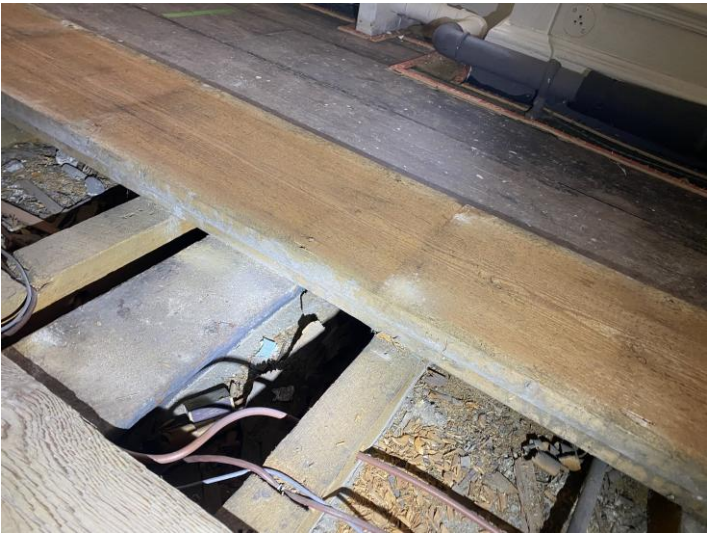
| <b>Sample Location:</b> | First Floor Yellow Bedroom | | | | |

| <b>Other Recommended Action:</b> | Asbestos has been found within the floor voids at all levels within the building, these materials were found during a restricted access inspection; leaving much of the floor voids uninspected. Further ACM's may be present & widespread within the uninspected parts of the floor voids.<br>We recommend to restrict all access into the floor voids, pending licensed asbestos removal works to decontaminate the voids. | | | | |

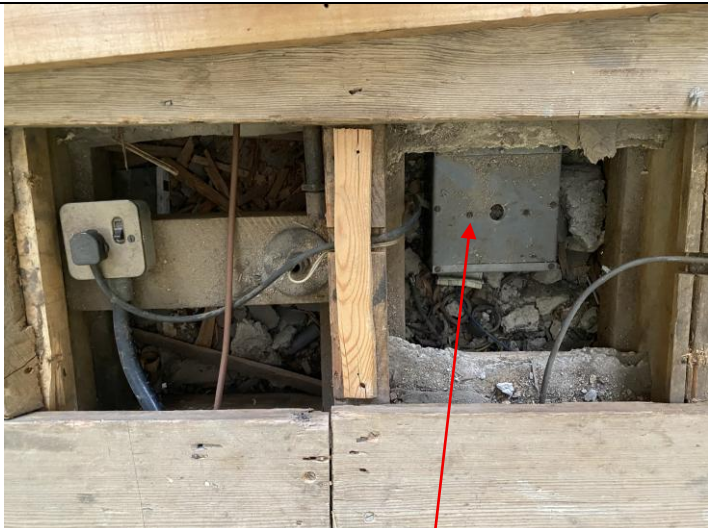
| <b>Sample Location:</b> | First Floor Yellow Bedroom | | | |

| <b>Recommended Removal Action:</b> | Removal by a licensed asbestos removal contractor | | | |
| <b>Other Recommended Action:</b> | Asbestos has been found within the floor voids at all levels within the building, these materials were found during a restricted access inspection; leaving much of the floor voids uninspected. Further ACM's may be present & widespread within the uninspected parts of the floor voids.<br>We recommend to restrict all access into the floor voids, pending licensed asbestos removal works to decontaminate the voids. | | | |

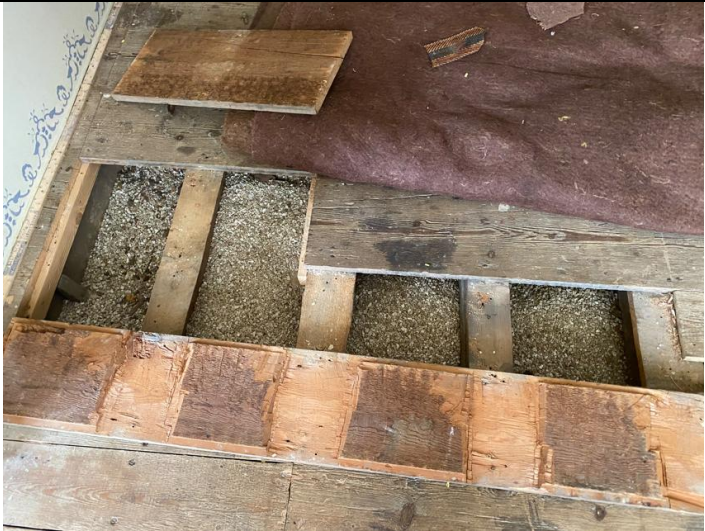
| <b>Sample Location:</b> | First Floor Mrs Hyams Bathroom | | |

| <b>Other Recommended Action:</b> | Asbestos has been found within the floor voids at all levels within the building, these materials were found during a restricted access inspection; leaving much of the floor voids uninspected. Further ACM's may be present & widespread within the uninspected parts of the floor voids.<br>We recommend to restrict all access into the floor voids, pending licensed asbestos removal works to decontaminate the voids. | | |

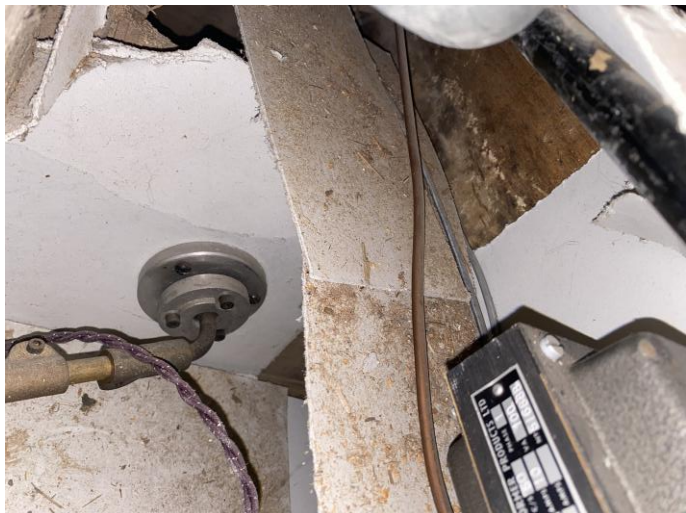
| <b>Sample Location:</b> | First Floor Mrs Hyams Bathroom | | | |

| <b>Recommended Removal Action:</b> | | Removal by a licensed asbestos removal contractor | | |
| <b>Other Recommended Action:</b> | | Asbestos has been found within the floor voids at all levels within the building, these materials were found during a restricted access inspection; leaving much of the floor voids uninspected. Further ACM's may be present & widespread within the uninspected parts of the floor voids.<br>We recommend to restrict all access into the floor voids, pending licensed asbestos removal works to decontaminate the voids. | | |

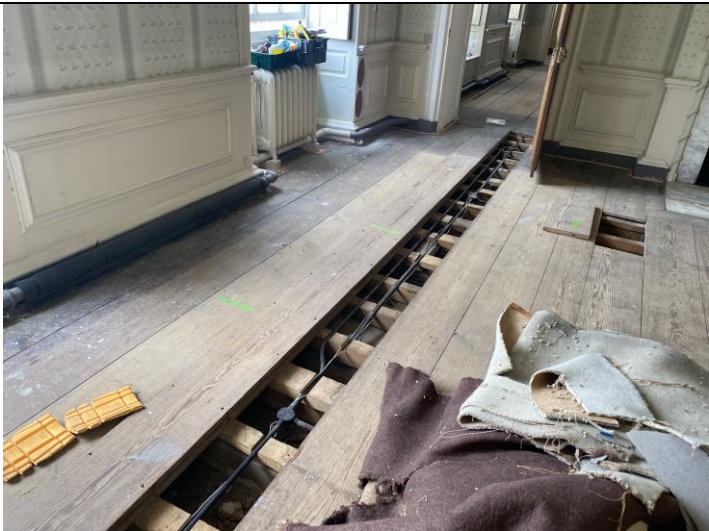
| <b>Sample Location:</b> | First Floor Mrs Hyams Bedroom | | |

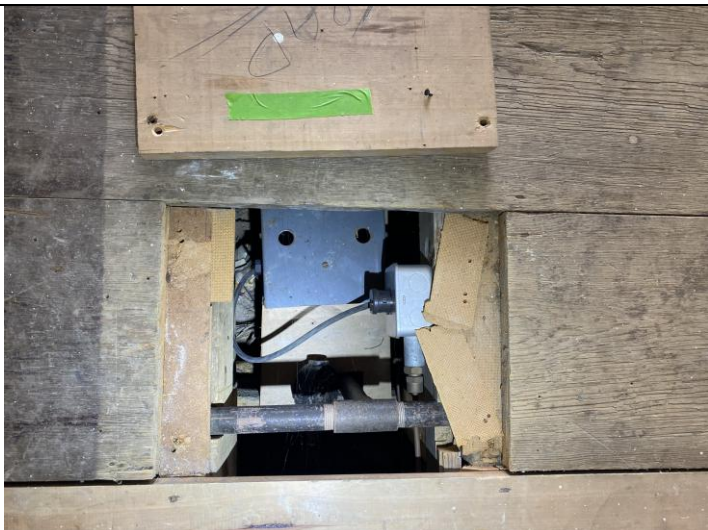
| <b>Sample Location:</b> | First Floor Mrs Hyams Bedroom | | | |
| <b>Extent of damage:</b> | High damage | 3 | <b>Approximate Extent/Quantity:</b> | Metal electrical box internal lining panels = <1 Sqm |

| <b>Recommended Management Action:</b> | | Add to asbestos register; Label & manage risk until removed | | |
| <b>Recommended Removal Action:</b> | | Removal by a licensed asbestos removal contractor | | |

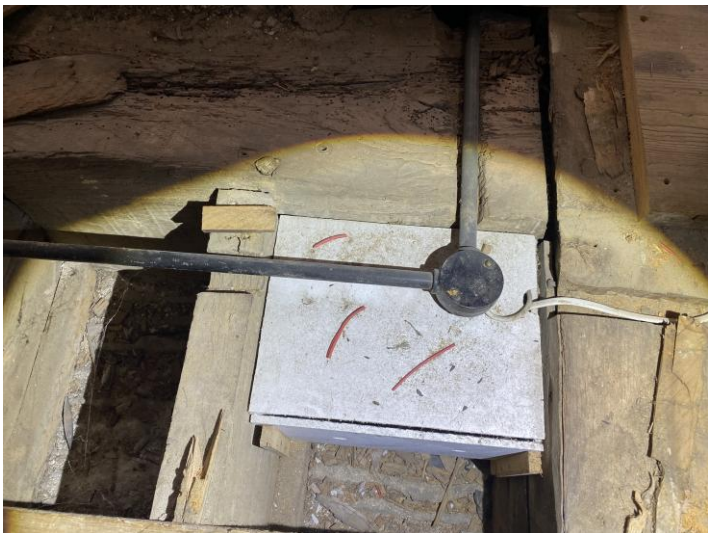
| <b>Sample Location:</b> | First Floor Mr Hyams Bedroom | | | |
| <b>Extent of damage:</b> | Medium damage | 2 | <b>Approximate Extent/Quantity:</b> | Boxing = <1 Sqm<br>Visible debris is present in the same location |

| <b>Recommended Management Action:</b> | Add to asbestos register; Label & manage risk until removed | | | |
| <b>Recommended Removal Action:</b> | Removal by a licensed asbestos removal contractor | | | |

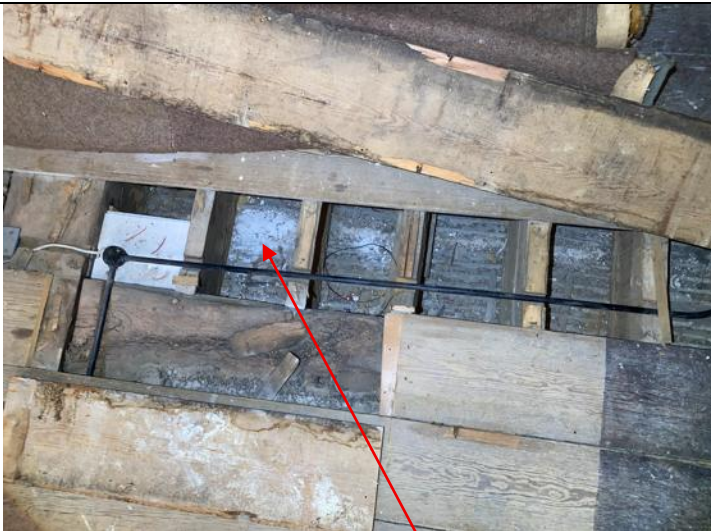
| <b>Sample Location:</b> | First Floor Mr Hyams Bedroom | | | |
| <b>Sample Position:</b> | Location D<br>Loose in floor void | | | |
| <b>Extent of damage:</b> | High damage | 3 | <b>Approximate Extent/Quantity:</b> | Not possible to quantify<br>Dust & debris likely created when cutting the material in situ |

| <b>Recommended Management Action:</b> | Add to asbestos register; Label & manage risk until removed | | | |
| <b>Recommended Removal Action:</b> | Removal by a licensed asbestos removal contractor | | | |

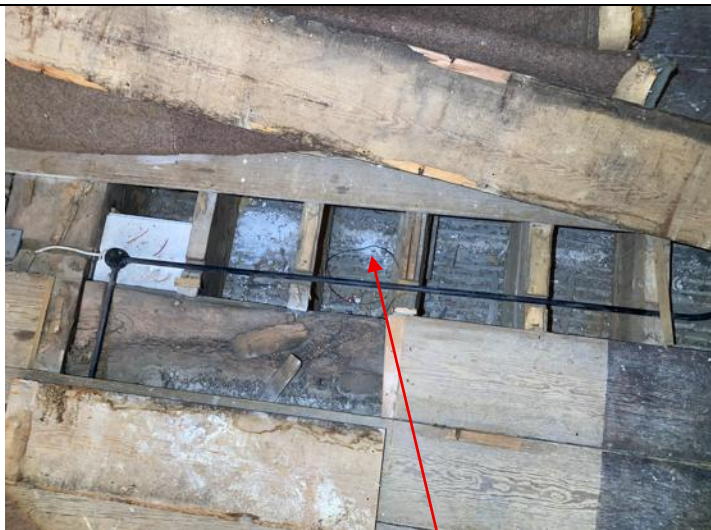
| <b>Sample Location:</b> | First Floor Mr Hyams Bedroom | | | |
| <b>Sample Position:</b> | Location D<br>Loose in floor void | | | |
| <b>Extent of damage:</b> | High damage | 3 | <b>Approximate Extent/Quantity:</b> | Not possible to quantify<br>Dust & debris likely created when cutting the material in situ |

| <b>Recommended Management Action:</b> | Add to asbestos register; Label & manage risk until removed | | | |
| <b>Recommended Removal Action:</b> | Removal by a licensed asbestos removal contractor | | | |

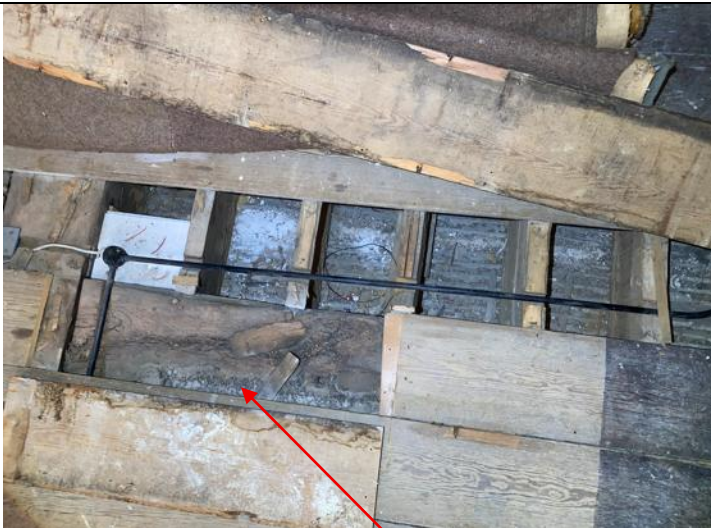
| <b>Sample Location:</b> | First Floor Mr Hyams Bedroom | | | |
| <b>Sample Position:</b> | Location C<br>Loose on top of large beam | | | |
| <b>Extent of damage:</b> | High damage | 3 | <b>Approximate Extent/Quantity:</b> | Not possible to quantify<br>Dust & debris likely created when cutting the material in situ |

| <b>Recommended Management Action:</b> | Add to asbestos register; Label & manage risk until removed | | | |
| <b>Recommended Removal Action:</b> | Removal by a licensed asbestos removal contractor | | | |

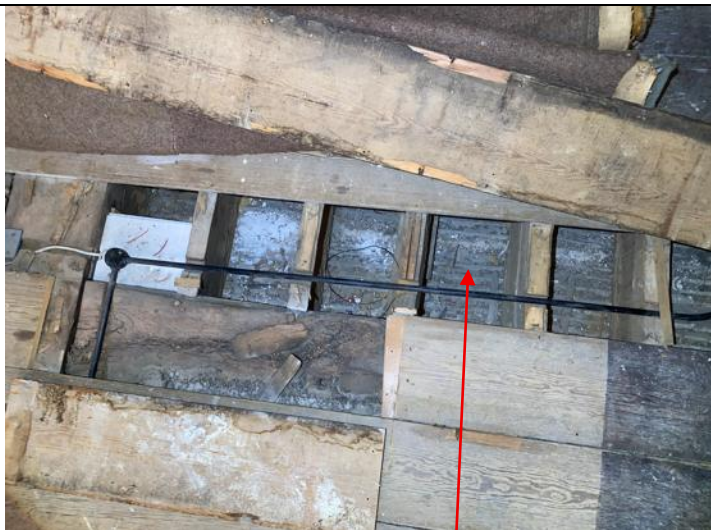
| <b>Sample Location:</b> | First Floor Mr Hyams Bedroom | | | |
| <b>Sample Position:</b> | Location D<br>Loose in floor void | | | |
| <b>Extent of damage:</b> | High damage | 3 | <b>Approximate Extent/Quantity:</b> | Not possible to quantify<br>Dust & debris likely created when cutting the material in situ |

| <b>Recommended Management Action:</b> | Add to asbestos register; Label & manage risk until removed | | | |
| <b>Recommended Removal Action:</b> | Removal by a licensed asbestos removal contractor | | | |

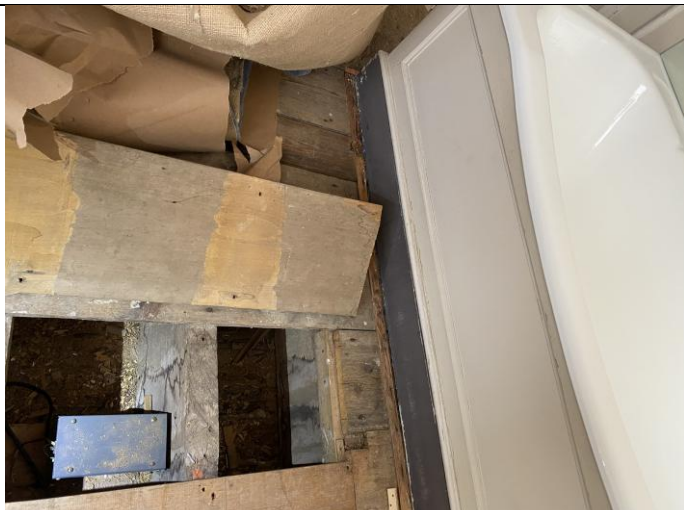
| <b>Sample Location:</b> | First Floor Mr Hyams Bathroom | | | |
| <b>Extent of damage:</b> | Unknown | 3 | <b>Approximate Extent/Quantity:</b> | Metal electrical box internal lining panels = <1 Sqm |

| <b>Recommended Management Action:</b> | | Add to asbestos register; Label & manage risk until removed | | |
| <b>Recommended Removal Action:</b> | | Removal by a licensed asbestos removal contractor | | |

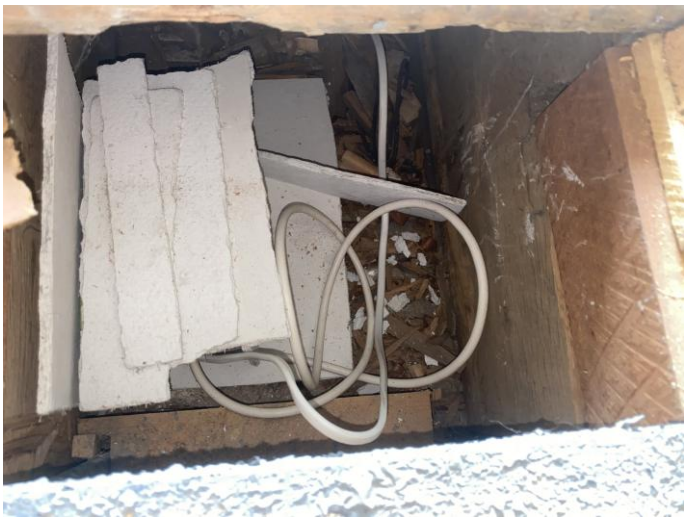
| <b>Sample Location:</b> | First Floor Blue Bedroom | | | | |
| <b>Sample Position:</b> | Location B<br>Boxing / loose | | | | |
| <b>Extent of damage:</b> | High damage | 3 | <b>Approximate Extent/Quantity:</b> | Boxing = <1 Sqm<br>Debris = Not possible to quantify<br>Visible debris is present in the same location | |

| <b>Recommended Management Action:</b> | | | Add to asbestos register; Label & manage risk until removed | | |
| <b>Recommended Removal Action:</b> | | | Removal by a licensed asbestos removal contractor | | |

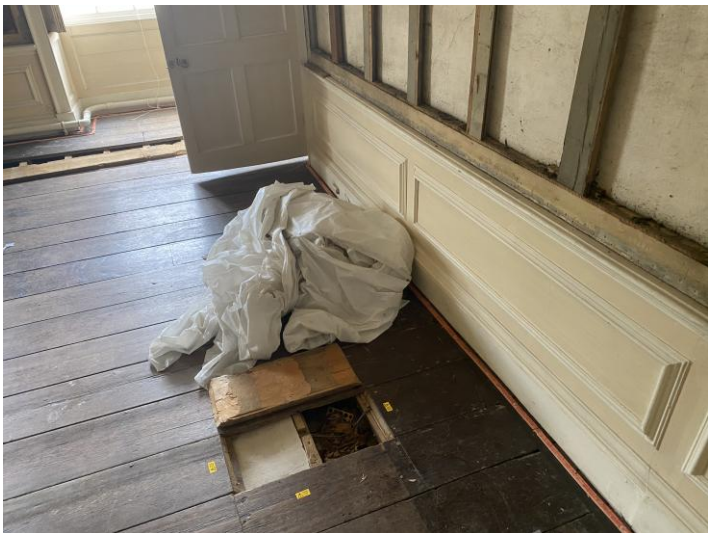
| <b>Sample Location:</b> | First Floor<br>Chinese Bedroom | | | |
| <b>Extent of damage:</b> | High damage | 3 | <b>Approximate Extent/Quantity:</b> | Boxing = <1 Sqm<br>Visible debris is present in the same location |

| <b>Recommended Management Action:</b> | Add to asbestos register; Label & manage risk until removed | | | |
| <b>Recommended Removal Action:</b> | Removal by a licensed asbestos removal contractor | | | |

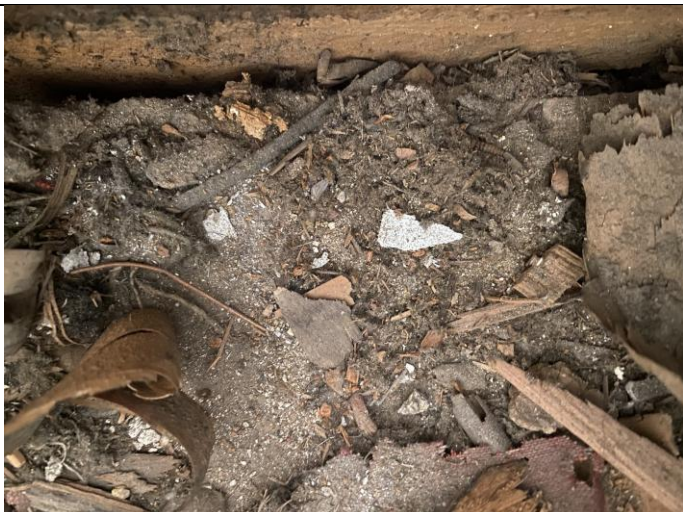
| <b>Sample Location:</b> | First Floor Chinese Bedroom | | | |
| <b>Sample Position:</b> | Location D<br>Loose in void | | | |
| <b>Extent of damage:</b> | High damage | 3 | <b>Approximate Extent/Quantity:</b> | Not possible to quantify<br>Dust & debris likely created when cutting the material in situ |

| <b>Recommended Management Action:</b> | Add to asbestos register; Label & manage risk until removed | | | |
| <b>Recommended Removal Action:</b> | Removal by a licensed asbestos removal contractor | | | |

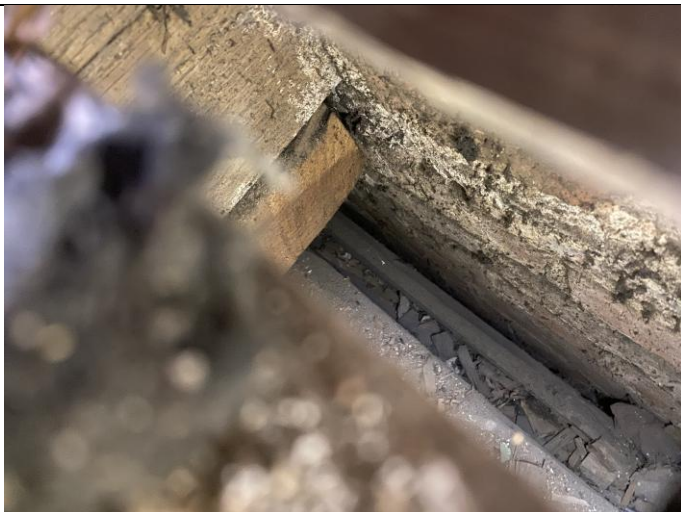
| <b>Sample Location:</b> | First Floor Chinese Bedroom | | | |
| <b>Extent of damage:</b> | High damage | 3 | <b>Approximate Extent/Quantity:</b> | Not possible to quantify<br>Dust & debris likely created when cutting the material in situ |

| <b>Recommended Management Action:</b> | | Add to asbestos register; Label & manage risk until removed | | |
| <b>Recommended Removal Action:</b> | | Removal by a licensed asbestos removal contractor | | |

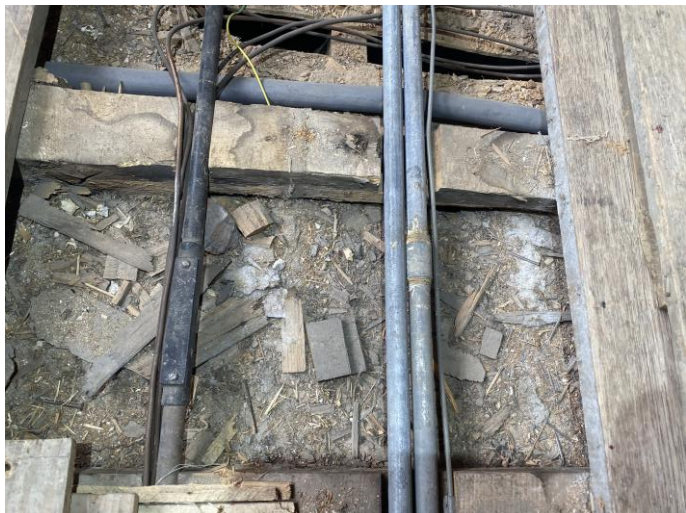
| Sample Location: | First Floor Chinese Bathroom | | | |
| Sample Description: | Loose material debris | | | |
| Extent of damage: | High damage | 3 | Approximate Extent/Quantity: | Not possible to quantify<br>Note: opening in void reveals a concealed dropped ceiling void beneath |

| Recommended Management Action: | | Add to asbestos register; Label & manage risk until removed | | |
| Recommended Removal Action: | | Removal by a licensed asbestos removal contractor | | |

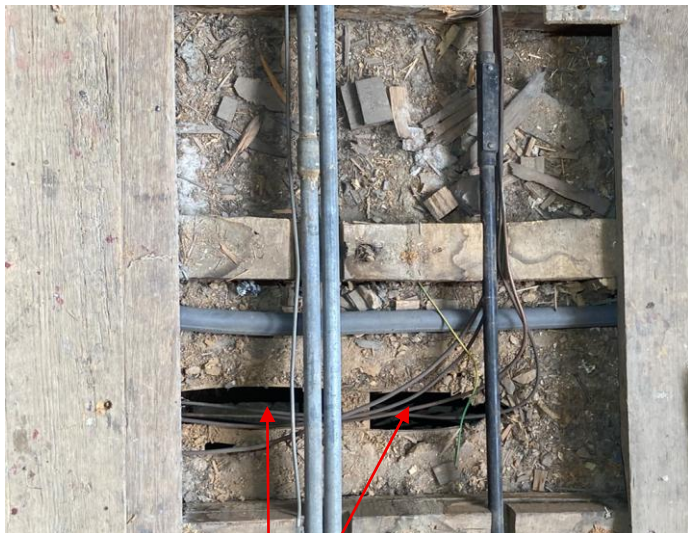
| <b>Sample Location:</b> | First Floor Chinese Bathroom | | | |
| <b>Sample Description:</b> | Loose material debris presumed in dropped ceiling void | | | |
| <b>Extent of damage:</b> | High damage | 3 | <b>Approximate Extent/Quantity:</b> | Not possible to quantify<br>Note: opening in void reveals a concealed dropped ceiling void beneath |

| <b>Recommended Management Action:</b> | | Add to asbestos register; Label & manage risk until removed | | |
| <b>Recommended Removal Action:</b> | | Removal by a licensed asbestos removal contractor | | |

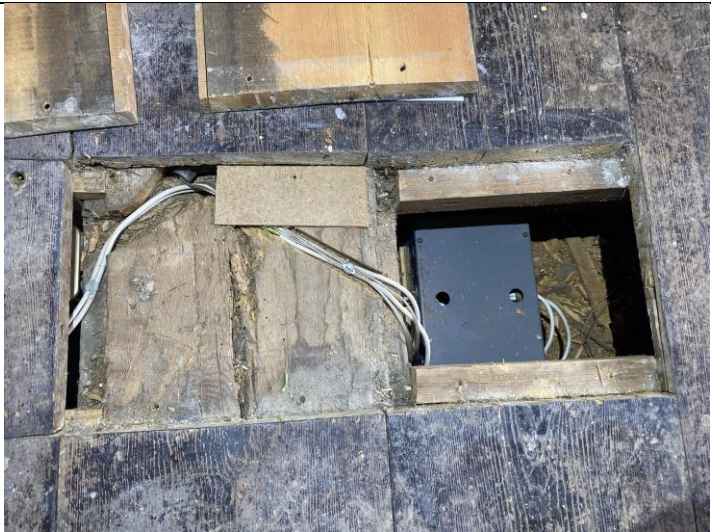
| <b>Sample Location:</b> | First Floor Pink Bedroom | | | |
| <b>Extent of damage:</b> | Medium damage | 2 | <b>Approximate Extent/Quantity:</b> | Metal electrical box internal lining panels = <1 Sqm |

| <b>Recommended Management Action:</b> | Add to asbestos register; Label & manage risk until removed | | | |
| <b>Recommended Removal Action:</b> | Removal by a licensed asbestos removal contractor | | | |

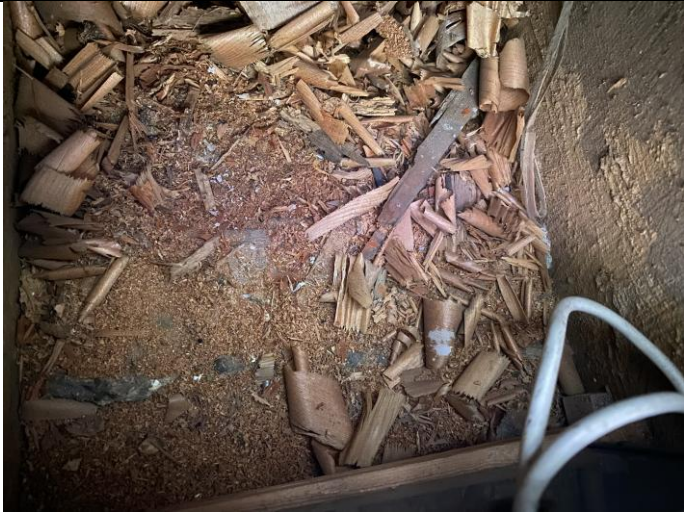
| <b>Sample Location:</b> | First Floor Pink Bedroom | | | |
| <b>Sample Position:</b> | Location B<br>Loose in void | | | |
| <b>Extent of damage:</b> | N/A | | <b>Approximate Extent/Quantity:</b> | N/A |

| <b>Recommended Remedial Action:</b> | N/A | | | |
| <b>Other Recommended Action:</b> | Asbestos has been found within the floor voids at all levels within the building, these materials were found during a restricted access inspection; leaving much of the floor voids uninspected. Further ACM's may be present & widespread within the uninspected parts of the floor voids.<br>We recommend to restrict all access into the floor voids, pending licensed asbestos removal works to decontaminate the voids. | | | |

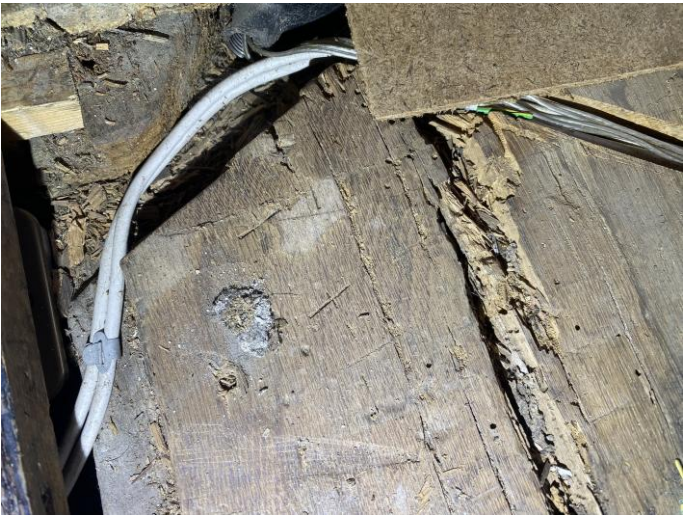
| <b>Sample Location:</b> | First Floor Pink Bedroom | | |
| <b>Sample Position:</b> | Location B<br>Loose on beam | | |
| <b>Extent of damage:</b> | N/A | <b>Approximate Extent/Quantity:</b> | N/A |

| <b>Other Recommended Action:</b> | Asbestos has been found within the floor voids at all levels within the building, these materials were found during a restricted access inspection; leaving much of the floor voids uninspected. Further ACM's may be present & widespread within the uninspected parts of the floor voids.<br>We recommend to restrict all access into the floor voids, pending licensed asbestos removal works to decontaminate the voids. | | | |

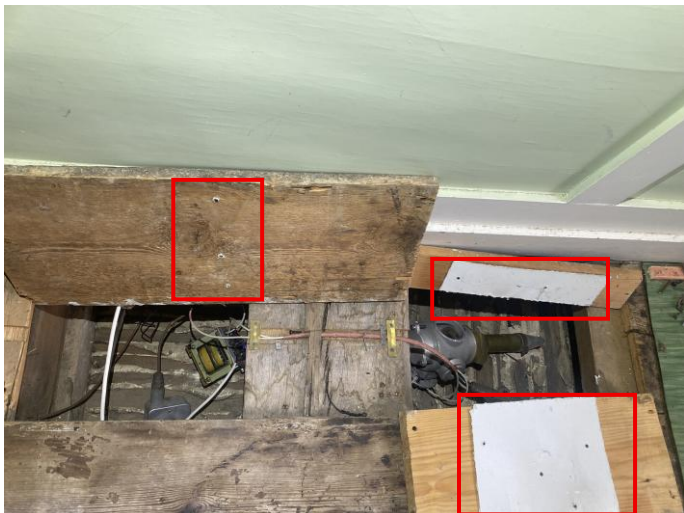
| <b>Sample Location:</b> | Second Floor Staff Bedroom 2 | | | |
| <b>Extent of damage:</b> | High damage | 3 | <b>Approximate Extent/Quantity:</b> | Pinned materials = <1 Sqm |

| <b>Recommended Management Action:</b> | | Add to asbestos register; Label & manage risk until removed | | |
| <b>Recommended Removal Action:</b> | | Removal by a licensed asbestos removal contractor | | |

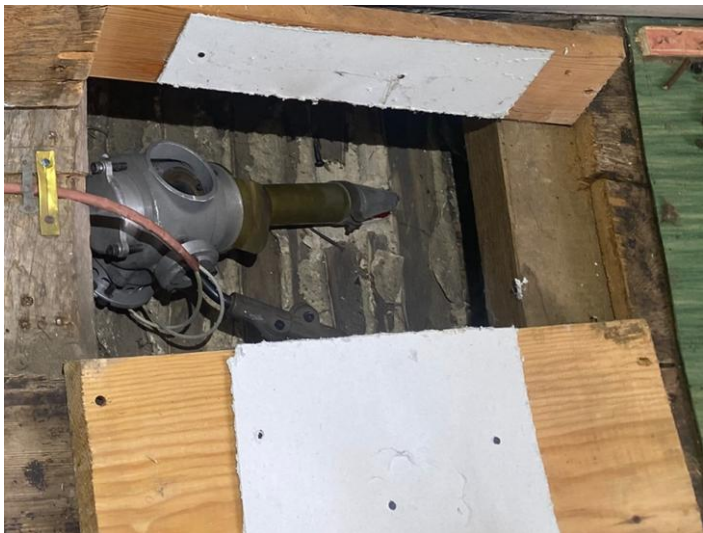
| <b>Sample Location:</b> | Second Floor Staff Bedroom 2 | | | |
| <b>Sample Position:</b> | Location A<br>Loose in void | | | |
| <b>Extent of damage:</b> | High damage | 3 | <b>Approximate Extent/Quantity:</b> | <1 Sqm visible<br>Access to whole of floor void restricted |

| <b>Recommended Management Action:</b> | | Add to asbestos register; Label & manage risk until removed | | |
| <b>Recommended Removal Action:</b> | | Removal by a licensed asbestos removal contractor | | |

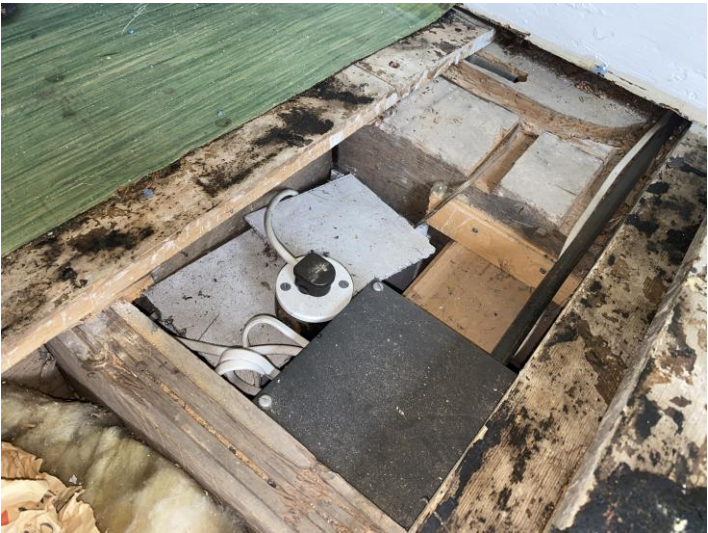
| <b>Sample Location:</b> | Second Floor Staff Sitting Room | | | | |
| <b>Extent of damage:</b> | High damage | 3 | <b>Approximate Extent/Quantity:</b> | Boxing = <1 Sqm<br>Visible debris is present in the same location | |

| <b>Recommended Management Action:</b> | | Add to asbestos register; Label & manage risk until removed | | | |
| <b>Recommended Removal Action:</b> | | Removal by a licensed asbestos removal contractor | | | |

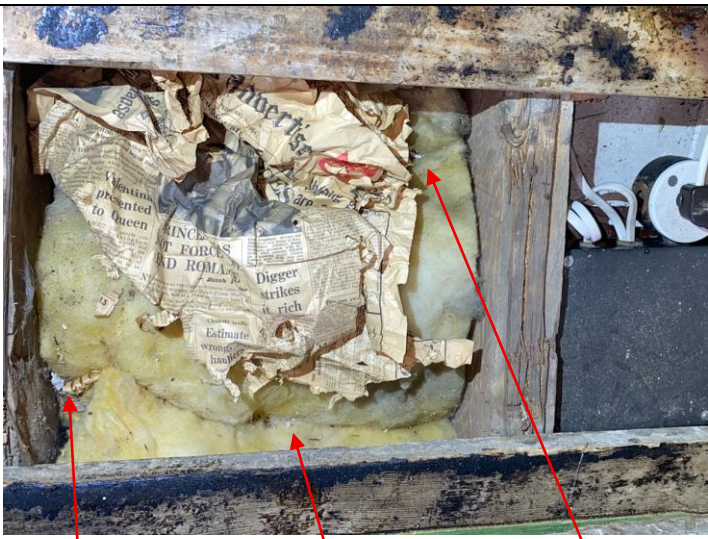
| Sample Location: | Second Floor Staff Sitting Room | | | |
| Sample Position: | Location A<br>Loose in void | | | |
| Extent of damage: | High damage | 3 | Approximate Extent/Quantity: | Not possible to quantify<br>Dust & debris likely created when cutting the material in situ |

| Recommended Management Action: | | Add to asbestos register; Label & manage risk until removed | | |
| Recommended Removal Action: | | Removal by a licensed asbestos removal contractor | | |

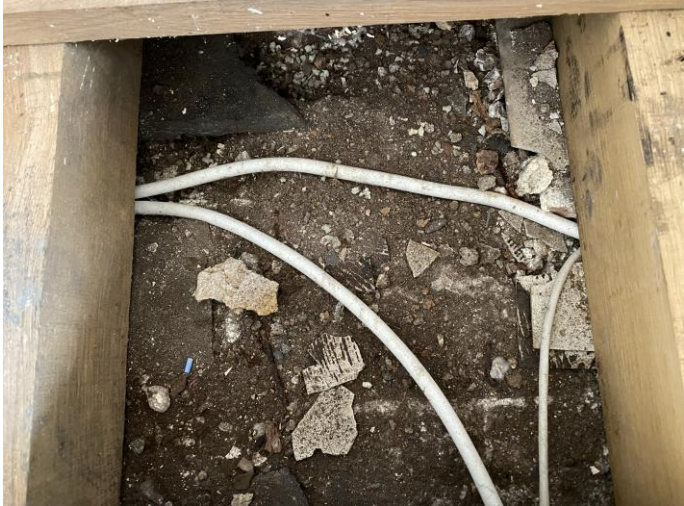
| <b>Sample Location:</b> | Basement Staff room | | | |
| <b>Extent of damage:</b> | High | 3 | <b>Approximate Extent/Quantity:</b> | Not possible to quantify<br>Materials used as packers & associated debris are present |

| <b>Recommended Management Action:</b> | Add to asbestos register; Label & manage risk until removed | | | |
| <b>Recommended Removal Action:</b> | Removal by a licensed asbestos removal contractor (licensed asbestos found in floor voids at other levels) | | | |
