## Peregrine Bryant Architects

### Further opening-up works required to Ramsbury Manor House to Facilitate Repair, Reservicing, and Asbestos Removal (HE-RMI 263: Issue V1: 30.04.26)

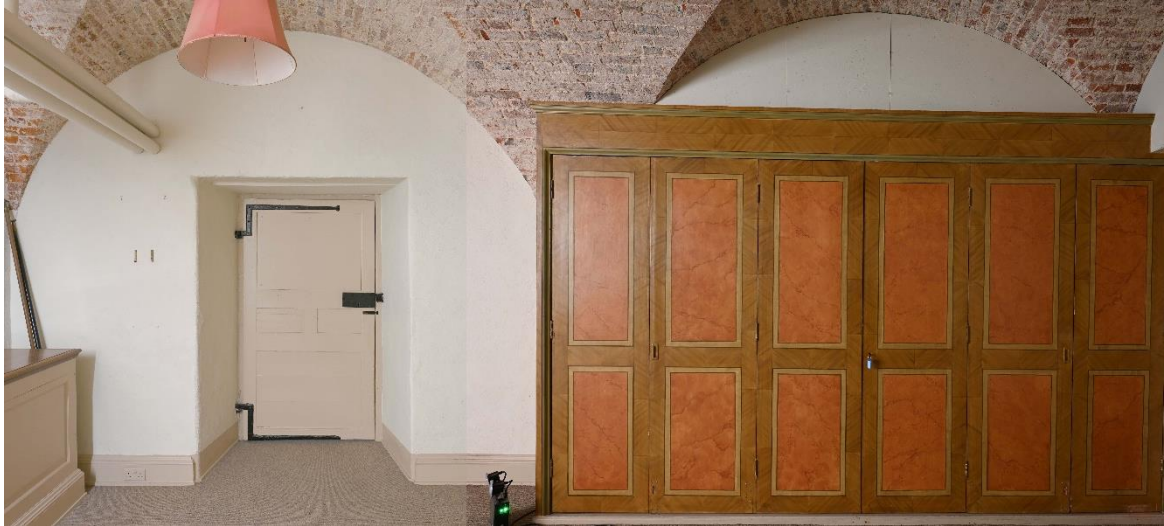
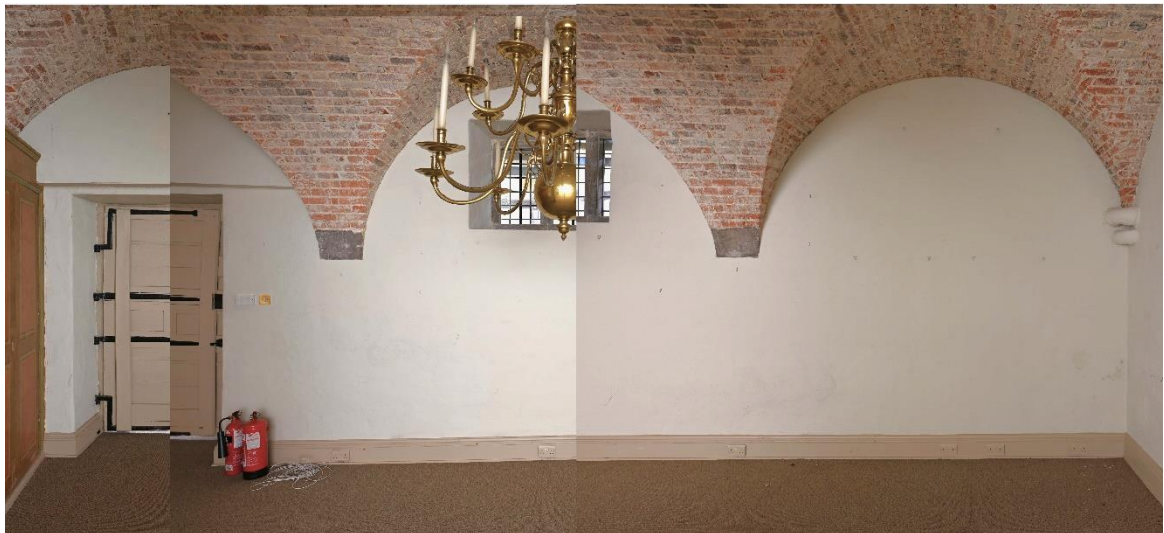
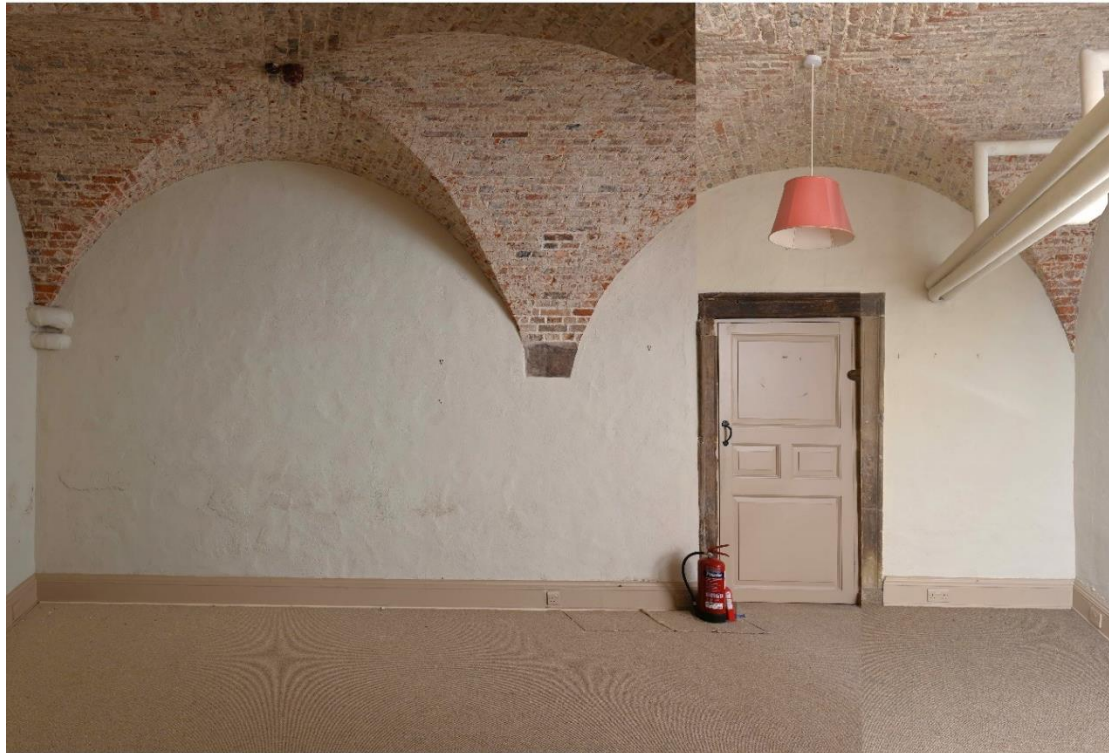
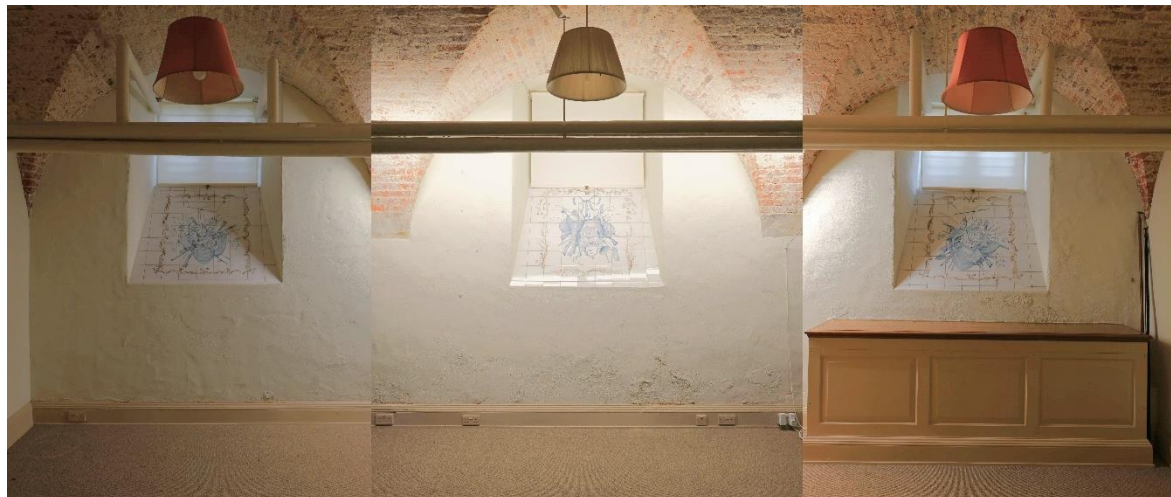
| Games Room (LGR02) | Floors | Walls | Ceiling |
|---|---|---|---|
| Description | Carpet above asbestos containing materials on solid sub-base | Low level skirting boards and plastered above | Brickwork vaulting supported off stone corbels and two decorated square stone columns |
| Need for opening-up | Yes, to assess damp to column bases and elsewhere and to remove asbestos | Yes, to establish cable routes | Not at this time |
| Opening-up proposed | Yes, three number 500x500 excavations in the floor, one adjacent to each column and one adjacent to the door to the plantroom. There is also the need to remove the asbestos below floor finishes | Remove 300x300 lime plaster from masonry walls in two locations one above and one below the light switch adjacent to the door | No |

*Figure 1: SE internal facade - Games room LGR02*

*Figure 2: SW internal facade - Games room LGR02*

*Figure 3: NW internal facade - Games room LGR02*

*Figure 4: NE internal facade - Games room LGR02*

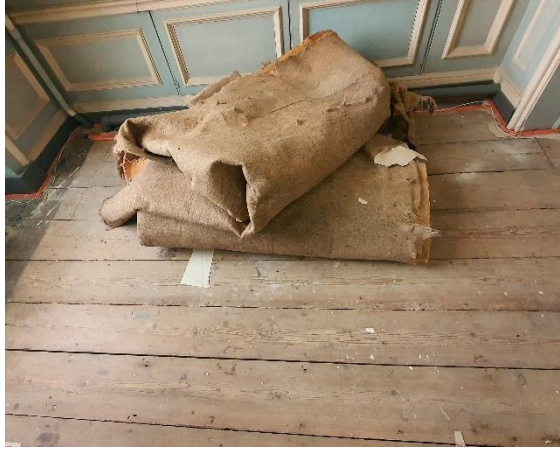
*Figure 5: Timber floor, post carpet removal -  
Blue Bathroom FR01*

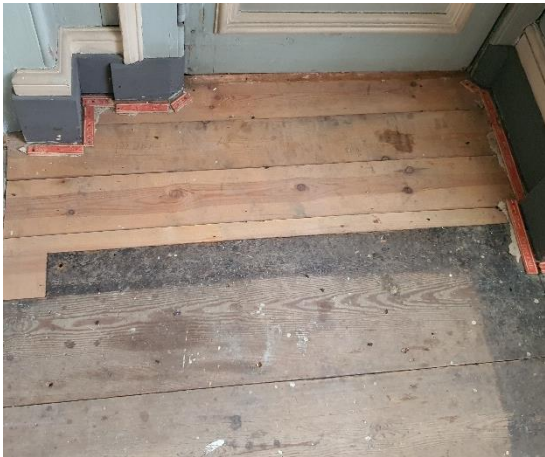
*Figure 7: Timber floor, post carpet removal -  
Blue Bathroom FR01*

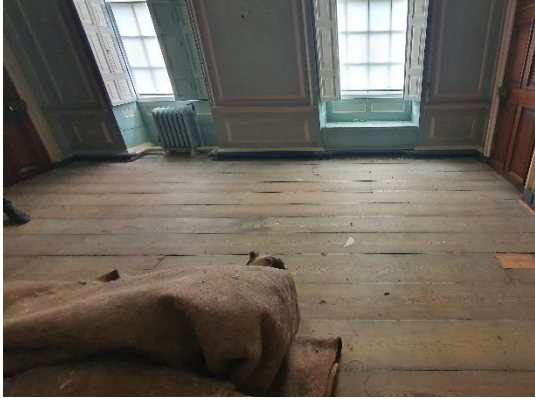
*Figure 12: Timber floor, post carpet removal - Blue Bedroom FR02*

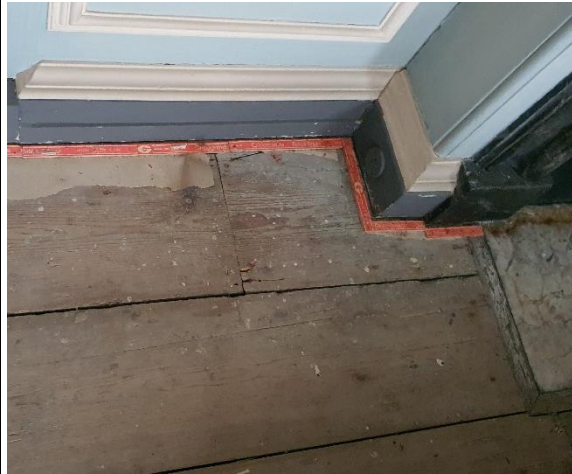
*Figure 13: Timber floor, post carpet removal - Blue Bedroom FR02*

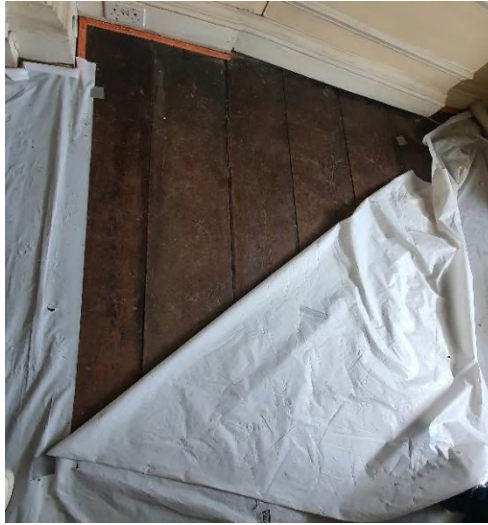
*Figure 18: Small inspected part of the timber -  
Chinese Bedroom FR03*

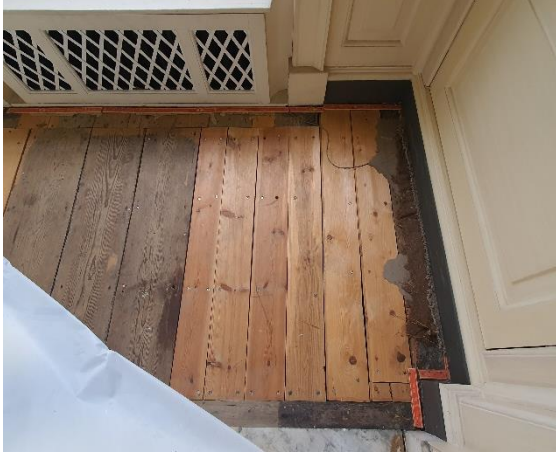
*Figure 24: : Exposed timber floor slats after the removal of the carpet – Chinese Bathroom FR04*

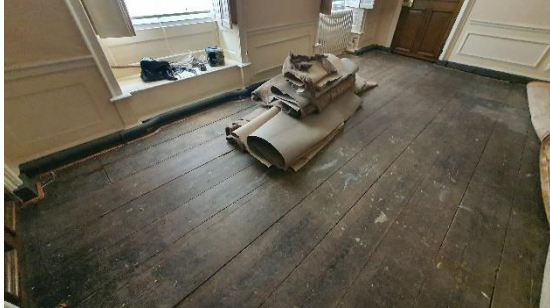
*Figure 29: Timber boards, post carpet removal - Pink Bedroom FR05*

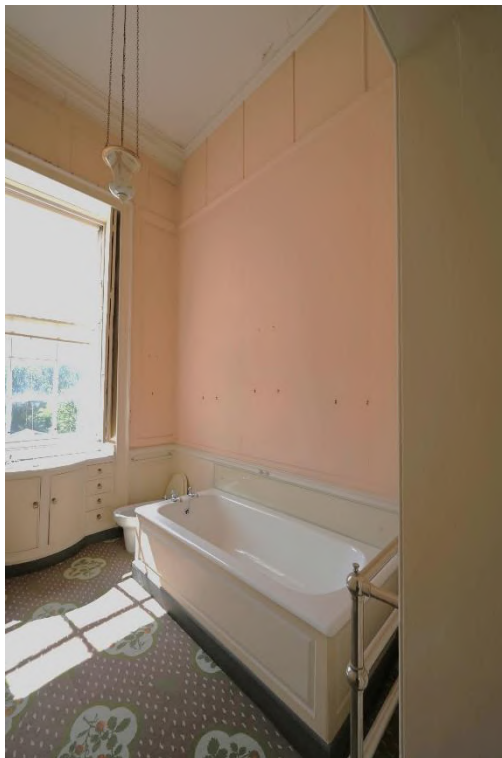
Figure 32: SE internal facade - Pink Bathroom FR06

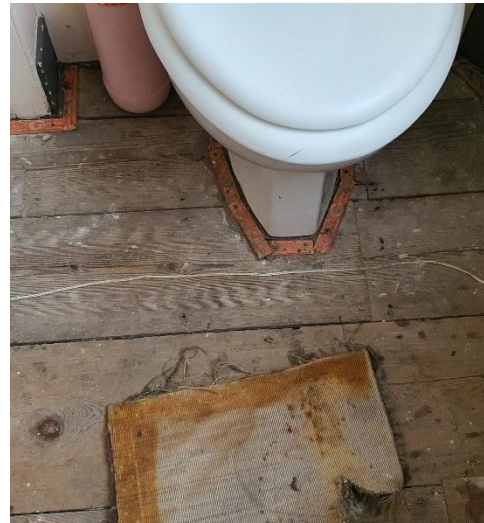
*Figure 36: Timber boards, post carpet removal - Pink Bathroom FR06*

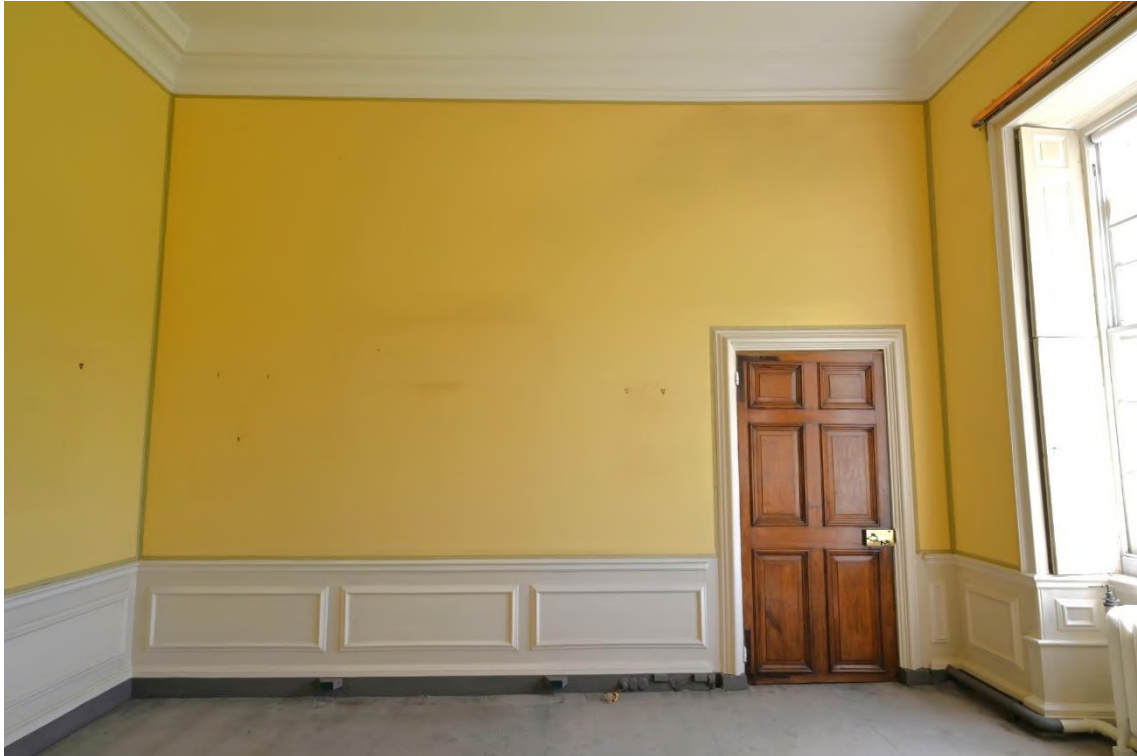
Figure 50: Floor post carpet removal - Mrs. Hyams  
Dressing Room FR08

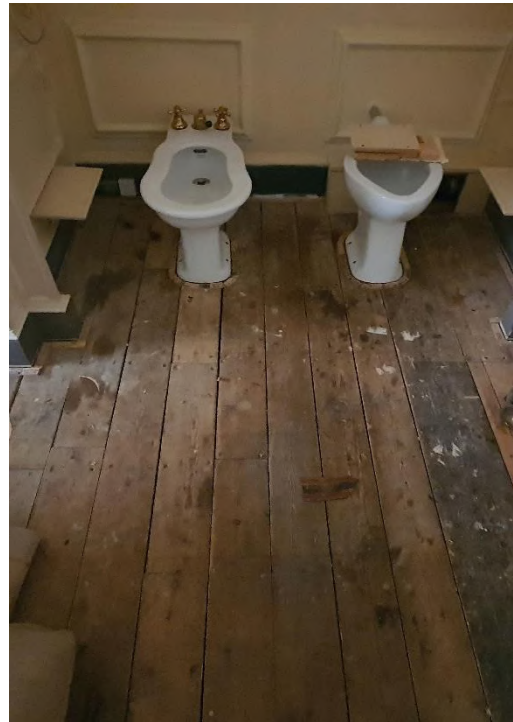
*Figure 68: Areas of adhesive from the vinyl that was removed - Mrs. Hyams Bathroom FR10*

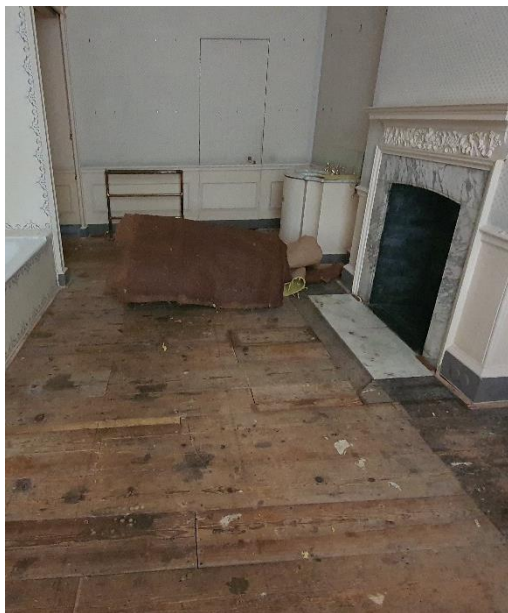
*Figure 69: Timber boards, post vinyl removal- Mrs. Hyams Bathroom FR10*

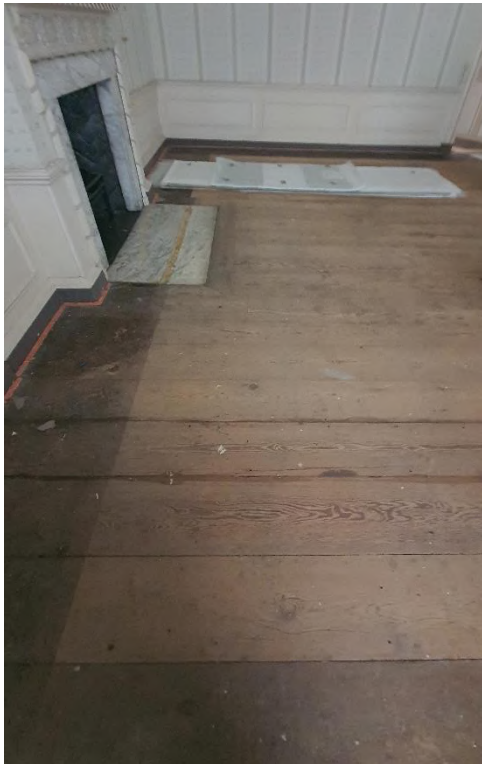
*Figure 77: Timber boards, post carpet removal -  
Mrs. Hyams Bedroom FR12*

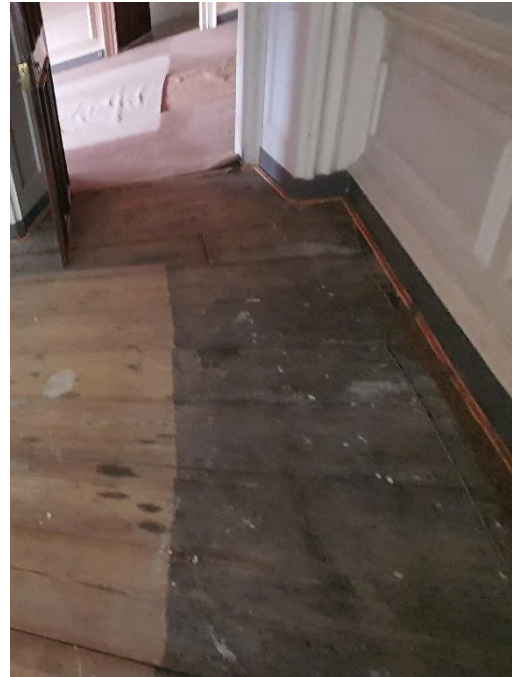
*Figure 83: Perimeter timber boards - Mr. Hyams Bedroom FR13*

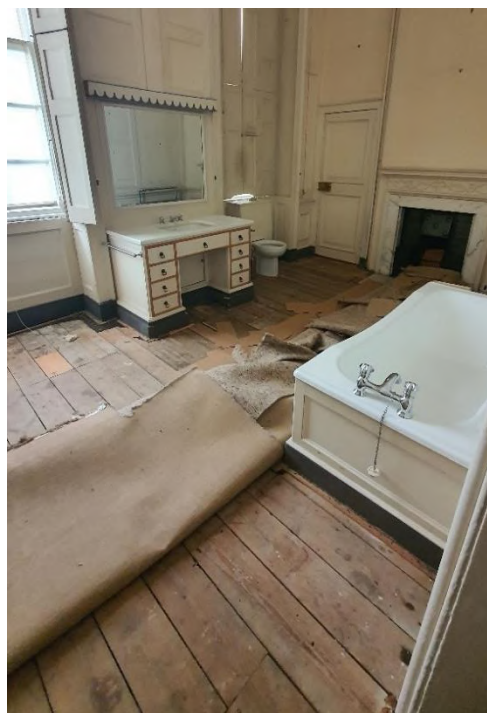
*Figure 90: Timber boards, post carpet removal - Mr. Hyams Bathroom FR14*

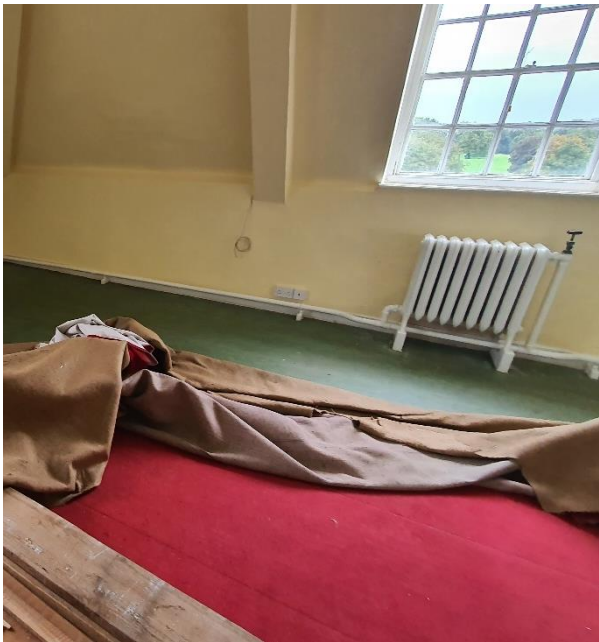
*Figure 4: Floor, carpet removal and vinyl - Staff Bedroom SR01*

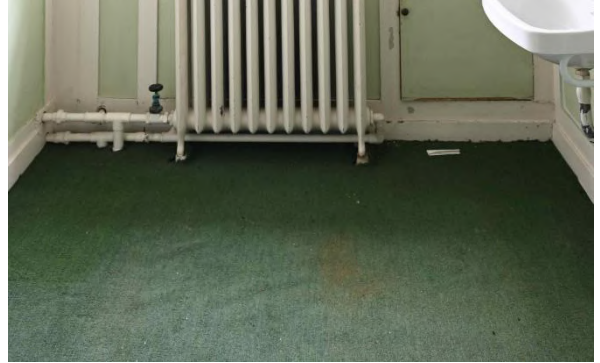
*Figure 16: Radiator and floor - Storeroom SR03*

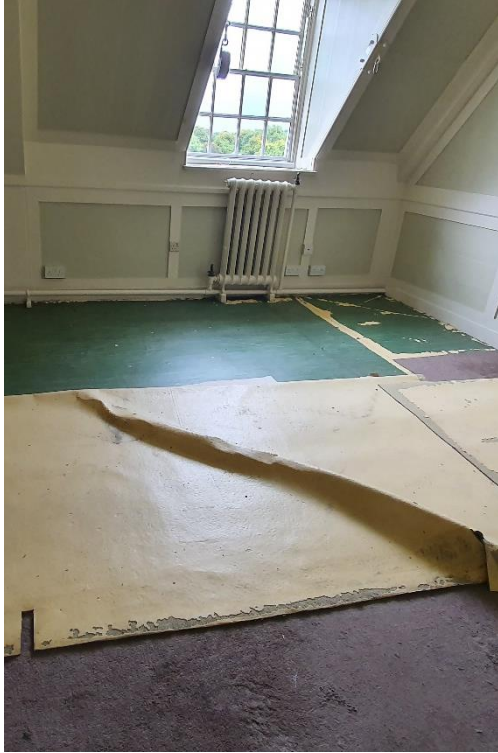
*Figure 21: Vinyl floor - Bedroom SR04*

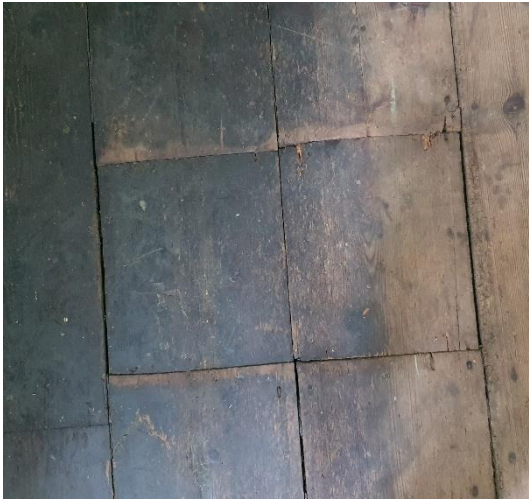
*Figure 26: Exposed timber floor post carpet removal - Bedroom SR05*

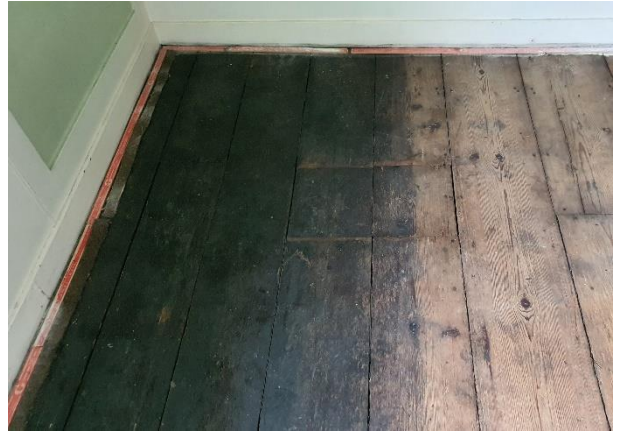
*Figure 27: Exposed timber floor post carpet removal - Bedroom SR05*

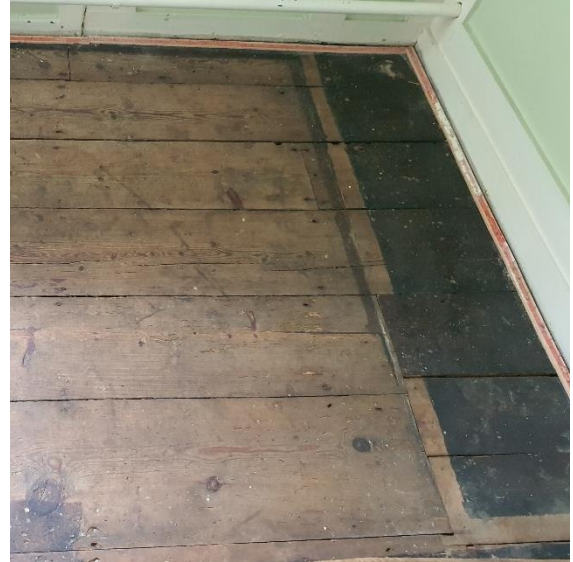
*Figure 33: Exposed timber floor post carpet removal -  
Dressing Room SR06*

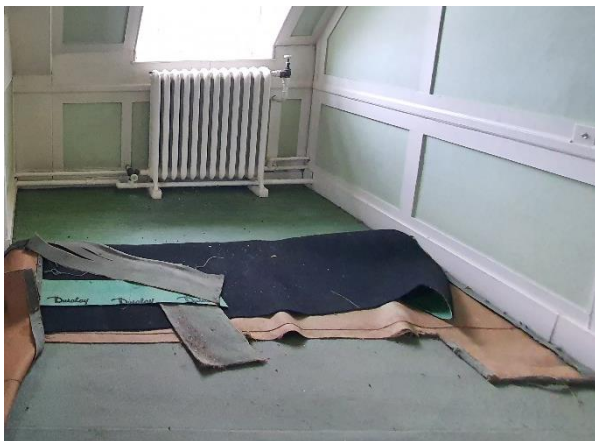
Figure 46: Removal of carpet and exposing vinyl - Green Bedroom SR08

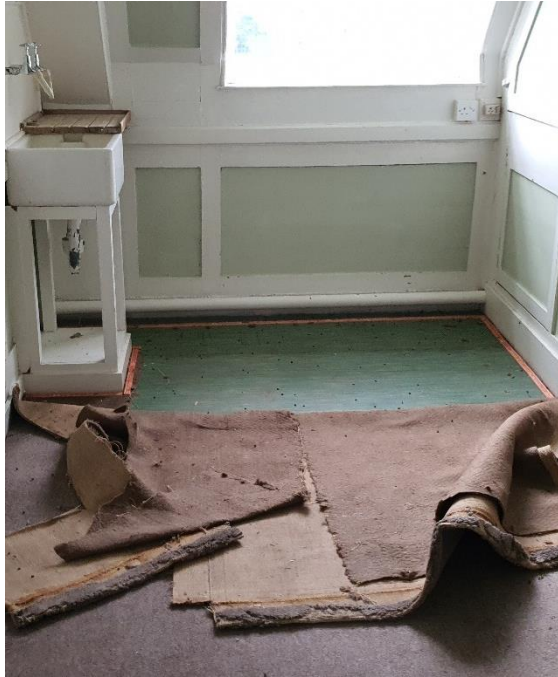
*Figure 52: Vinyl under carpet - Linen Room SR09*

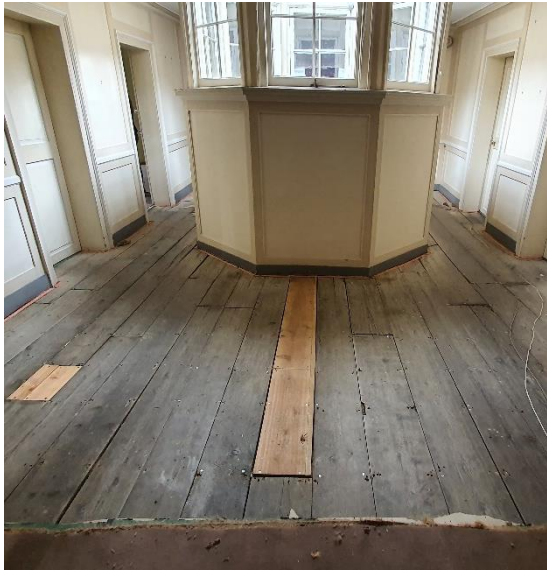
*Figure 57: Timber floor exposed after removal of carpet – Central Landing SR10*

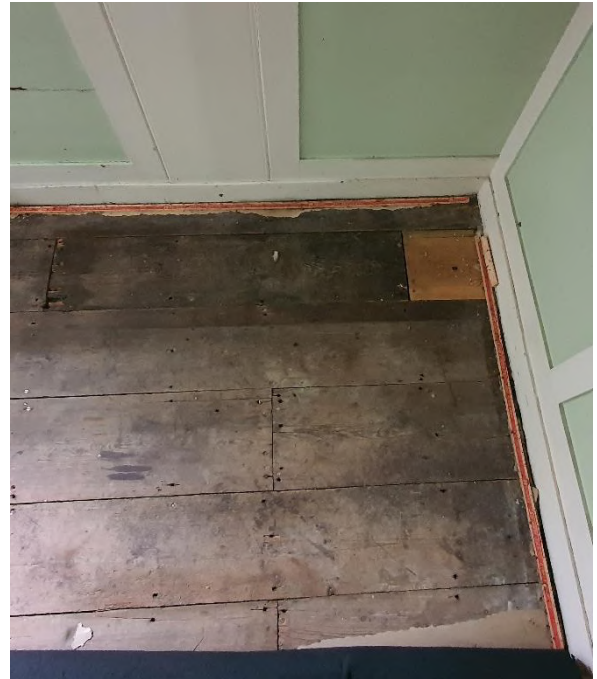
*Figure 72: Inside cupboard - Sewing Room SR13*

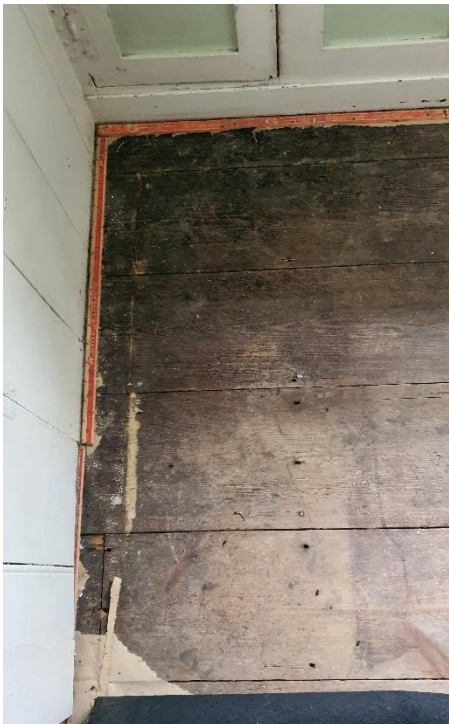
*Figure 73: Timber floorboards exposed post removal of carpet - Sewing Room SR13*

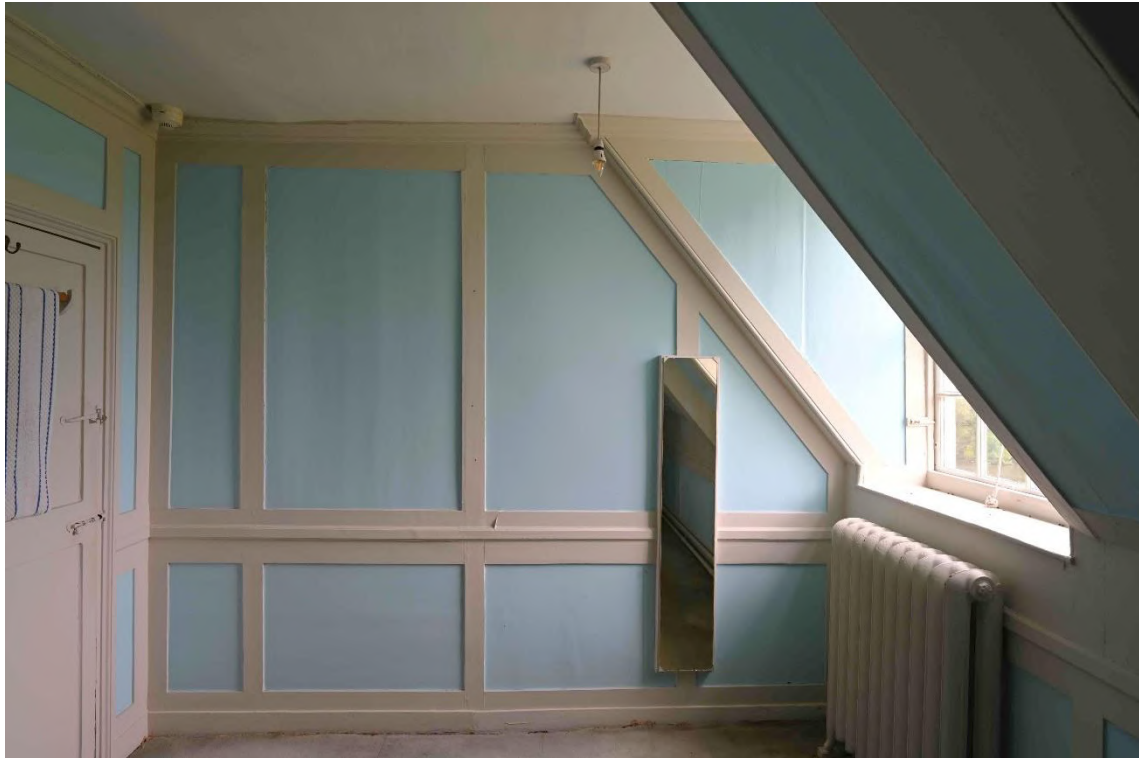
*Figure 74: Timber under carpet - Sewing Room SR13*

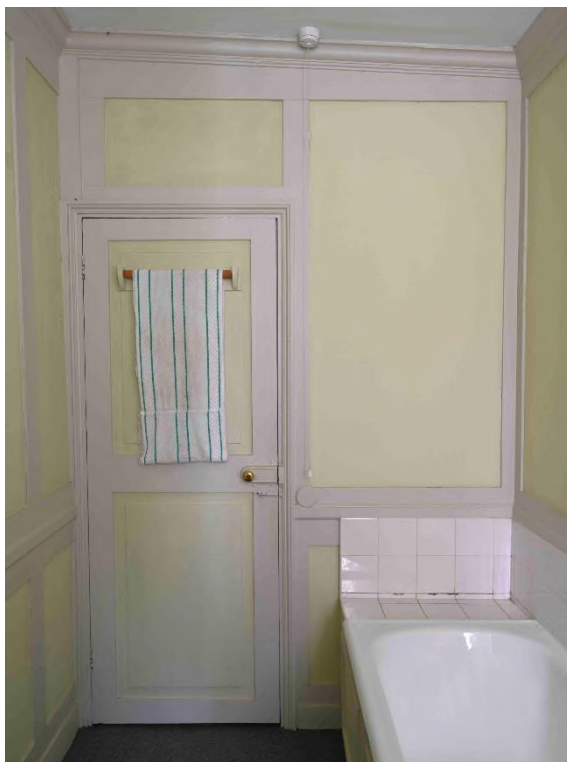
*Figure 79: Floor - removal of carpet and exposing the vinyl - Staff Bathroom SR14*

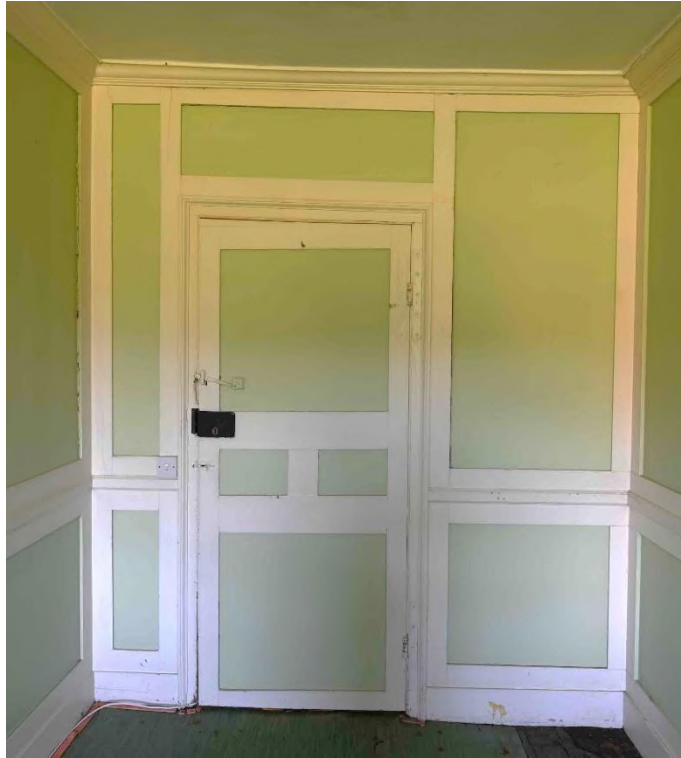
*Figure 88: Floor, vinyl under carpet - Staff  
Bathroom SR16*

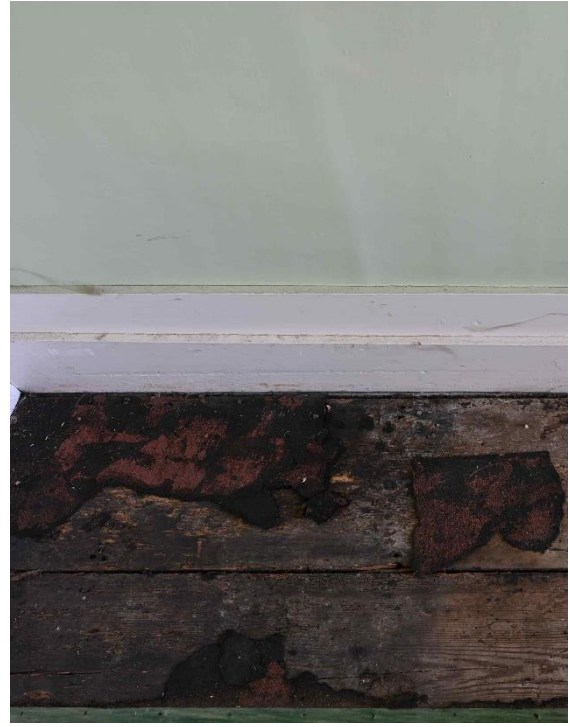
*Figure 93: Floor and services inspection - Staff Bathroom SR17*
