# RAMSBURY MANOR HOUSE INTERIORS

FURTHER OPENING UP, LIFTING OF ALL FLOORBOARDS, FURTHER TRIAL HOLES,  
AND ASBESTOS REMOVAL

Design & Access Statement  
April 2026

PEREGRINE BRYANT ARCHITECTS

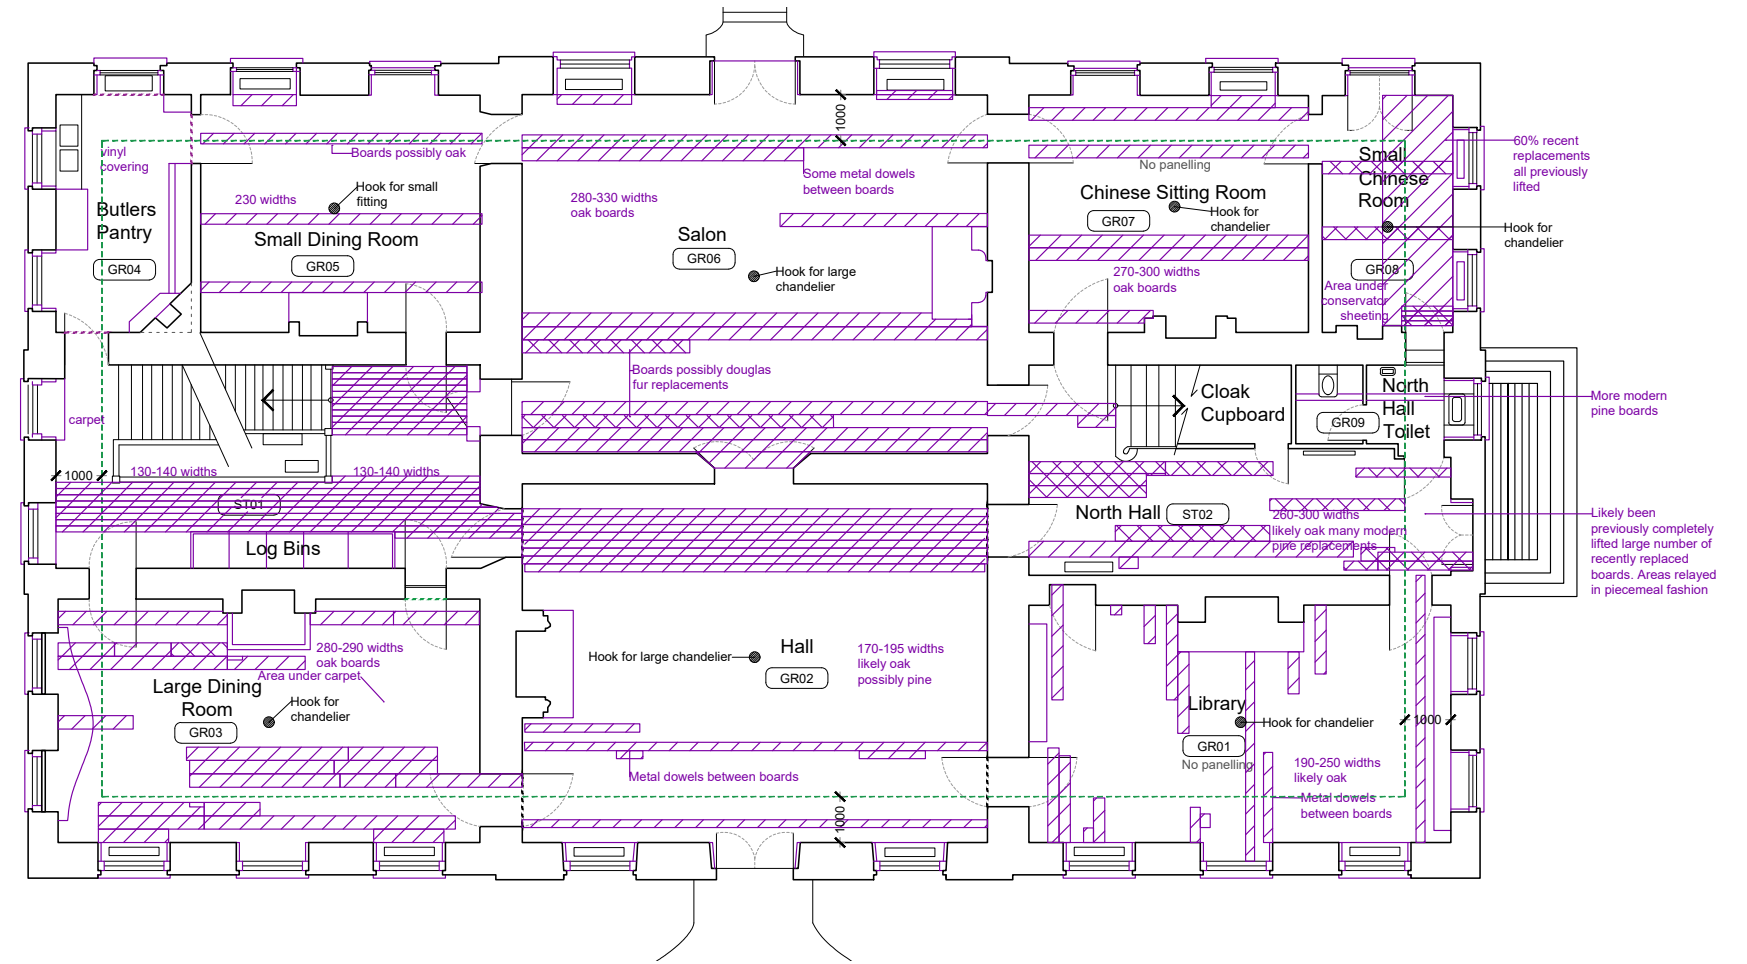
Ground Floor

Floorboards highlighted in purple had obvious signs of having been refixed and were strongly suspected to had been lifted before.

Evidence of board lifted and screwed back down

Newer/replacement board

Floorboards within 1m of external wall to be lifted

Floorboards to be lifted

Area of floor above chandelier to be opened up and structure inspected

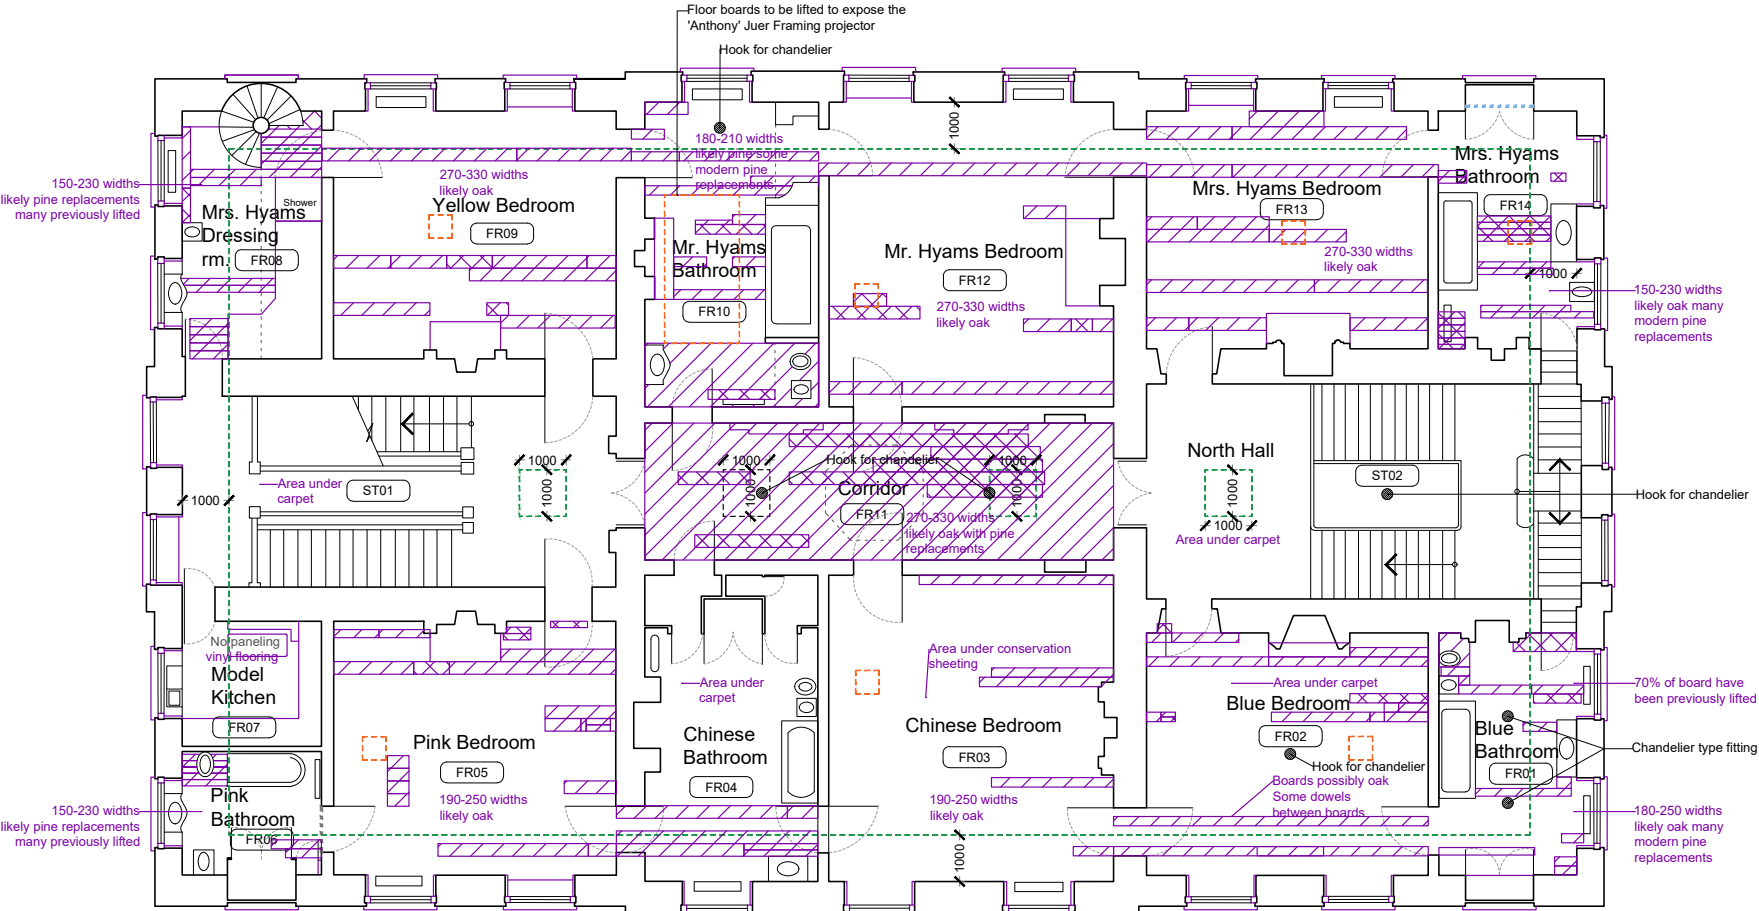
First Floor

Floorboards highlighted in purple had obvious signs of having been refixed and were strongly suspected to had been lifted before.

Evidence of board lifted and screwed back down

Newer/replacement board

Floorboards within 1m of external wall to be lifted

Floorboards to be lifted

Area of floor above chandelier to be opened up and structure inspected

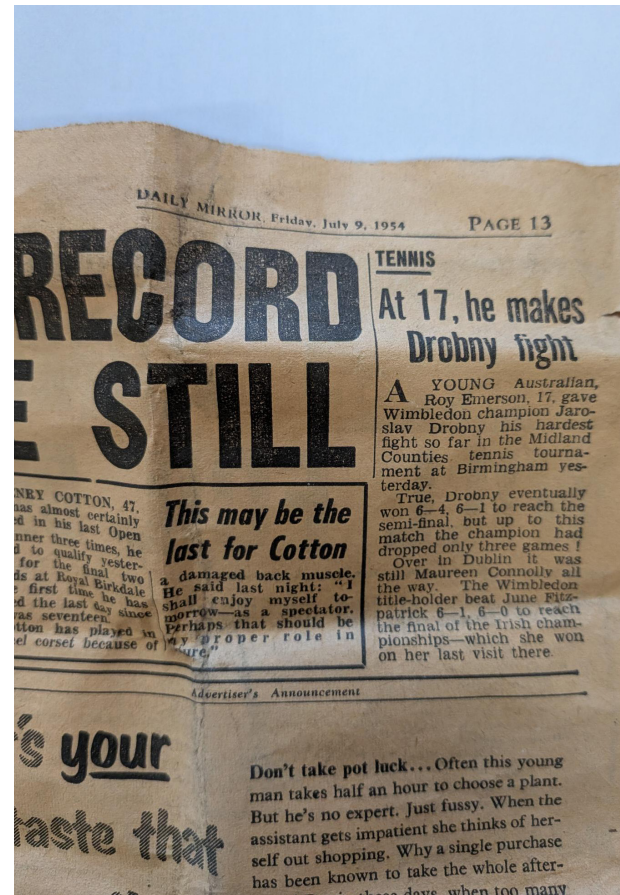
Newspaper from 1954 found in floor void (Second Floor)

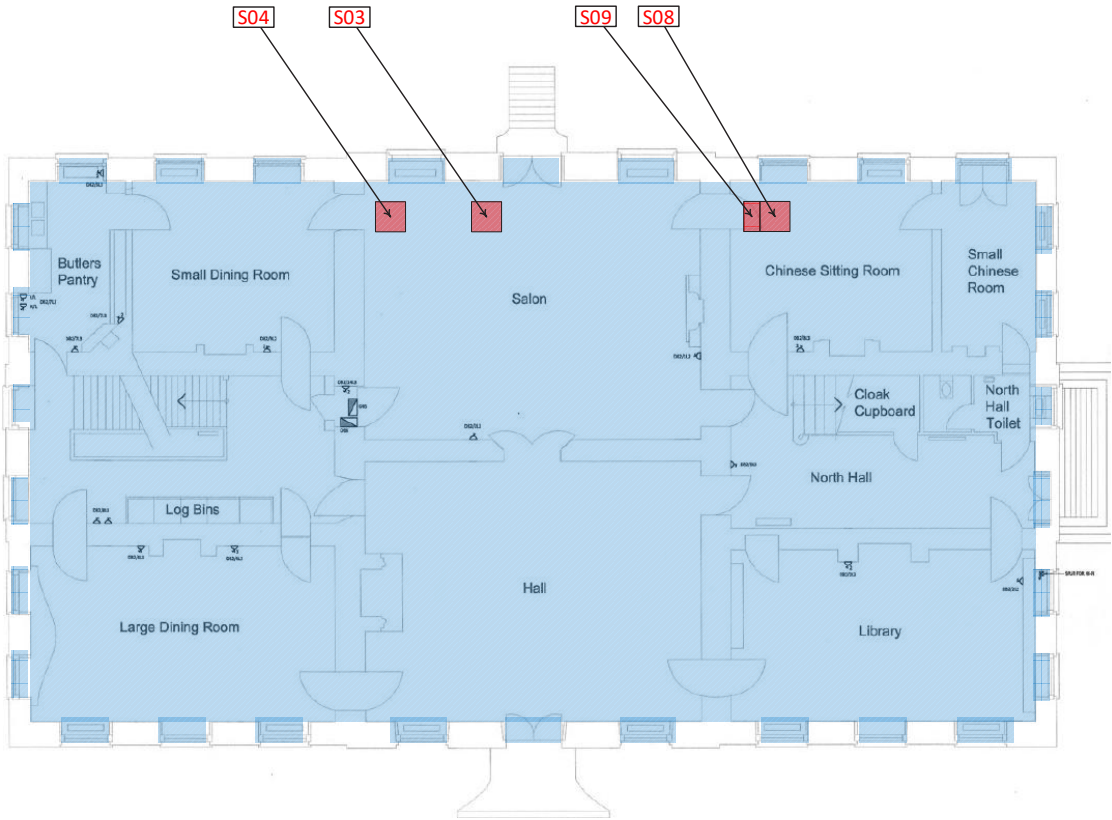
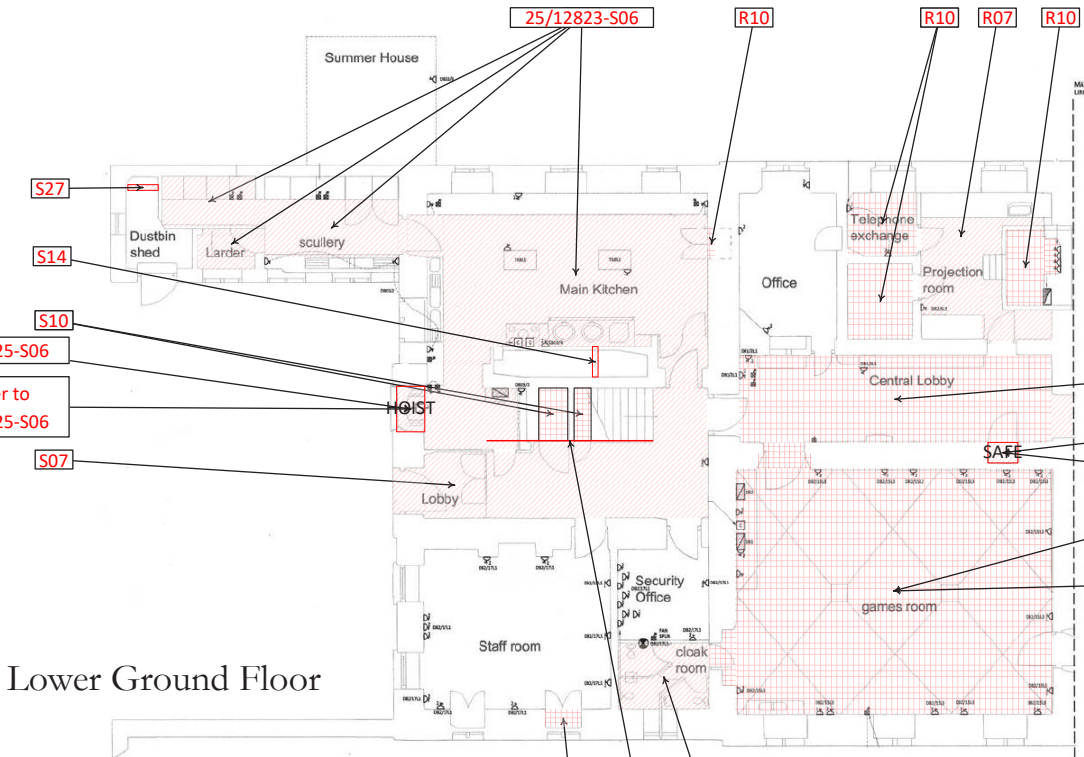
Drawings from Asbestos Refurbishment and Demolition Survey To Specific Locations Only by Asbestos 2Go Limited 25/12948 & 25 12866

Asbestos was also found within flue vent pipes, lining panels, radiator casings, vinyl flooring, adhesive and around M&E equipment and to the hoist shaft.

ACMs found on the Lower Ground Floor are contained within the floor finishes (vinyl floor tiles with asbestos bitumen and sheet vinyl with asbestos paper). No opening-up is required to facilitate this removal; however methods to remove the bitumen will require specialist grinding to the surface of the concrete base. Also, due to the backing paper likely heavily adhered to the concrete base, this will be removed as far as practical and then a latex coating will be applied to encapsulate anything that remains and a note included on the future asbestos management plan.

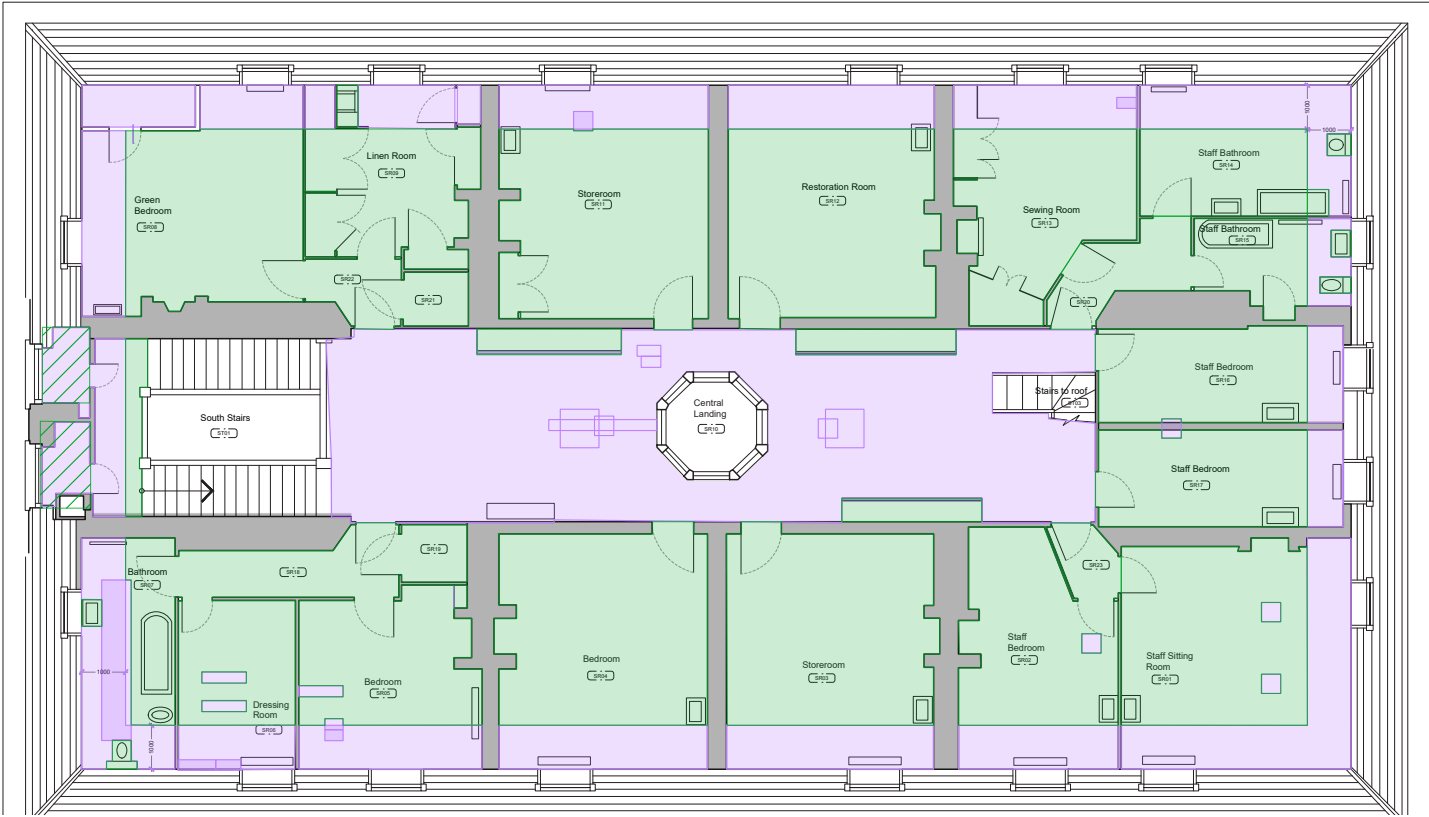
Second Floor

To progress with a repairs specification, including relating to structural elements, further opening up is required. Room conditions survey revealed water damage underneath bathrooms and sinks, and investigation is needed to determine if rot is present in the floors in these areas.

With access required to floor voids to allow inspection and recording, and future access required to update services and carry-out repairs, the full extent of asbestos needs to be known and asbestos needs to be removed. Any asbestos containing material (ACM) will need to be removed before any works within the floor voids can be carried out. Careful lifting up of all floorboards to enable the removal of known asbestos and comprehensive survey and removal of further ACM will be undertaken as identified in the Heritage Statement.

Requested further opening up and asbestos removal
