**TREES AT LAND ADJ TO TUDOR COTTAGE, PARK LANE, CHERHILL, CALNE, SN11 8QN.**

**Brief:**

Survey trees that have a potential impact on the proposed development at Land Adj to Tudor Cottage, Cherhill, SN11 8QN from the plans provided. Comment upon their condition, suitability for retention and the impact they may have upon the proposed development.

**Date of Inspection:** 09.07.25

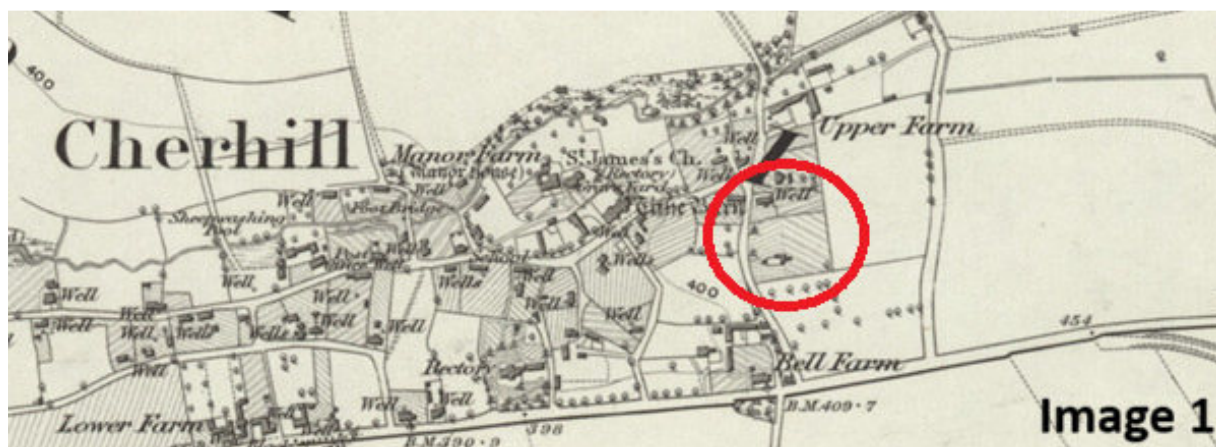
Image 1 is a segment of an 1889 map, Wiltshire Sheet XXVII. The red circle shows the area of the proposed development at Land Adj to Tudor Cottage, Cherhill, SN11 8QN. From this map it can be seen that there is a dwelling and an outbuilding in the area close to the proposed development. These buildings are not present on the 1922 edition of this map.

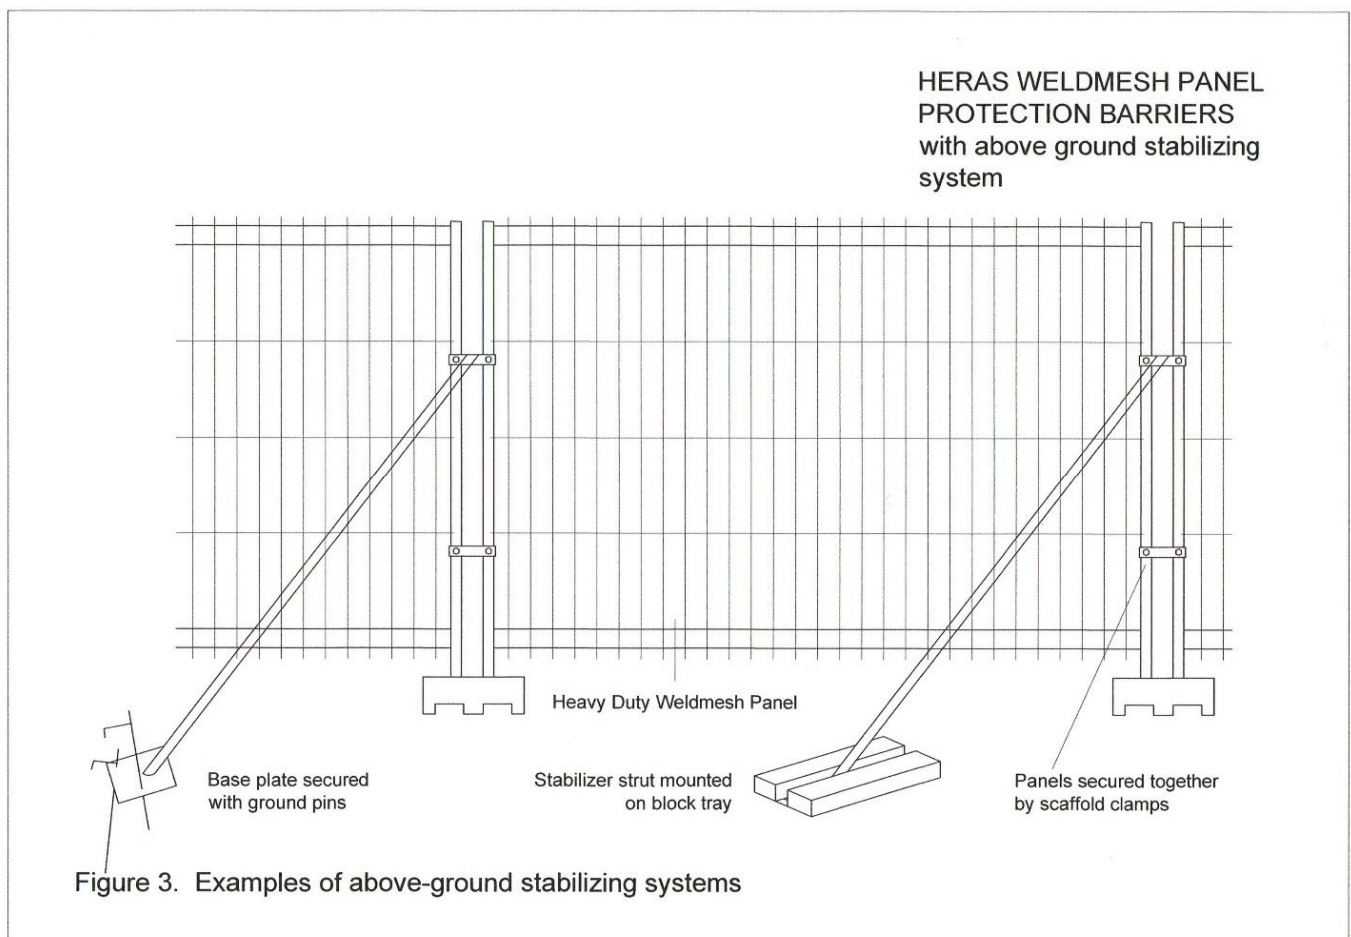
In order to protect the trees and their rooting environments tree protection fencing will need to be erected. The position of this fencing is shown on drawing 6801 and represented by the purple line. This fencing will need to comply with BS5837:2012, *Trees in relation to design, demolition and construction – Recommendations*. Figure 3 shows the required fencing that will need to be in place before any works can start on the proposed project. This fencing should not be moved without consultation with the project Arborist or the Local Authority Tree Officer.
