# Structural chimney appraisal

17 The Close, Salisbury

| Document ref. | 14781.1 |

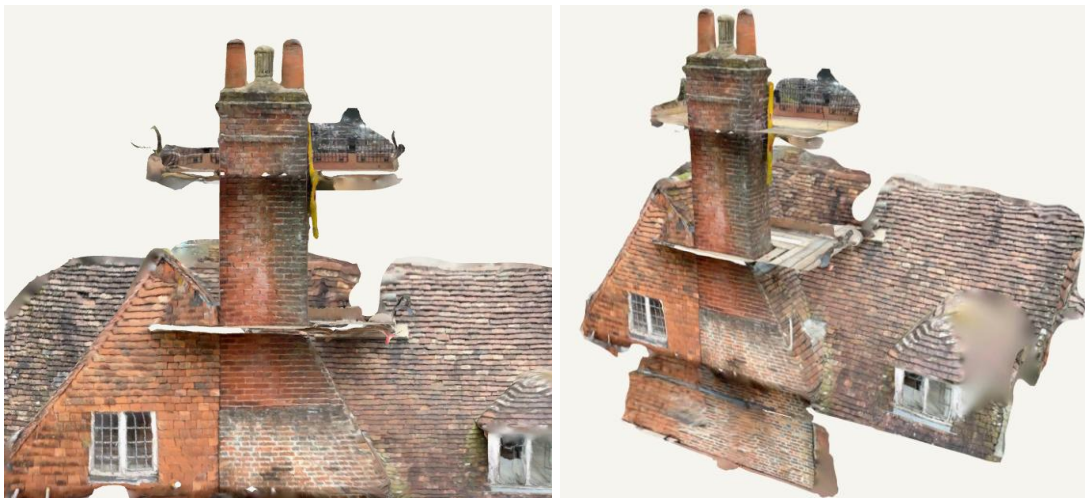
Figure 6 – Chimney A LiDAR scan images [L-R = west, SW]

The stack is partially built into the north west gable. There is a visible change in brick and pointing quality from the adjacent window head upwards. The stack contains three grouped flues. The brick is laid in stretcher bond. No headers were noted and it is assumed that the withes (brick flue divider), which can be seen when looking down the pot, are not bonded to the outer stack masonry. The flaunching has cracked and 15mm loss of pointing is typical across the elevations.

- Plan dimensions = 580mm x 1280mm
- Maximum exposed height (from lowest roof tile) = circa 3.5 metres
- Verticality check
  - South elevation = plumb over 3.15m height
  - West elevation = chimney leaning 50mm east at top over 2.23m height (2.3mm lean per 100mm height)
  - *Measurement of the south elevation is from the u/s of the cap corbel, and the west is from the u/s of the top scaffold lift.*

The safest course of action for all chimneys is to rebuild the stacks with salvaged bricks in suitable lime mortar. A durable NHL5 may be suitable but an experienced mason should be consulted to conclude if this is compatible with the existing bricks. However, as a less drastic measure, it may be justifiable to strengthen chimneys A and B by installing stainless helical bar stitching (Helibar or similar) with extensive repointing. This would need to be combined with periodic future monitoring, say yearly, which will require close access (within touching distance) to the stacks. The helical bars will ensure that the chimney continues to function as a cellular stack by robustly tying each shaft wall to the return walls. Chimney C will need to be rebuilt from close to the ridge line.

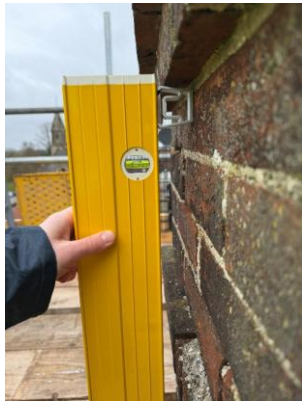
Figure 11 – South verticality check

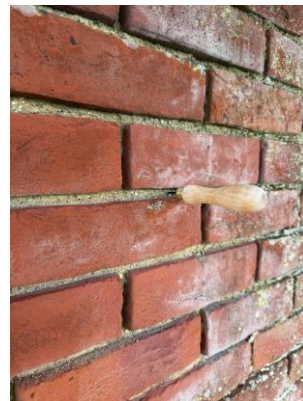
Figure 14 – Penetration with bradawl

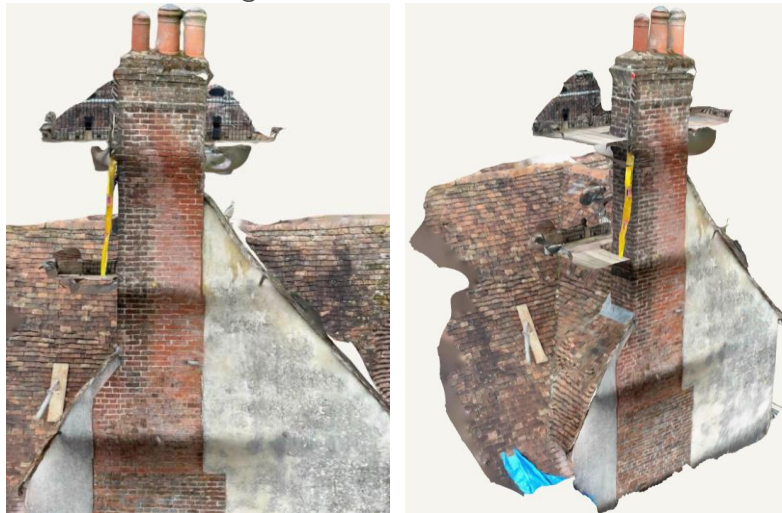
Figure 15 – Chimney B LiDAR scan images [L-R = east, SE]

The stack is partially built into the north east gable. As per chimney A, the stack contains three grouped flues and the brick is laid in stretcher bond. The north and east elevations appear to have been previously repointed in lime but are now failing. A separation crack is present in the south elevation, suggesting that the east and west elevations are moving apart, possibly as a deformation/tension effect on the side away from the lean.

- Plan dimensions = 580mm x 1280mm
- Maximum exposed height (from lowest roof tile) = circa 4.5 metres
- Verticality check
  - South elevation = stack leaning 30mm north at top over 2.03m height (1.5mm lean per 100mm height)
  - East elevation = plumb over 3.15m height
  - *Measurement of the south elevation is from the u/s of the top scaffold lift., and the west is from u/s of the cap corbel*
- Level check
  - East elevation string course = 50mm lower at north end

Chimney B is plumb in the minor axis but has a significant lean in the major axis. Although the stability of the stack is less concerning here, the stress concentrations in the masonry below are likely to be high. The separation cracks noted are an indication that the lean may be causing some tensile related deformation on the opposite side.

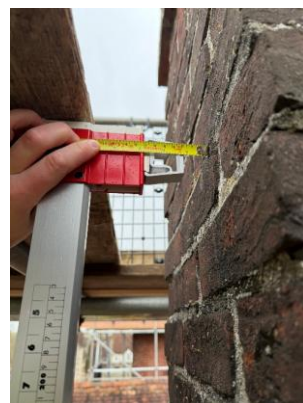
Figure 25 – East verticality check

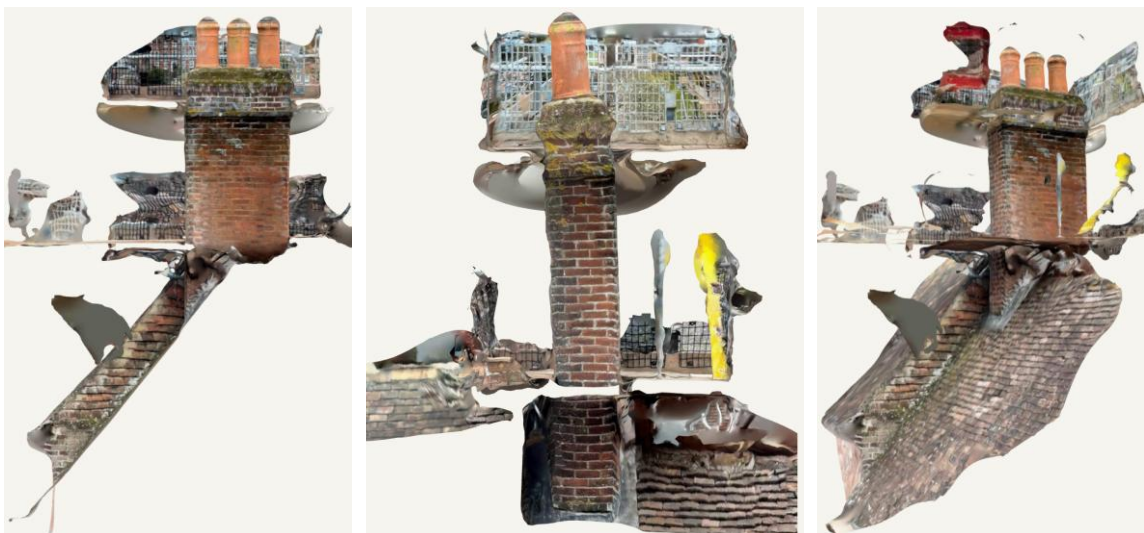
Figure 32 – Chimney C LiDAR scan images [L-R = north, east, NE]

The chimney is located at the suspected original rear elevation of the house before it was historically extended. As per chimney A & B, the stack contains three grouped flues and the brick is laid in stretcher bond. However, the stack is wider than the other two. The flue was viewed from the pot and no parge coat appeared to be present.

- Plan dimensions = 580mm x 1525mm
- Maximum exposed height (from lowest roof tile) = circa 4.5 metres
- Verticality check – *measurements are from u/s cap corbel*
  - North elevation = chimney leaning 78mm south at top over 2.3m height (3.4mm lean per 100mm height)
- Level check
  - North elevation string course = 10mm lower at west end
- Individual flue plan opening size = 1.5 brick square

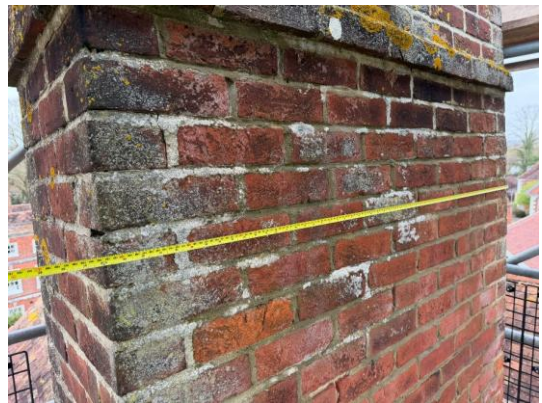
Figure 38 – North elevation measurement

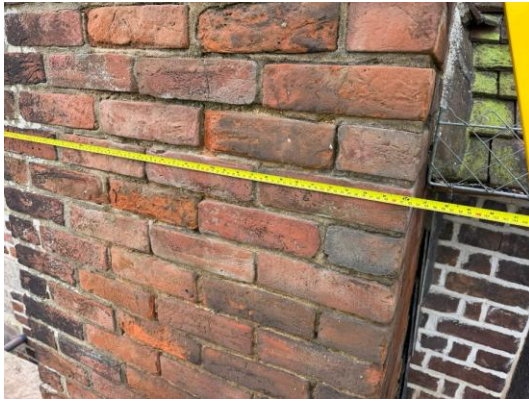
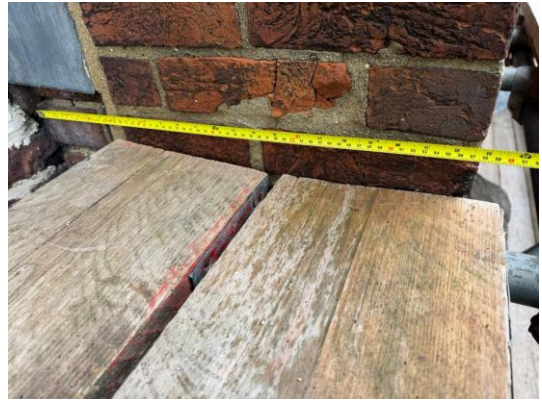
The stack is located against the east elevation, toward the front of the house. It appeared to be in fair condition. The top could not be inspected from within touching distance due to the top scaffold lift being much lower. Verticality measurements are estimated and accurate readings would be beneficial before making a decision on any remedial works.

- Plan dimensions = 580mm x 920mm
- Verticality check *← measurements are from u/s corbel*
  - North elevation = stack leaning approx. 30mm south at top over 3.15m (0.95mm lean per 100mm height)
  - East elevation = stack leaning 50mm east at top over 3.15m height (1.6mm lean per 100mm height)
  - *Note, dimensions are approximated. Remeasure on site recommended.*

Figure 47 – East elevation measurement

Figure 48 – South elevation measurement
