# STRUCTURAL APPRAISAL REPORT [REV 1]

ON BEHALF OF: Carter Jonas, Taunton

BARN AT  
HIGHWAY FARM  
CALNE  
SN11 8SR

DATE OF ISSUE: 11<sup>TH</sup> MAY 2026

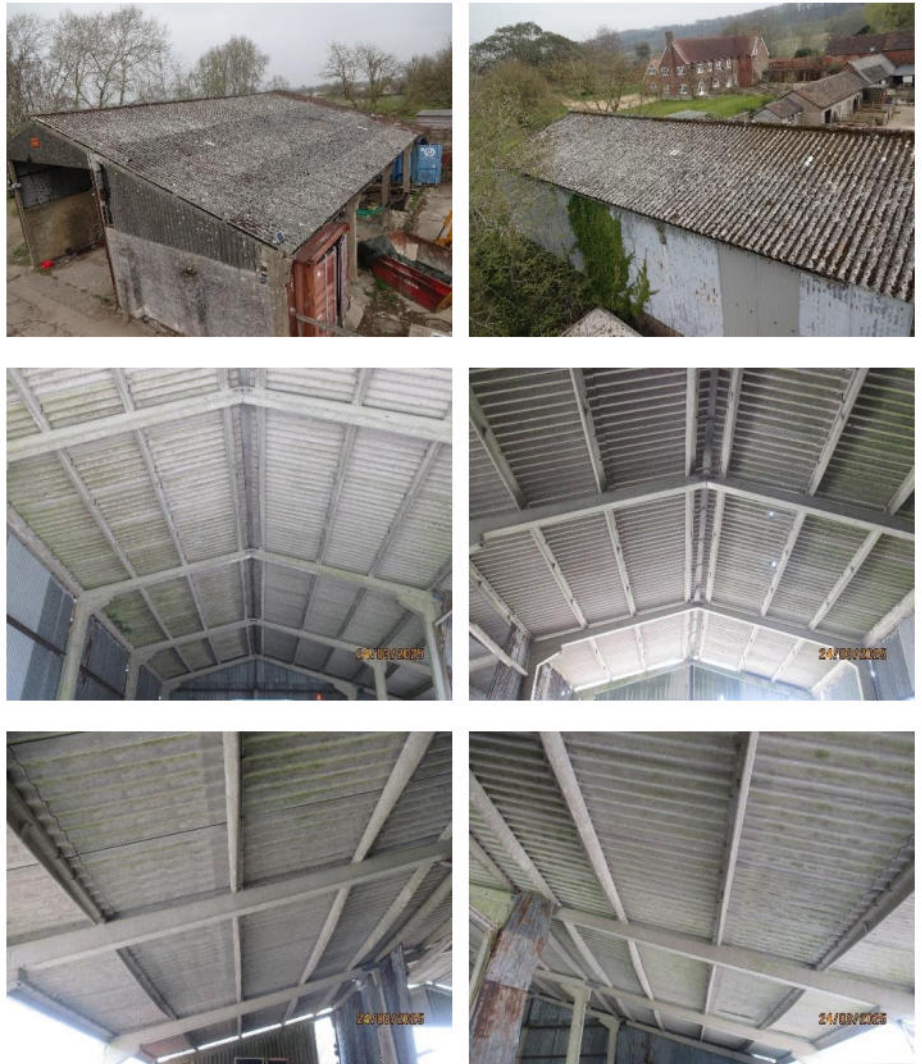
*Images showing the barn and lean-to roof*

At the lean-to, four concrete eaves beams have minor spalling at their underside, revealing the steel reinforcement inside. The end of the primary rafter, located at the front, right hand corner of the lean-to has similar deterioration. The spalling is the result of minor rusting of the steel reinforcement embedded inside these components.

The roof covering is intact and extends across the entire barn. The roof covering contains four minor splits and four minor perforations through, which given the extent of the roof covering demonstrates only minor defect to be present. Whilst not a structural issue, the roof covering should be repaired, either by filling the splits and perforations or by localised reinstatement.

The roof structure and roof covering are in reasonable condition and free from significant defect, requiring only minor repair.

The beams should be repaired and sealed, with an appropriate treatment and filler material.

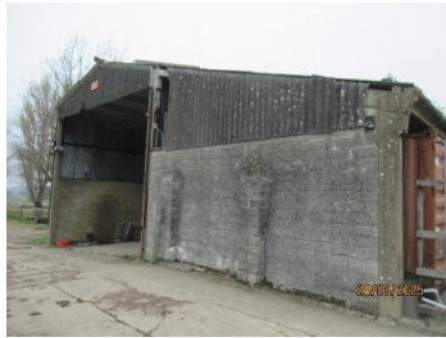
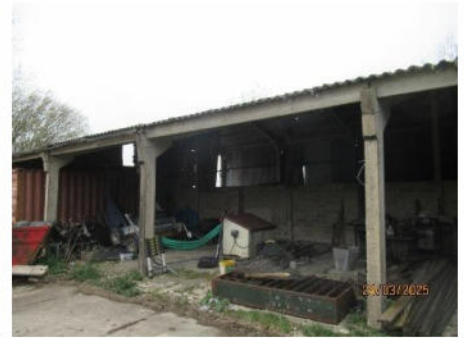
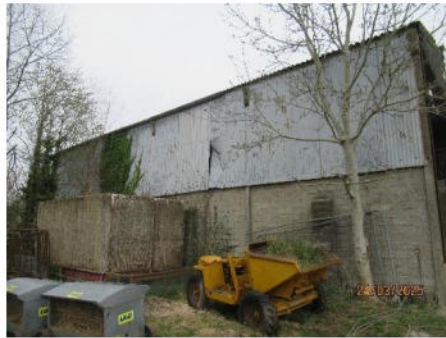
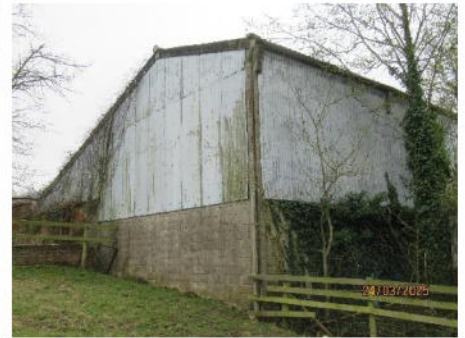
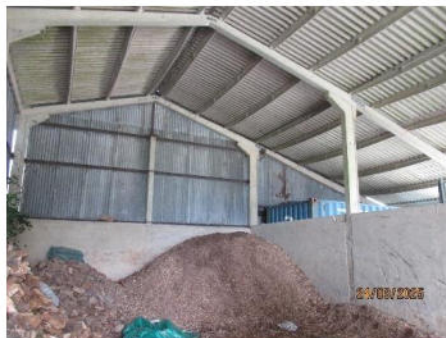
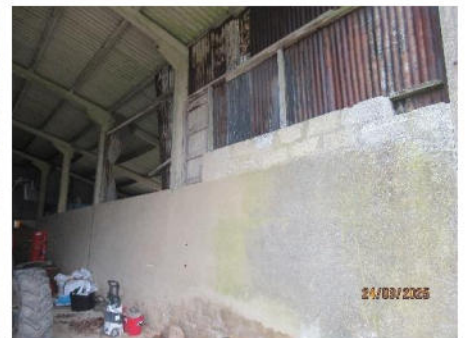
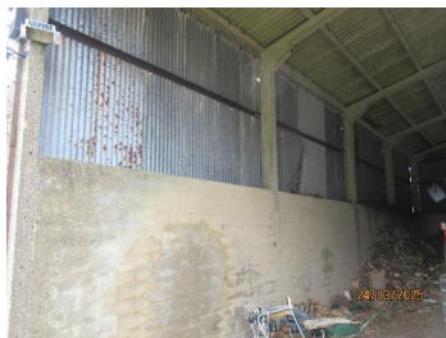
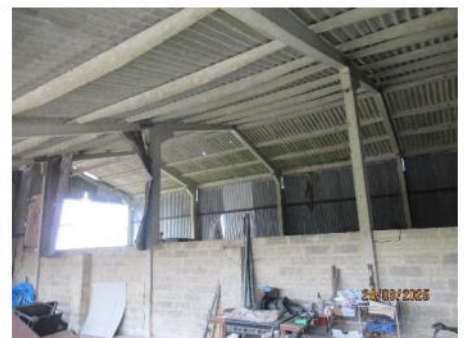
*Images showing the barn walls*
