# Preliminary Ecological Appraisal and Roost Assessment

Home Farm, Shaw Hill, Shaw, Wiltshire, SN12 8EW

This report is prepared to inform a planning application with the Wiltshire Council. The proposal is described as:

‘The erection of 2no. dwellings with associated soft landscaping’.

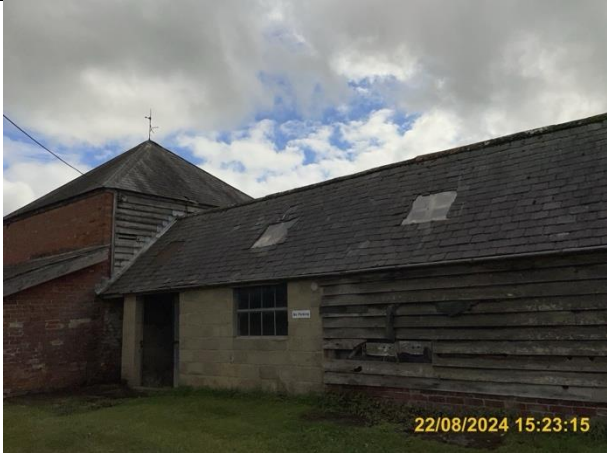
| Window/doors frames and lintels B1a | Timber | <b>Condition/description</b><br>Timber doors with small gaps along the frame, broken window with metal sheet behind on the southern elevation and opening without barrier on the northern and southern elevation, and well-sealed window on the northern elevation.<br><br><b>Suitability/access</b><br>Small gaps between door frame and doors provide access into internal void. Metal sheet behind the broken window on the southern elevation limits access into internal void, but the unrestricted openings on the southern and northern elevation provide access into the interior. | | |

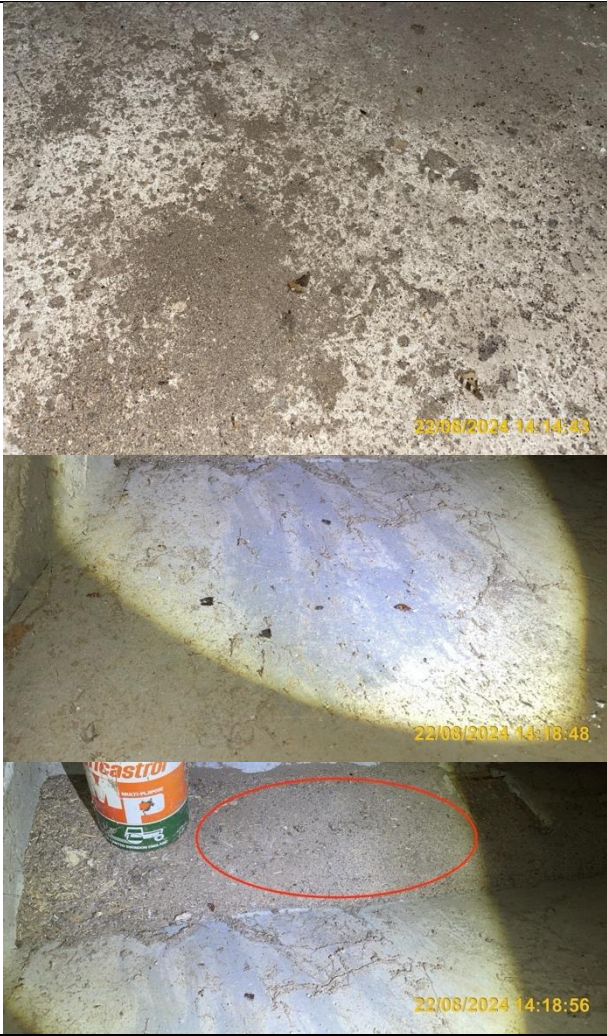
| Internal voids<br>B1b | Timber rafters and ridge beam. Open floor to ridge. Mortise and tenon joints. | <p><b>Condition/description</b></p> <p>First storey can be accessed through opening into the corridor between B1a and B1b. The interior was dark with low levels of natural light spill through gaps in window frames and brickwork. Second storey is accessed by a ladder and contains two dark enclosed spaces, running along eastern elevation and western elevation of the building. Both spaces don't have a barrier in their opening, allowing full access. The second storey has some natural light spill through the gaps between timber cladding and metal sheets which were used to board up windows and door.</p> <p><b>Suitability/access/evidence of bats</b></p> <p>First storey had a low number (&lt;5) of discarded moths and butterfly wings. A large number of bat droppings (~50) with mixture of colours and discarded moths and butterfly wings (~20) were seen within both two dark enclosed spaces on the second storey. Samples were collected for DNA analysis. There is a mixture of colours which shows different ages of droppings, with darkest droppings indicating more recent activity. Size and shape of droppings indicate a large bat, such as serotine or horseshoe.</p> | |

| <i>Recommendations</i> | <p><b>Roosting habitat [B1+B2]</b><br/>Three bat emergence/re-entry surveys are required on B1 and B2 during the active bat season (May – September) to confirm presence/likely-absence of bats roosting in or on the building.<br/>These survey visits should be completed during the optimal survey period mid-May to August inclusive. The survey visits should be at least three weeks apart. Sub-optimal: early May and September. Would require greater justification of timing e.g., weather conditions, known local bat activity.<br/>Six surveyors are required to provide full coverage of the building's elevations to look for emerging/re-entering bats. An infrared camera should also be employed as part of the survey to see where any specific roost locations are located.<br/>Lighting mitigation may be required based on the outcome of the night bat surveys. An EPSL application to Natural England will be required. The EPSL application requires that all surveys have been undertaken within the most recent active bat season and planning permission must have been granted and all relevant wildlife-related conditions have been discharged prior to submission.</p> <p><b>Foraging and commuting habitat</b><br/>No activity surveys are required, however foraging and commuting behaviour will be observed and recorded during the night time of bat emergence surveys.</p> <p><b>Artificial lighting</b></p> |

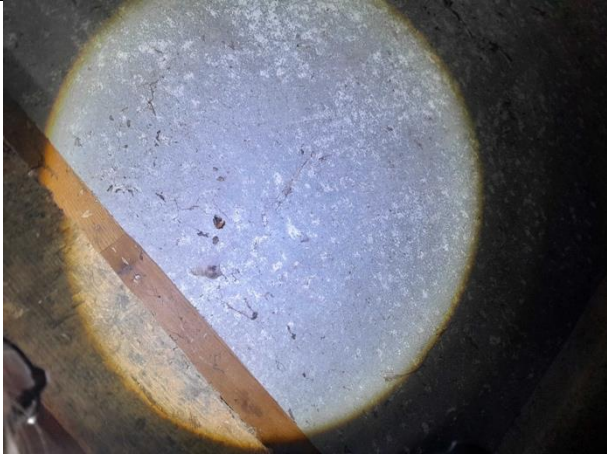
| Loft void B1b | Timber rafters and ridge beam. Open floor to ridge. | <p><b>Condition/description</b></p> <p>Loft void is on the third storey of the building, it has timber rafters and ridge beam in good condition, and it is 2 m high and 4 m wide in diameter. The loft roof is not lined, with exposed slate tiles. 2 dead birds, presumably pigeons, 4 pigeon nests and rodent droppings were seen. The loft void couldn't be fully accessed and surveyed due to safety reasons as the loft joists were unstable.</p> <p><b>Suitability/access/evidence of bats</b></p> <p>Bats can access the loft void through crevices in slate tiles, eaves and opening leading to the second storey. ~10 bat droppings and discarded moth and butterfly wings were found, however due to safety reasons it was not possible to inspect the whole area of loft void and therefore more evidence of bats might have been missed. Samples were collected for DNA analysis. The loft is suitable for roof-void dwelling bats, which require gaps from as small as the width of our thumb to access the roost and need timber joists or beams on which to roost.</p> | |

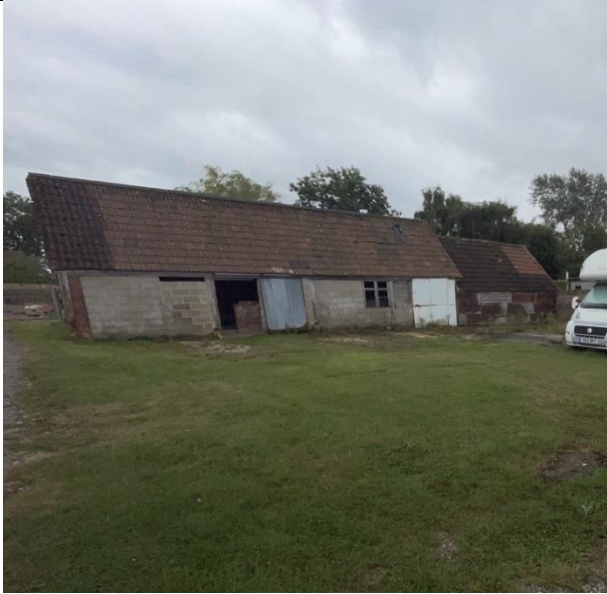
| | | | | | |
|---|--|--|--|---|--|
| <p><b>Summary</b></p> <p>B2 is a one-storey farm building in poor condition, with two sections (B2a, B2b) connected internally by an unrestricted opening. The roof is clay tiled and walls consist of timber clad, brickwork and breeze block. All structures contain suitable bat roosting and access features for crevice and void-dwelling bats. These include crevices and gaps under/in timber boards, eaves, roof tiles, brickwork and barge board. Moreover, there are areas of unrestricted access in form of open area of B2b which leads to the exterior. There are two internal voids. Within the internal void of B2a evidence (bat droppings and discarded insect wings) of bats using the interior was found. No evidence was found on external walls, however, this couldn't be used to indicate a likely absence of crevice dwelling bats. This is because bats such as pipistrelles can be found roosting behind hanging tiles, soffit and barge or eaves boarding, between roofing felt and roof tiles or in cavity walls, and all internal evidence is trapped within these crevices. Moreover, any</p> | | | | | |

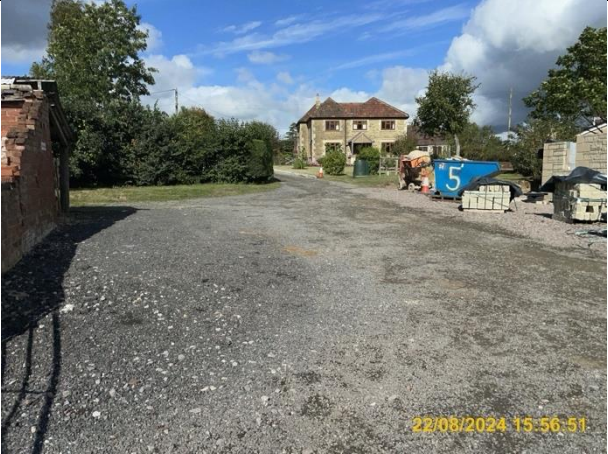
| <b>Developed land; sealed surface</b> | |
|---|---|
| | <p>Figure 2: Artificial unvegetated, unsealed surface comprising driveway (adjacent to northern area of modified grassland)</p> |

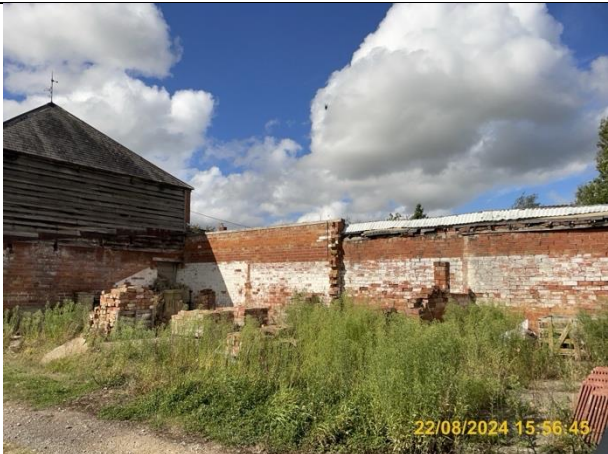
| | <p>Figure 3: Ruderal vegetation adjacent to eastern and southern elevation of B1b</p> |

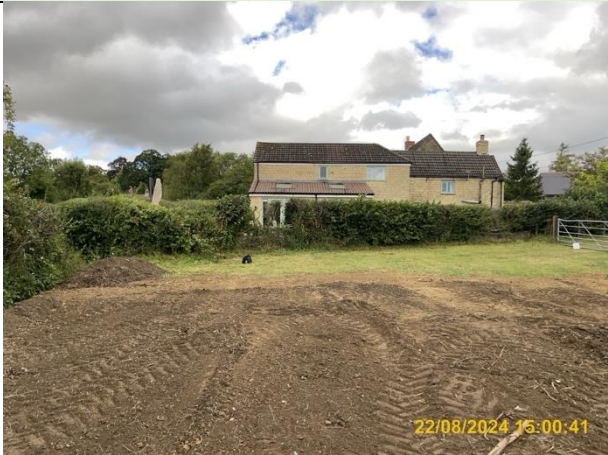
| | <p>Figure 4: Bare ground along the western site boundary</p> |

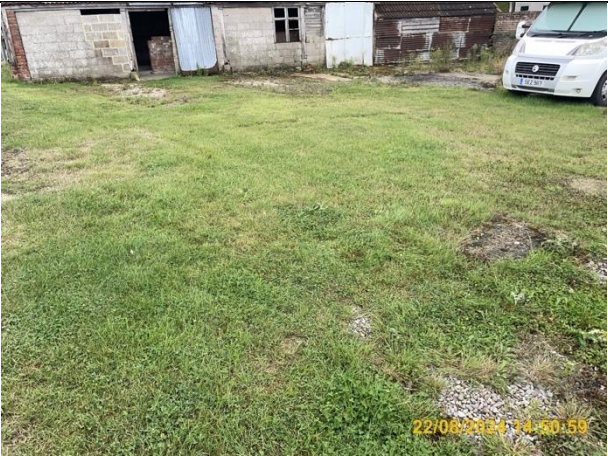
| | | Figure 5: Area of modified grassland adjacent to western elevation of B2a |

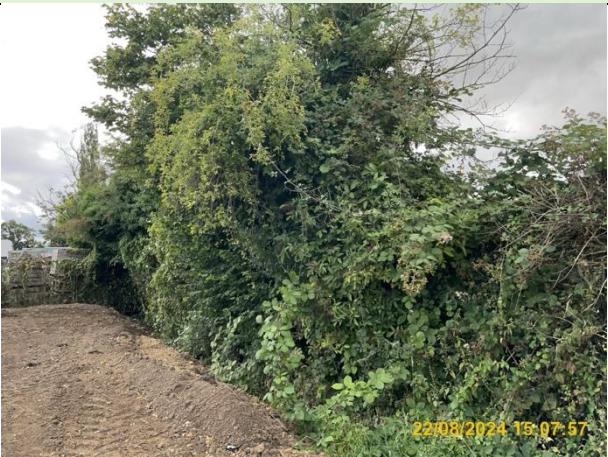
| | | Figure 6: Native hedgerow with trees along western site boundary |

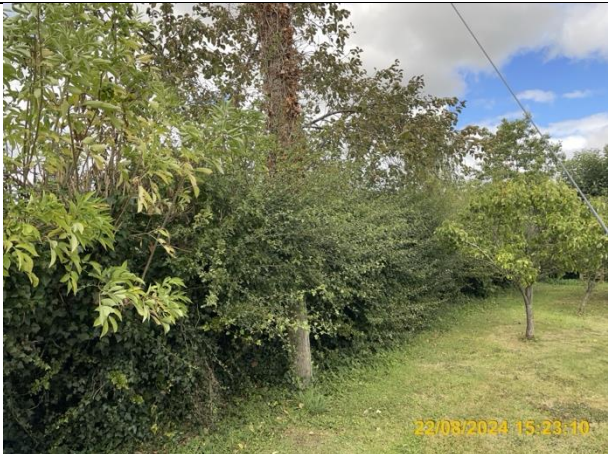
| | | Figure 7: Native hedgerow with trees along northern site boundary | |

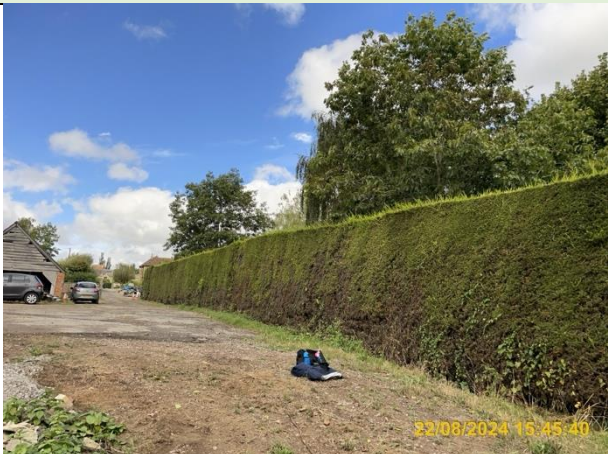
| | | Figure 8: Non-native ornamental hedgerow with trees along eastern site boundary | |

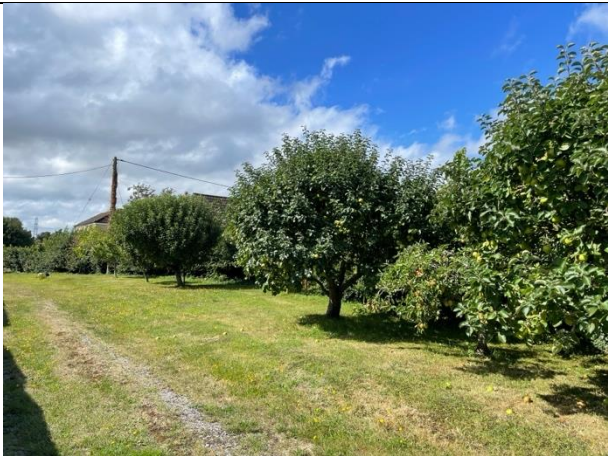
| | | Figure 9: Scattered fruiting trees within area of modified grassland, adjacent to northern site boundary | |

| <i>Recommendations</i> | <p><b>On-site habitats</b></p> <p>Fruiting trees present on-site should be retained and/or replanted where retention is not possible. To compensate for the proposed habitat losses at the site, the following habitat creation and enhancement measures should be explored:</p> <ul style="list-style-type: none"> <li>• Creation of modified grassland in the area of bare ground.</li> <li>• Enhancement of retained areas of modified grassland via the provision of native wildflowers or wildflower turf.</li> </ul> <p><b>Notable habitats</b></p> <p>None required.</p> <p><b>Biodiversity net gain</b></p> <p>The Environment Act (2021) requires all developments (excluding exemptions) to deliver a 10% net gain in biodiversity. This is mandatory for larger developments and comes into force for smaller developments on 2nd April 2024. Due to the loss of more than 25m<sup>2</sup> habitat, the development is not exempt from demonstrating a compliant biodiversity net gain, as per current Natural England Guidance: <a href="https://www.gov.uk/guidance/biodiversity-net-gain-exempt-developments">https://www.gov.uk/guidance/biodiversity-net-gain-exempt-developments</a>. Therefore, the planning application must be accompanied by a landscaping/habitat creation and enhancement strategy, biodiversity net gain calculations and a habitat management and monitoring plan to ensure the proposed development delivers a 10% net gain.</p> |
