## Off Mains Drainage Survey Report Prepared For:

2 Field Cottages  
Manningford Bruce  
SN9 6HU

**Date of Survey:** 16/04/2025  
**Engineer:** Paul Stewart

**Project Description:** CCTV Survey

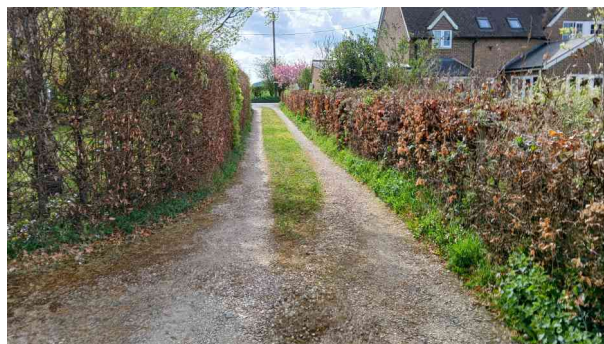
access to rear of properties from road

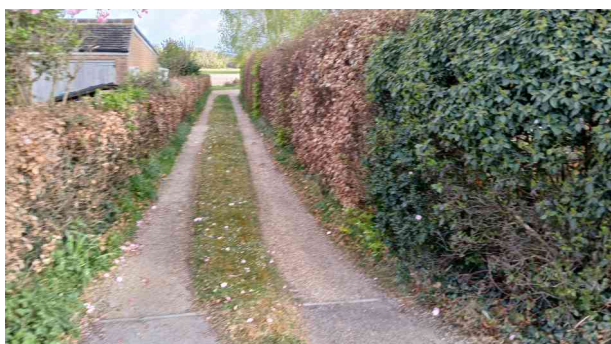
access to rear of properties

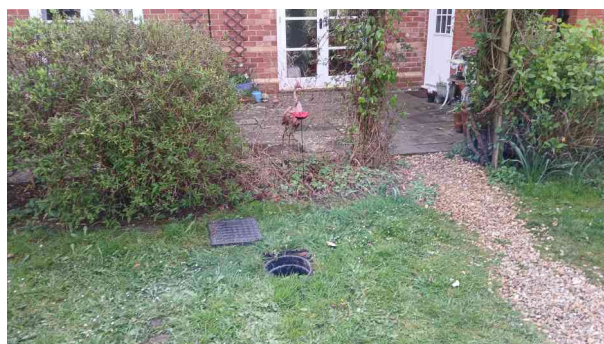
location of IC1

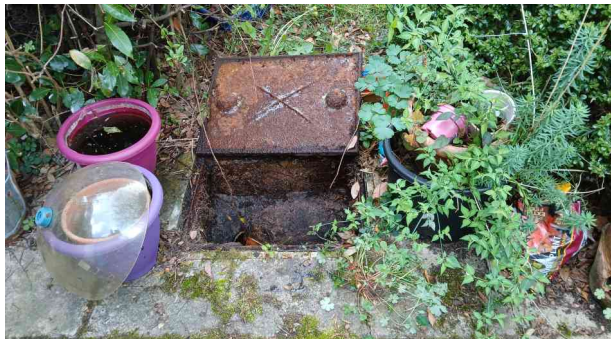
location of MH2

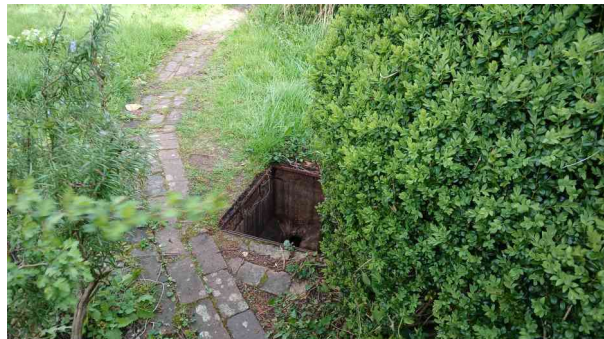
location of Mh3

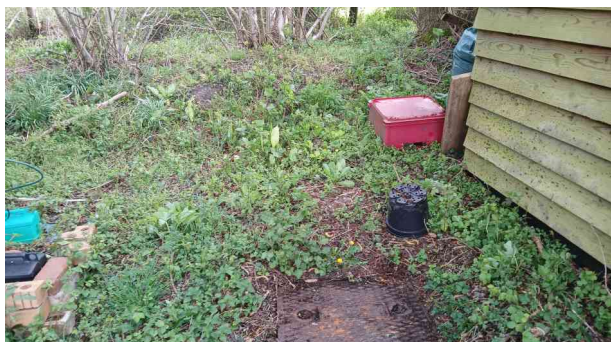
The tank is undersized for the maximum occupancy of the property and the discharge soakaway chamber is only 3m away from the seasonal ditch, therefore the system in place does not comply with building regulations and the general binding rules for discharge.

location of soakaway chamber

Install 10m of new pumped outlet and install a new sample chamber and new seasonal soakaway to run adjacent to the seasonal ditch to the rear left hand side of the No.1 rear garden. Permit required.

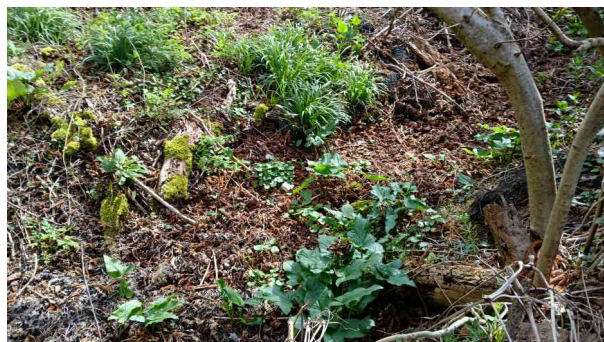
seasonal ditch

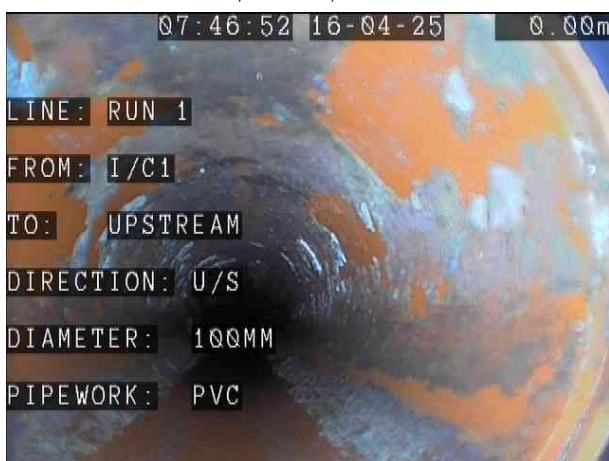
SVP2X\_2f5a6b66-e9cb-4e58-a999-9d84ffddcf9\_20250422\_202413\_428.jpg, 00:00:15, 0.00 m  
Water level, 5% of the vertical dimension

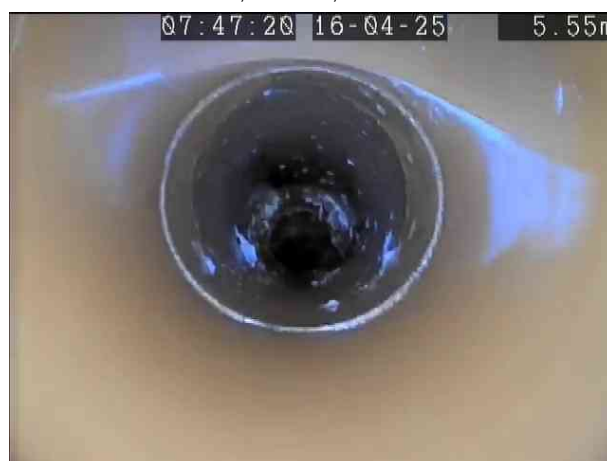
SVP2X\_65399523-1535-45ca-9879-d7d9fa23af80\_20250422\_202449\_658.jpg, 00:00:41, 5.55 m  
Junction at 12 o'clock, 100mm dia

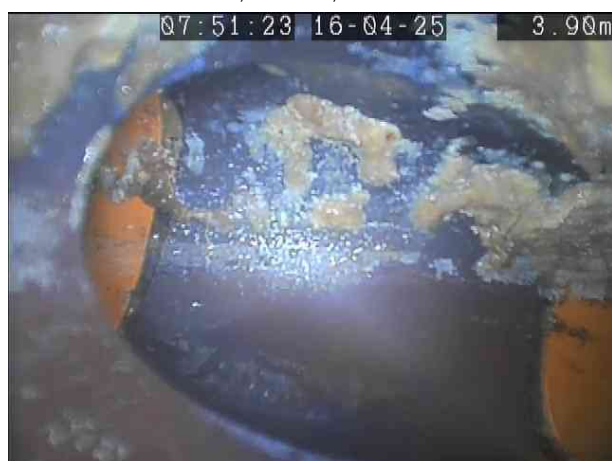
IC1X\_acb02c9f-2e38-4489-9f50-ba81d72da4f9\_20250422\_203712\_327.jpg, 00:00:07, 3.90 m  
Connection other than junction at 3 o'clock, 100mm dia

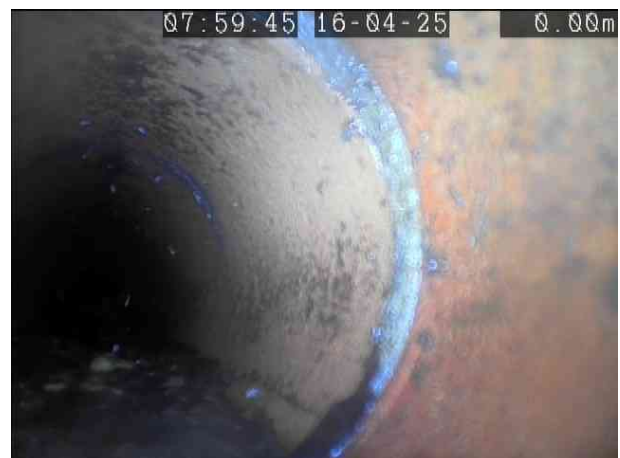
DISUSEDX\_d9921927-0f1e-4ee1-8422-190217e6844d\_20250422\_204046\_931.jpg, 00:00:07, 0.00 m  
Water level, 5% of the vertical dimension

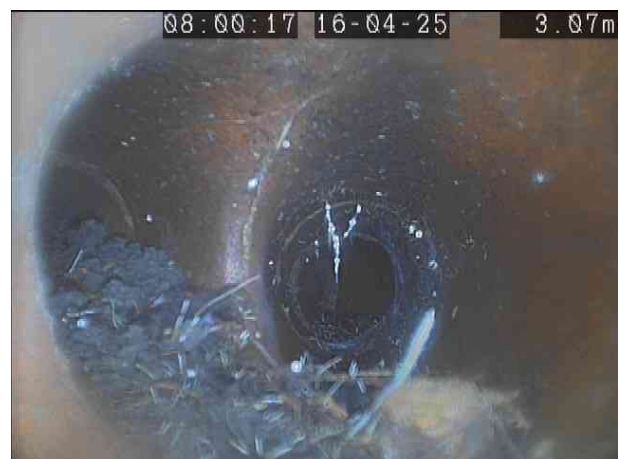
DISUSEDX\_cf9fbd5c-465f-42d0-9002-a93d179469b7\_20250422\_204125\_106.jpg, 00:00:38, 3.31 m  
Junction at 9 o'clock, 100mm dia

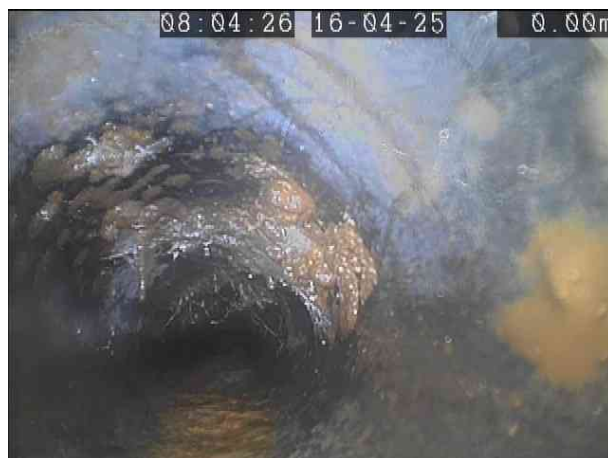
SVP3X\_b86abdcf-c54d-4dd9-9824-2094d7c18474\_20250422\_204341\_301.jpg, 00:00:07, 0.00 m  
Water level, 5% of the vertical dimension

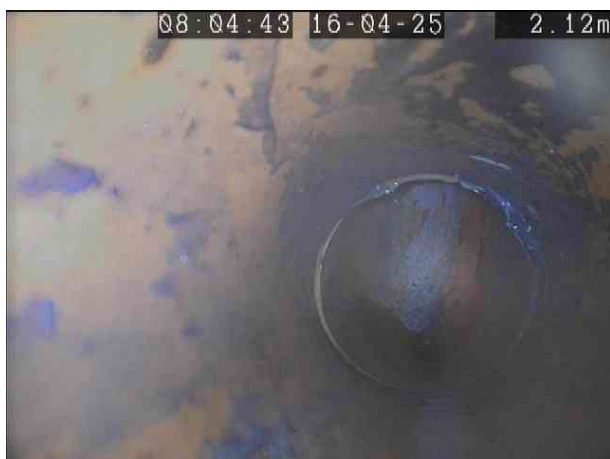
SVP3X\_3c829e4c-8699-4725-abf1-1212e879c6a6\_20250422\_204411\_315.jpg, 00:00:22, 2.12 m  
Pipe material changes to polyvinyl chloride at this point

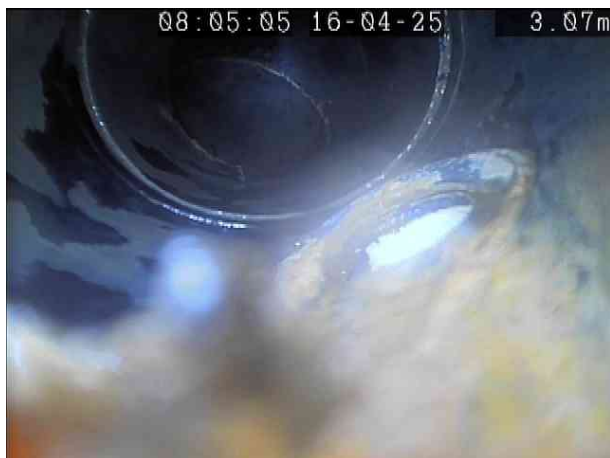
SVP3X\_1809c224-6f01-424b-a5d3-5086a986d191\_20250422\_204447\_196.jpg, 00:00:44, 3.07 m  
Finish node, other special chamber, reference: SVP3, SVP3

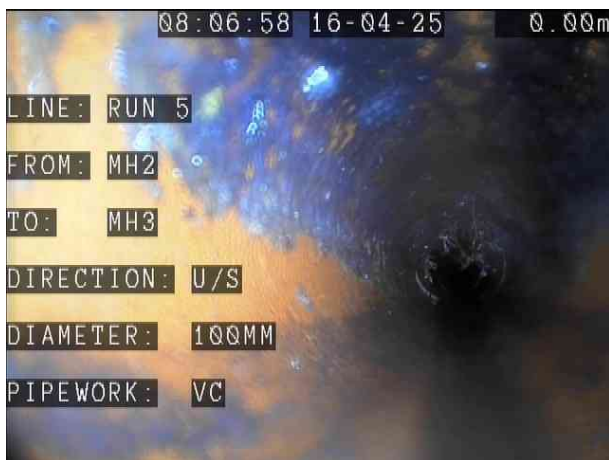
MH2X\_937808e8-e1bd-4e08-8414-d06b8045331e\_20250422\_204646\_540.jpg, 00:00:00, 0.00 m  
Start node, manhole, reference: MH2

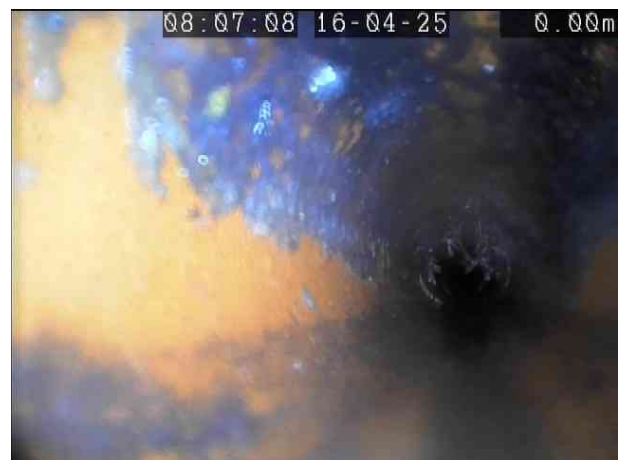
MH2X\_4fa9d46b-c15c-4c25-8d49-d01a10b72930\_20250422\_204748\_985.jpg, 00:00:11, 0.00 m  
Water level, 5% of the vertical dimension

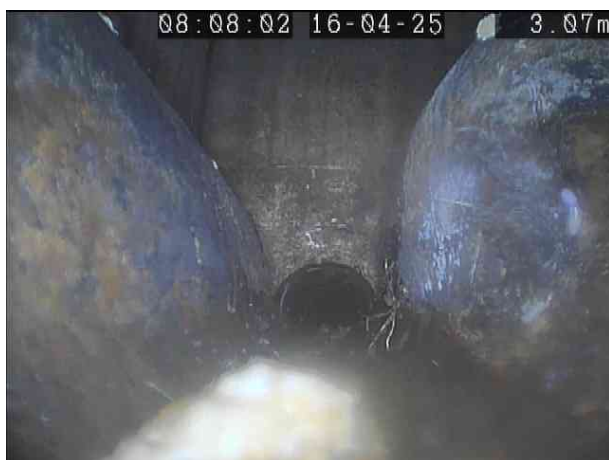
MH2X\_9d782177-8fb7-4136-9c76-49fc72d00be8\_20250422\_204911\_766.jpg, 00:01:06, 3.07 m  
Finish node, manhole, reference: MH3

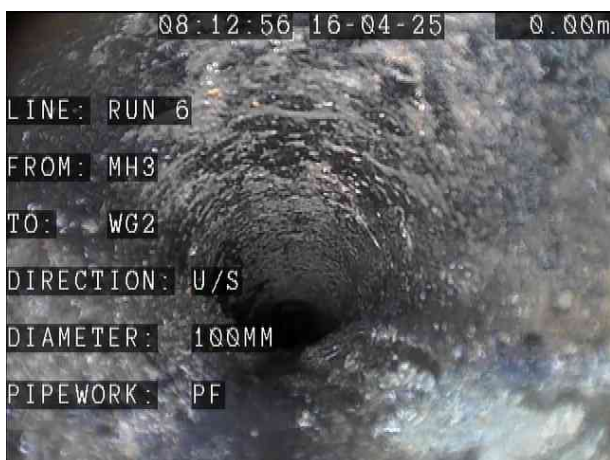
WG2X\_2641b69a-66d1-4ee4-a122-f692a65fc24d\_20250422\_205113\_673.jpg, 00:00:00, 0.00 m  
Start node, manhole, reference: MH3

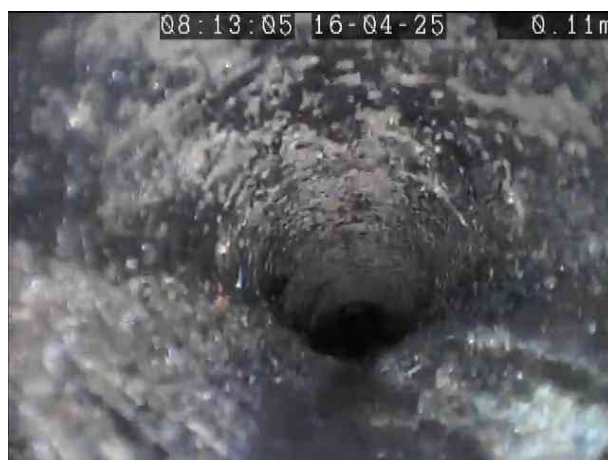
WG2X\_8e1fd0c9-2f83-4260-a5db-fe44bbc54f88\_20250422\_205122\_896.jpg, 00:00:12, 0.00 m  
Water level, 5% of the vertical dimension

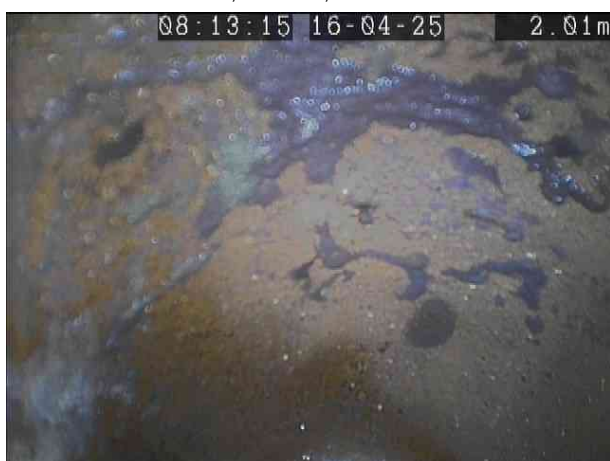
WG2X\_44a7ada1-d353-4657-a115-3cef9722ddf6\_20250422\_205141\_535.jpg, 00:00:22, 2.00 m  
Finish node, gully, reference: WG2

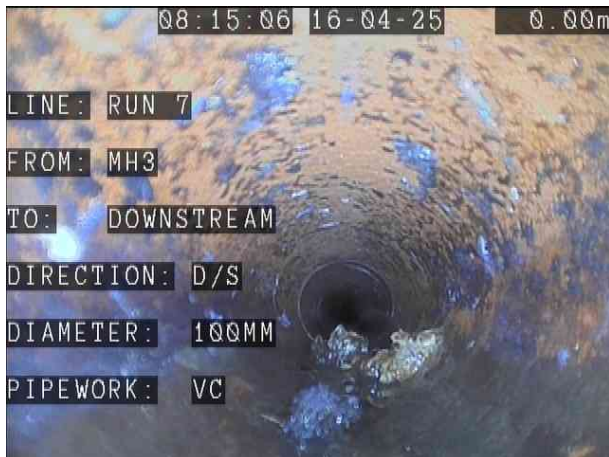
MH3X\_eeb99af2-2db1-4137-a4b4-3bfbde2c9ffd\_20250422\_205733\_218.jpg, 00:00:00, 0.00 m  
Start node, manhole, reference: MH3

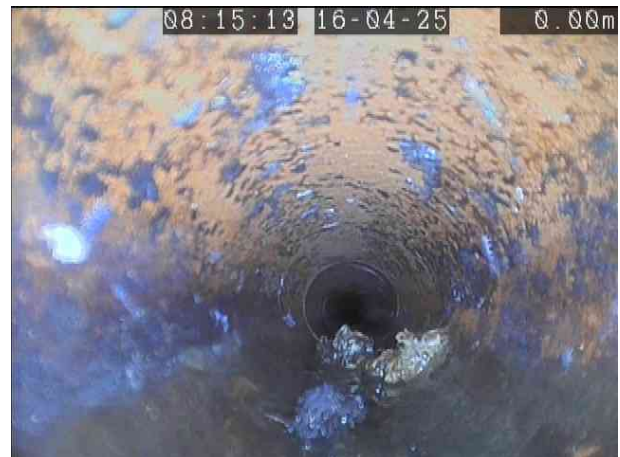
MH3X\_6534276e-4608-4c14-af5c-cdde9894a9f8\_20250422\_205744\_358.jpg, 00:00:07, 0.00 m  
Water level, 5% of the vertical dimension
