**Prepared by:** Esco trading Ltd

**Client:** Ed & Amy Shelton

**Address:** Knockdown Farm, Knockdown, Tetbury, GL8 8QY

# Infiltration Test Report

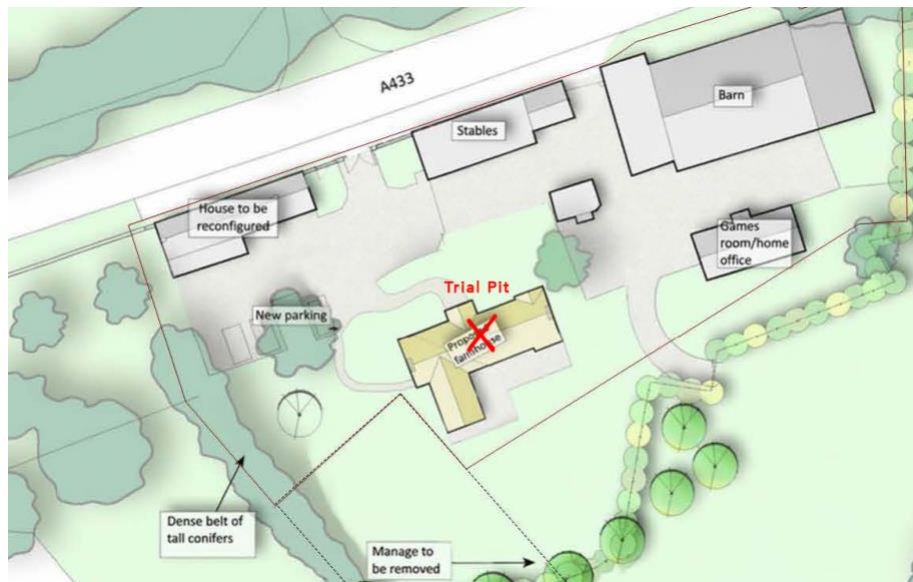
Fig 1: Site map

A trial pit was excavated by Pro Build Construction on 16 October 2025 at the proposed site at Knockdown Farm, Knockdown, Tetbury, GL8 8QY. The location was chosen as the lowest point on the proposed site ~0.5m lower than the surrounding soil.
