**Title:**        **Lacock Abbey**  
                  **Dining Room Roof**

**Job No:**    **22289**

**Date:**        **September 2025**

**Client:**      **The National Trust**

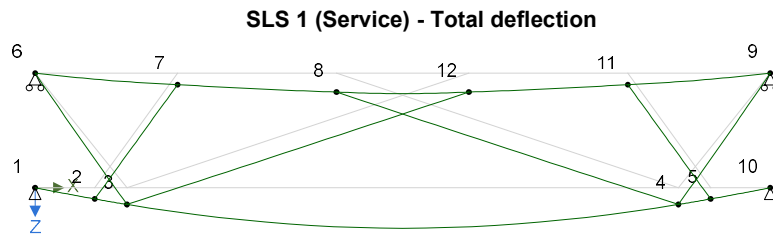
The existing structure was modelled, and found to have excessive deflection of the lower tie beam. The upper beam was also slightly over the allowable limits. These recommended limits are based on  $\text{span} / 360$  for all loading, or  $\text{span} / 250$  for imposed load only. The stresses and worst case forces from the girder analysis were reviewed for the principal beam members, and both the upper and lower tie beams passed these checks. It should be noted that the lower tie beam was found to be running at 98% capacity in this analysis.
