**Botanic Garden Glasshouse  
Lacock Abbey  
Lacock  
Wiltshire**

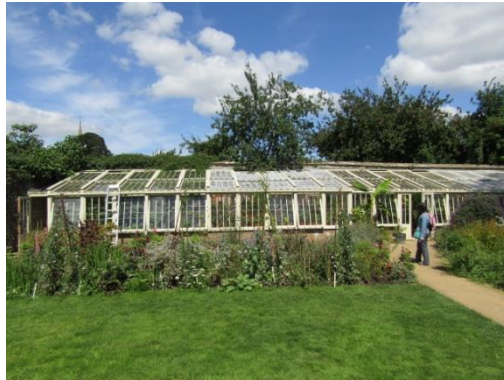
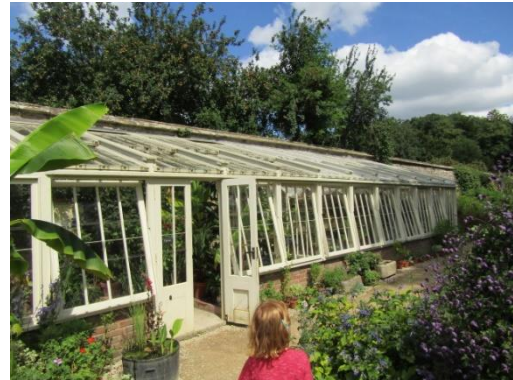
The glasshouse was reconstructed in the mid 2000's on the footprint of the earlier greenhouses. The construction is a timber frame built against the outer face of the southern wall of the walled garden. The western, left hand section of the building was the first constructed and then the right hand part built a few years later. The timber used in the construction was Douglas Fir which is a softwood and the left hand first 10 bays have been replaced in Sepele which is an African hardwood due to rot in the original frame. It should be noted that the original window were reused.

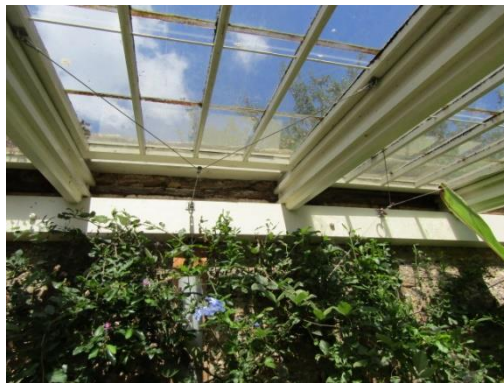
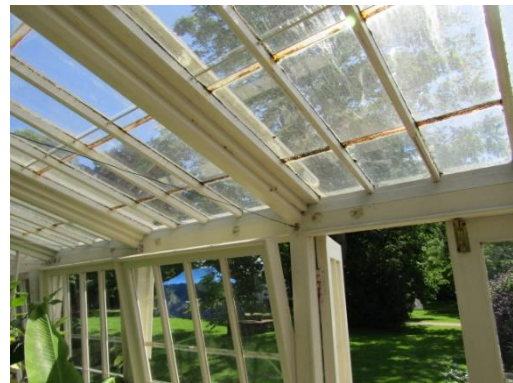
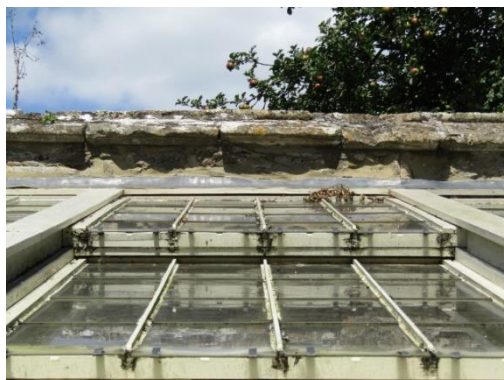
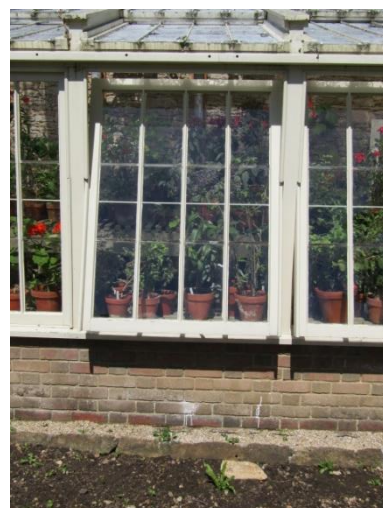
The glasshouse has a mono-pitched roof which is supported by main rafters supported at the northern end off a bearer set off the masonry wall and then onto a post at the front which is part of the front glazed frame. The rafter is joined by a small metal cleat and at the rear an angle to the main bearer. The mono-pitched roof consists of an upper sash which is opening and then a lower fixed sash. On the front frame the windows have a central pivot.

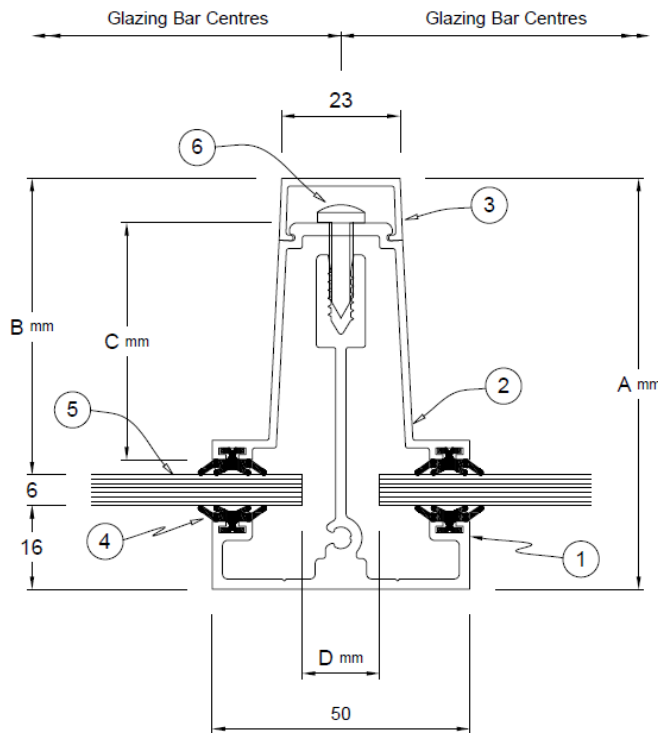
Diagrammatic sketch of traditional aluminium glazing bar with traditional aluminium cover caps

One of the main issues is the water run off and the junction of the glazing to the glazing bar. Where a sash requires replacement then the glazed section could be replaced utilising a hardwood frame but using a glazing system such as that produced by the patent glazing company. They produce an aluminium glazing bar and restraint system and therefore the rotting of the timber glazing bar would be eliminated. The appearance will be similar but the sashes would have to be re-detailed so they still function with the top opening sash which may be problematic due to the height of the upstand cover strip.
