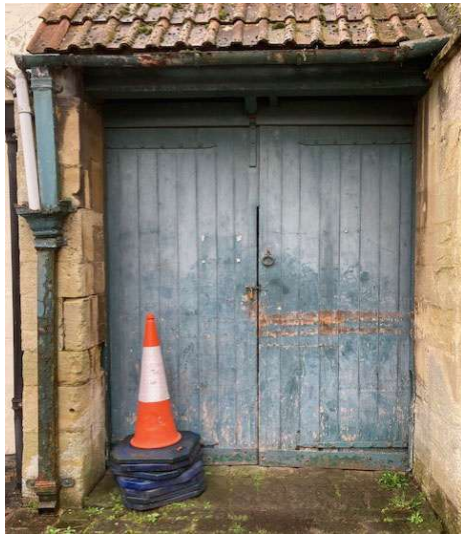
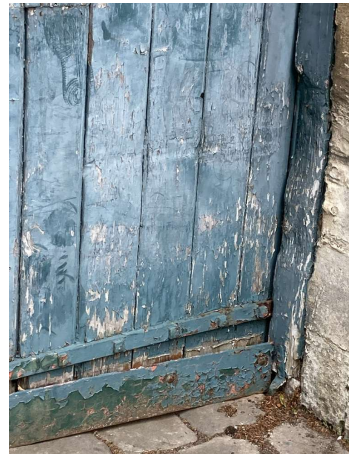
Existing main doors to the fire station. Doors to be sanded back. The timber to the bottom edge of the doors is rotten. This will need to be cut out and new timber scarfed in. Missing glazing to be replaced with new panes of single glazing to match the existing. Timber panel above the doors to be replaced with new. Lead flashing to be carefully removed and replaced with new. Prime and paint to match the existing. New hardware required.
