# Crack Investigation at Salisbury Guildhall

Salisbury City Council

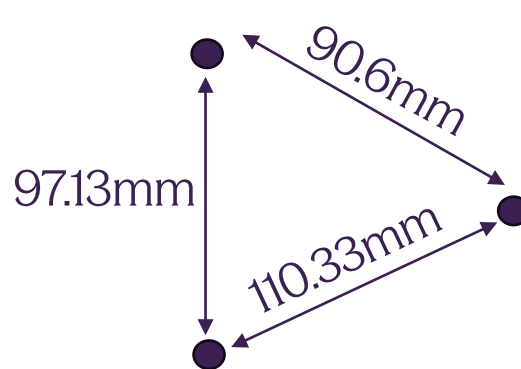
Figure 1: Tell tales recordings on North wall

Additional cracking was observed elsewhere within Oak Court. On the north wall, a crack measuring approximately 2.6 metres in length and up to 3 mm in width was identified. Tell-tale crack gauges have been installed at this location, indicating that this crack is subject to ongoing monitoring. Measurements taken at the time of inspection are recorded and referenced within Figure 1 and can be seen in images P31 & P33.

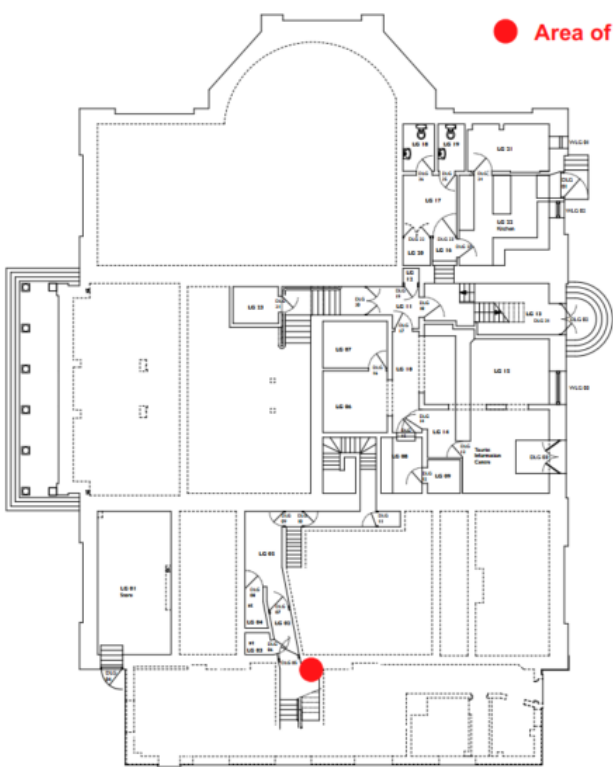
Basement

Identified below is each floor plan view of where the cracks are situated and correspond and link with each other for ease of view.

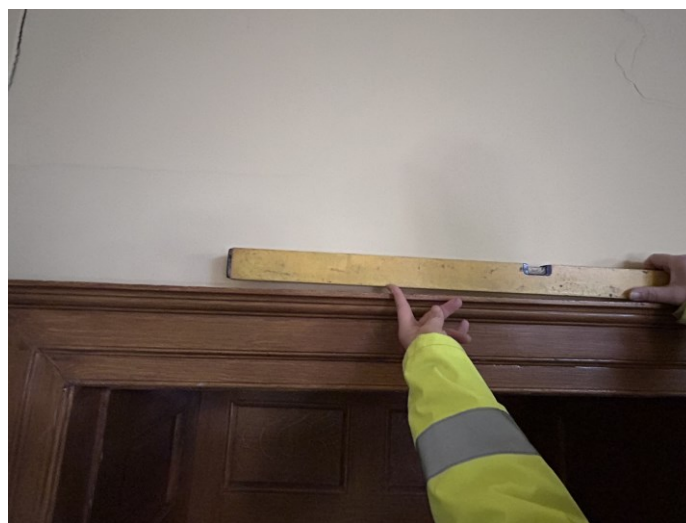
P30 – Door frame has dropped approx 30mm.
