# RIBA STAGE 3 - STATEMENT OF SIGNIFICANCE FOR LISTED BUILDING CONSENT APPLICATION

Window renovations  
16 Cross Keys, Corsham SN13 0DT  
Revision (-) Issued June 2026

TABLE 1: CONDITION SURVEY

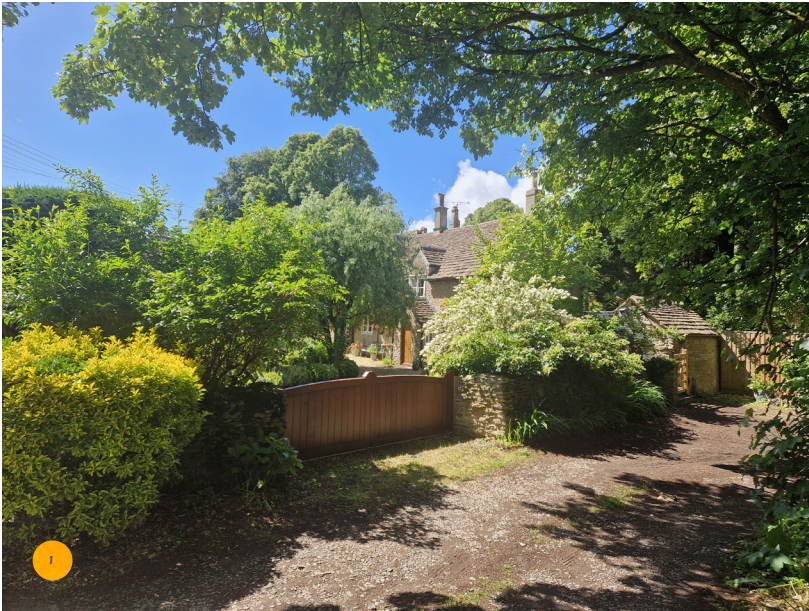
FIG 1. VIEW LOOKING TOWARDS HOUSE FROM MAIN ROAD TO SOUTH EAST ELEVATION

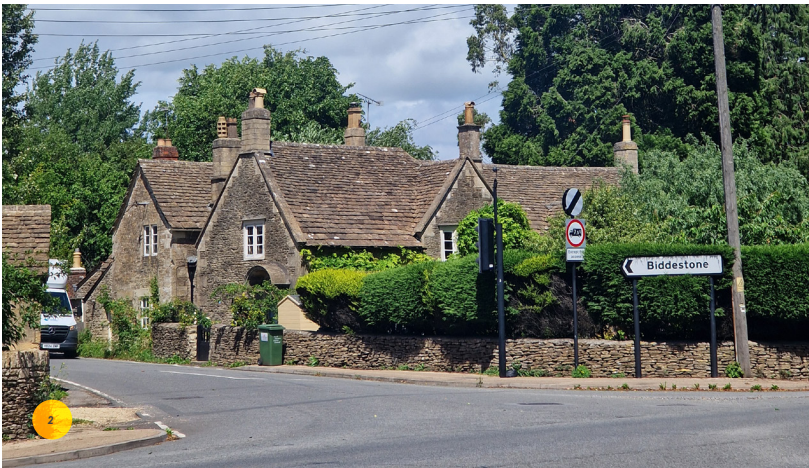
FIG 2. VIEW OF HOUSE FROM MAIN ROAD

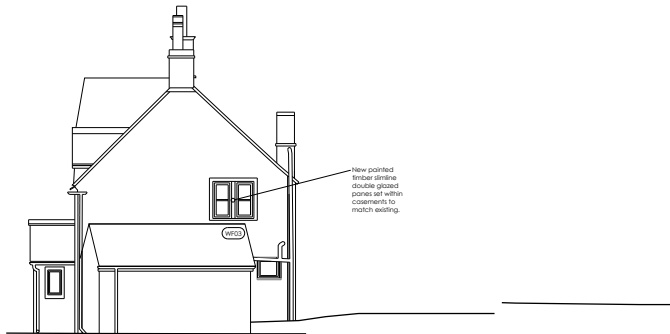
**NORTH-EAST ELEVATION**

| Window Ident | Location | Action needed to the frames | Action needed to the Sashes |
|---|---|---|---|
| WF03 | North-East elevation | Casements very poor. Lower half of stiles, bottom rail and glazing bars rotten and beyond repair, will need to be remade | Frame very poor, Cill and Jambs beyond repair. Frame will need to be remade |

Frames and casements to be repaired in accordance with the noted actions in Table 1. Where appropriate, historic fabric shall be retained wherever possible, with localised, rotted sections of frames to be carefully removed with new paint-quality hardwood frames scarfed / spliced in.

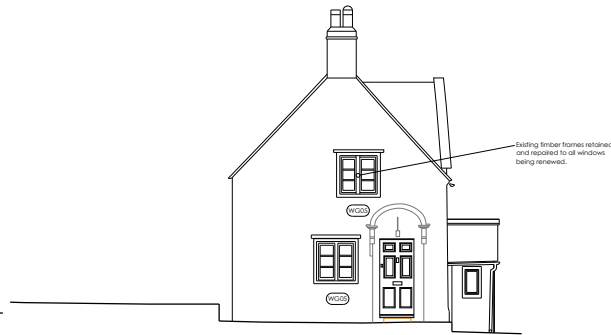
**SOUTH-WEST ELEVATION**

| Window Ident | Location | Action needed to the frames | Action needed to the Sashes |
|---|---|---|---|
| WG05 | South-West elevation | Casements very poor. Lower half of stiles, bottom rail and glazing bars rotten and beyond repair, will need to be remade | Frame very poor, Cill and Jambs beyond repair. Frame will need to be remade |
| WF04 | South-West elevation | Casements very poor. Lower half of stiles, bottom rail and glazing bars rotten and beyond repair, will need to be remade | Frame very poor, Cill and Jambs beyond repair. Frame will need to be remade |

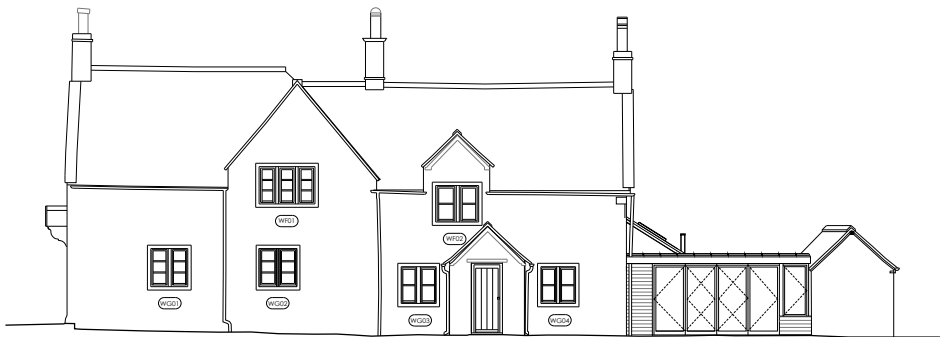
**SOUTH-EAST ELEVATION**

| Window Ident | Location | Action needed to the frames | Action needed to the Sashes |
|---|---|---|---|
| WG01 | South-East elevation | Casements very poor. Lower half of stiles, bottom rail and glazing bars rotten and beyond repair, will need to be remade | Frame very poor, Cill and Jambs beyond repair. Frame will need to be remade |
| WG02 | South-East elevation | Casements very poor. Lower half of stiles, bottom rail and glazing bars rotten and beyond repair, will need to be remade | Frame very poor, Cill and Jambs beyond repair. Frame will need to be remade |
| WG03 | South-East elevation | Casements very poor. Lower half of stiles, bottom rail and glazing bars rotten and beyond repair, will need to be remade | Frame very poor, Cill and Jambs beyond repair. Frame will need to be remade |
| WG04 | South-East elevation | Casements very poor. Lower half of stiles, bottom rail and glazing bars rotten and beyond repair, will need to be remade | Frame very poor, Cill and Jambs beyond repair. Frame will need to be remade |
