## Off Mains Drainage Survey Report Prepared For:

20, 21, 22 & 23  
Kingston Deverill,  
BA12 7HE.

**Date of Survey:** 07/04/2025  
**Engineer:** Paul Stewart

## Drainage Survey Standard Report:

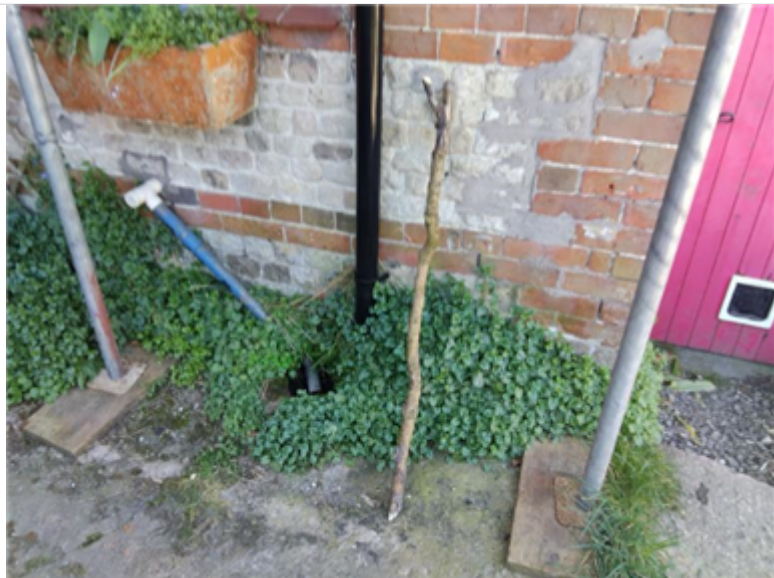
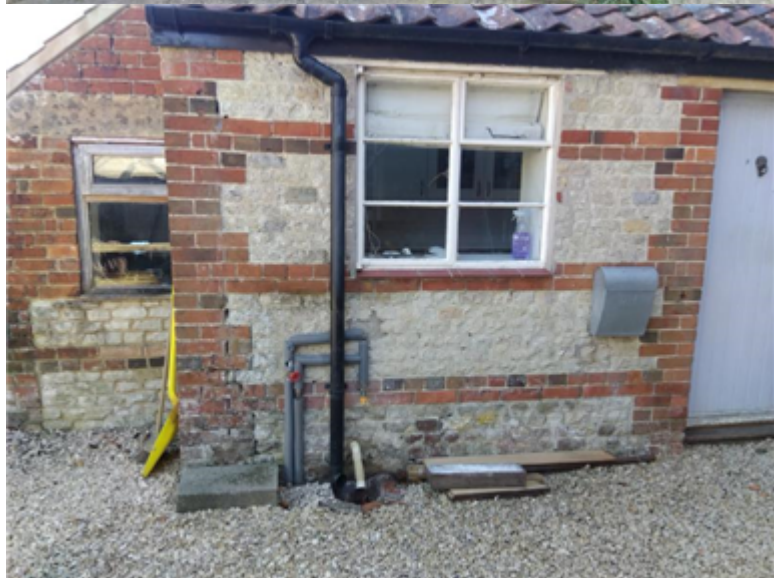
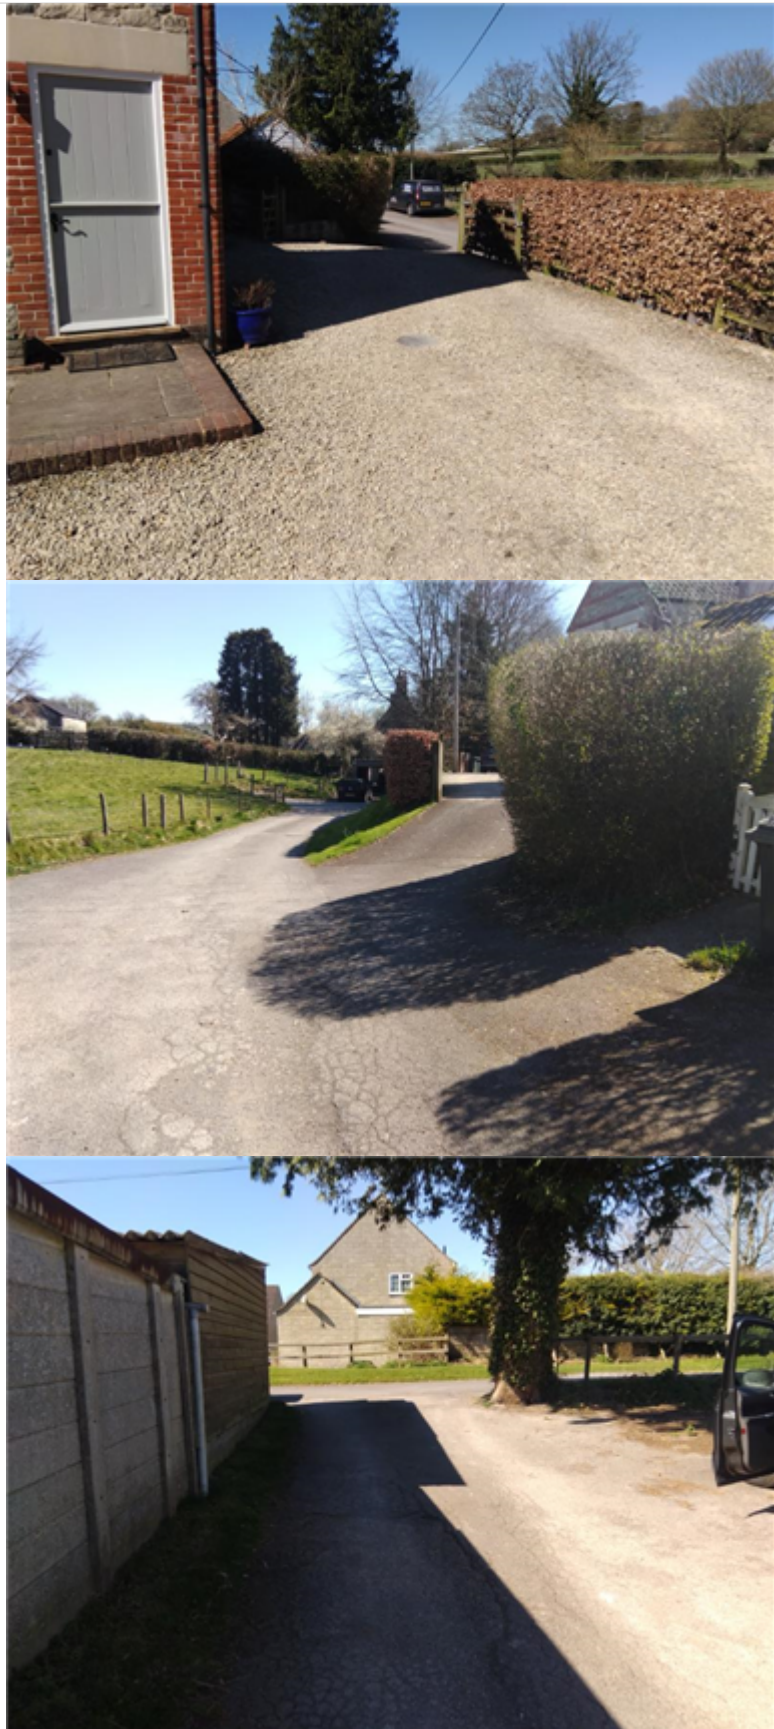
**Additional photographs for the report:**

The foul drainage drainage at the properties appear to have minimal fall and would recommend regular cleaning/maintenance. Foul drainage was backed up on our arrival, this was cleared while onsite.

MH2 - replace frame and cover as gravel is accessing the foul drainage due to poor surround. HPWJ of entire foul system.

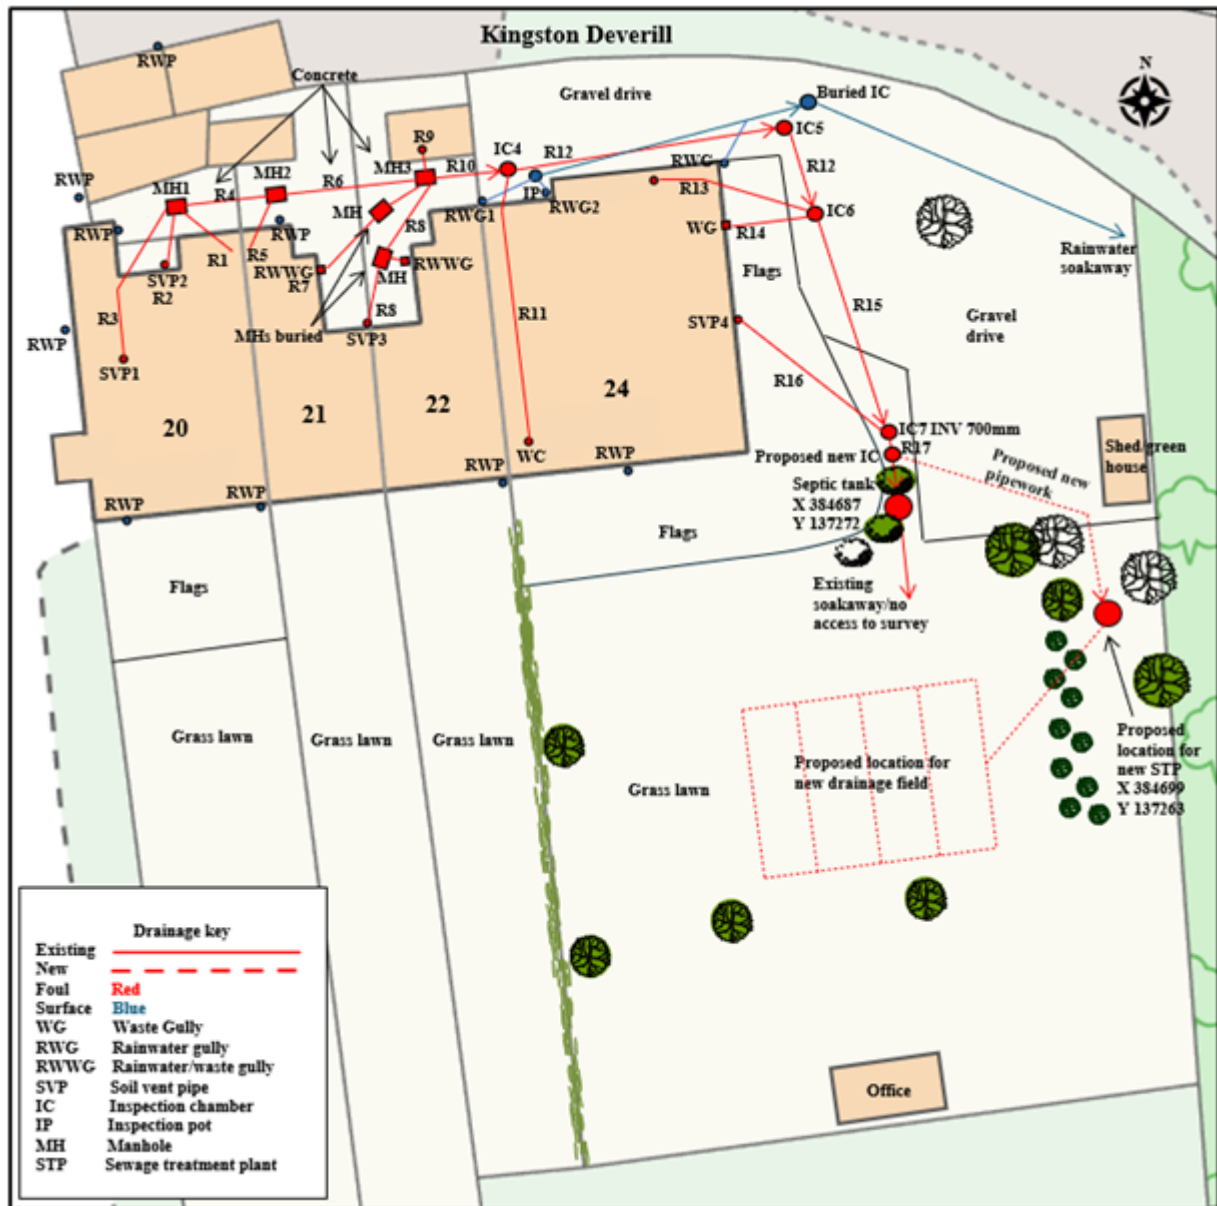
Site Plan:

**Start of the drainage system:** Front of property No.20

**Location of tank:** Left hand side of No.23.
