## Preliminary Ecological Appraisal & Preliminary Roost Assessment

The Kennels, Spye Park, Chippenham, Wiltshire, SN15 2PR SN152PR

The Meadowbrook Trust

This report is prepared to inform a planning application with Wiltshire Council. This proposal can be described as 'The existing kennels building and stables will be sensitively renovated to form two guest houses. The adjacent puppy kennels will be repurposed to accommodate wellness facilities including a steam room, sauna and cold plunge. A landscaped courtyard will be introduced between the three buildings, creating an outdoor space that connects the accommodation and wellness facilities'.

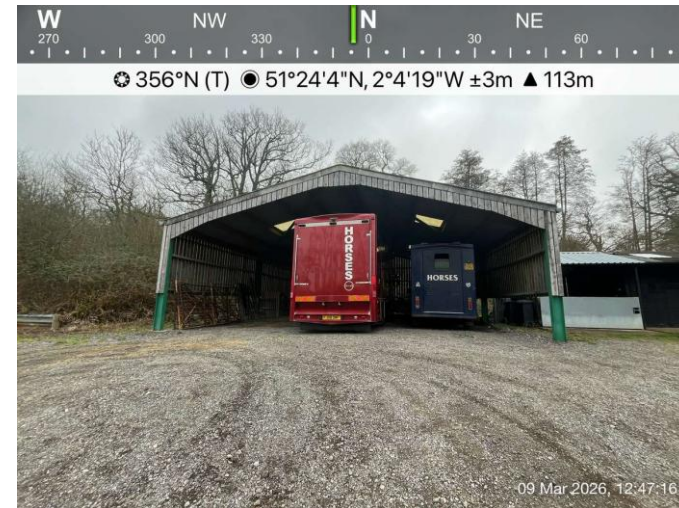
B2 is a detached, single-storey, metal-framed storage barn. The structure features a gabled roof clad in corrugated metal sheeting. No bat evidence was recorded during the survey of this building.

In line with Good Practice Guidelines (Collins, J (Ed) 2023), B2 is assessed to have negligible habitat value for roosting bats due to the lack of traditional features that would typically provide suitable roosting opportunities for bats. Additionally, the building is likely to be subject to temperature fluctuations due to the nature of the construction materials, creating an unstable thermal environment that does not support bat roosting.

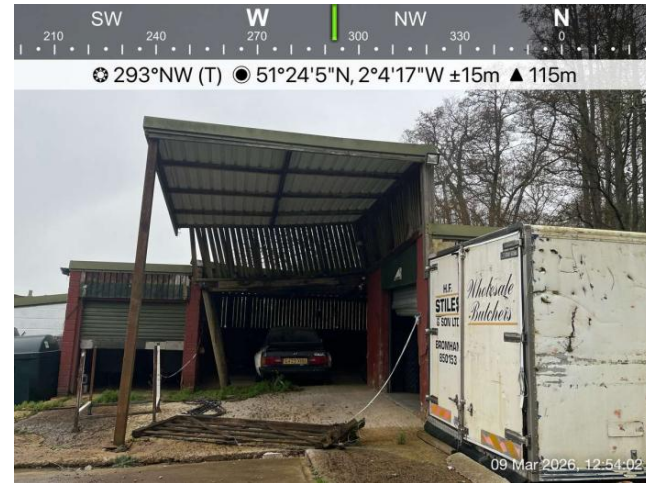
Photo 8: View of offsite building to the north.

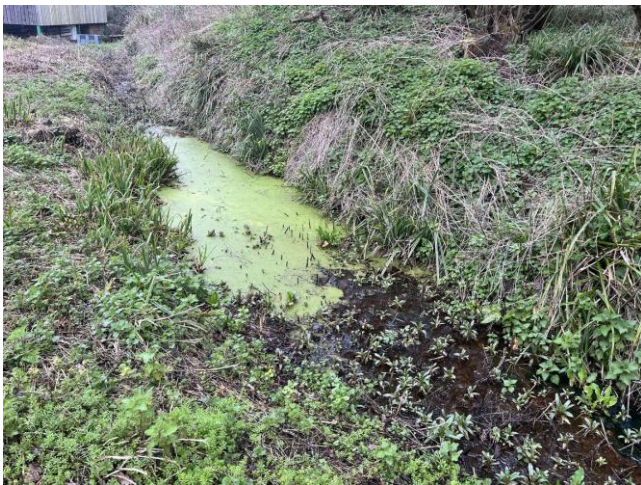
Two ditches are located to the north of the site. The first ditch runs along the edge of the woodland and was observed to contain standing water with submerged, emergent and floating vegetation, which may provide suitable conditions for amphibian breeding. Additionally, a small rubble pile was observed within the ditch, which could support sheltering and hibernation. The second ditch is located behind B3 and did not contain any water at the time of the survey, making it largely unsuitable as breeding habitat.

*Photo 9: View of ditch along the northern boundary.*

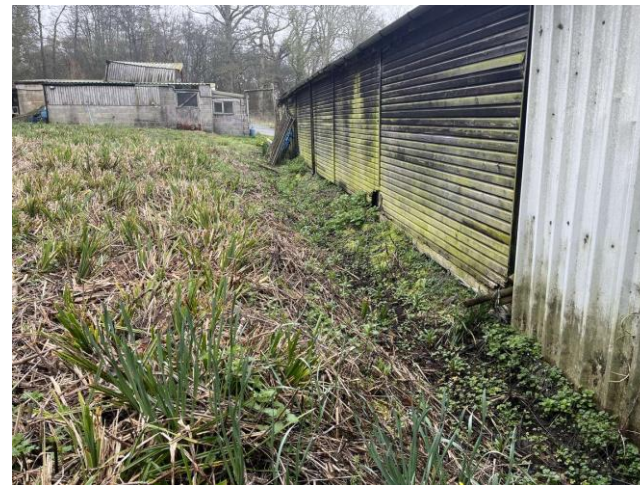
*Photo 10: View of ditch behind B3.*

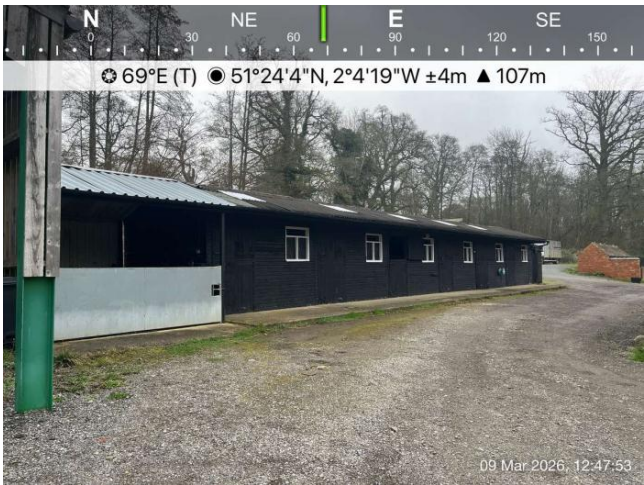
Photo 16: B3

B3 is a single-storey, detached, timber-framed building which has previously been used as horse stables. The main structure has a gabled roof clad in corrugated bitumen felt. To the west elevation of the building, there is a small metal-framed structure with a corrugated metal roof that is utilised for storage. No internal voids were recorded during the survey, and no bat evidence was found within the building. Internally, the building has a timber beam structure.

| Feature | Materials | Condition/Suitability | Photographs |
|---|---|---|---|
| Walls | Timber-framed | The walls of the building exhibit open cracks and voids. Specifically, on the northern elevation, a broken timber panel has created a gap, allowing access to the internal space and providing potential roosting opportunities between the external timber structure and internal timber boards. Additionally, several stable doors on the southern elevation are frequently left open, granting access to the interior space. Internally, the building has timber beams which may provide a suitable surface for | |
