# Technical Note

## Tudor House west cross-frame structural proposals

| PROJECT INFORMATION | | | | |
|---|---|---|---|---|
| Project title | | Church House, Salisbury | | |
| Document ref. | | 14914.4 | | |

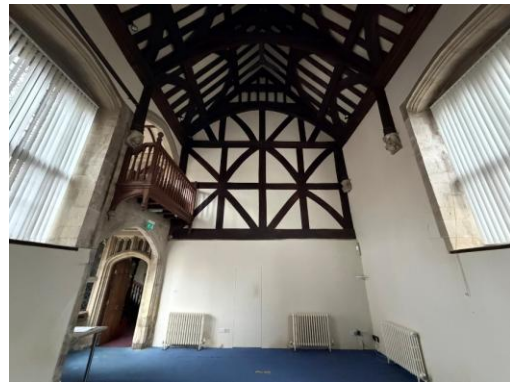
Figure 9 – west cross-frame, E elevation

The beam at the base of the west cross-frame has rotated significantly at its north end, with the surrounding frame showing local displacement as a result. The movement is considered to be predominantly historic, although there is evidence of more recent movement. The rotation is considered to have arisen from the eccentric position of the ground-floor partition supporting the beam, with the effect compounded by eccentric loading from the secondary beams. If the beam continues to rotate, the stability of the cross-frame and the Solar floor are likely to be compromised.

The main beam has rotated significantly at its north end, with the top moving westwards towards the Solar. The remainder of the cross-frame has moved locally with it. A substantial gap is present between the wall-piece corbel and the cross-frame, which illustrates the scale of movement. The movement is considered to be predominantly historic, as indicated by intact finishes, earlier strengthening attempts (including a saddle and bolts), and pieces of timber inserted to fill gaps. It is understood that the building has not been subject to significant maintenance or renovation for several decades. Notwithstanding that most of the movement is likely to be historic, there is evidence of more recent change.

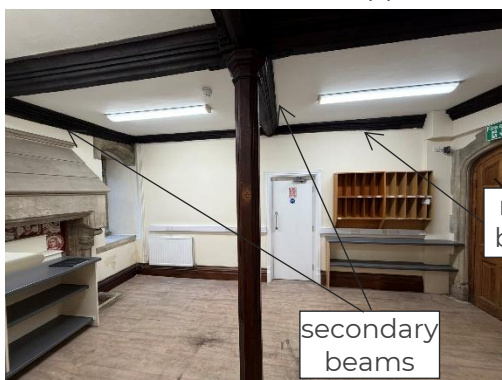
Figure 14 – partition below cross-frame, Solar undercroft elevation

It is considered likely that the cross-frame originally extended down to ground level. This interpretation is based on the presence of mortice holes to the underside of the main beam, which may formerly have received post or jowl tenons. At present, a partition comprising masonry at the north and south ends and studwork centrally, sits beneath the main beam. The partition is tight to the underside of the beam and appears to be load-bearing.

The rotation of the beam is considered to have arisen from the off-centre ground-floor partition supporting the main beam. This rotational tendency is further compounded by eccentric loading from the secondary beams. There is little inherent resistance to this rotation beyond the stiffness of the mortice-and-tenon stud connections and, potentially, some degree of horizontal diaphragm or propping action at the top of the beam at floorboard level.

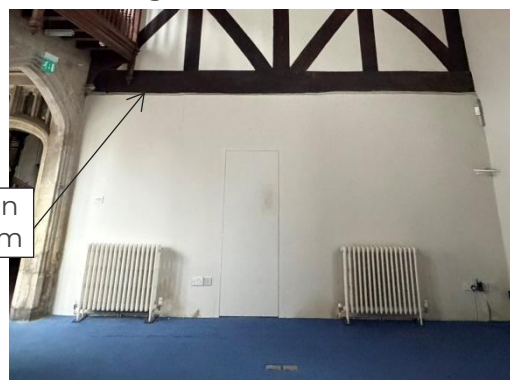
Figure 16 – partition below cross-frame, Hall elevation

The main beam now bears onto the ground-floor brick and stud partition. The beam is heavily moulded on the Solar undercroft (west) side. Presumably to avoid the moulded face, the partition below the main beam is not centred beneath it, but instead is positioned below the flat, unmoulded portion toward the Hall side. In addition to supporting the cross-frame elements, the main beam also supports secondary beams forming part of the Solar floor. These beams are of similar character, with moulded soffits.
