# **Heritage Impact Assessment**

**Unit 5, Wilton Shopping Village,  
Wilton, Wiltshire**

Reference: 261036

**Heritage Impact Assessment**

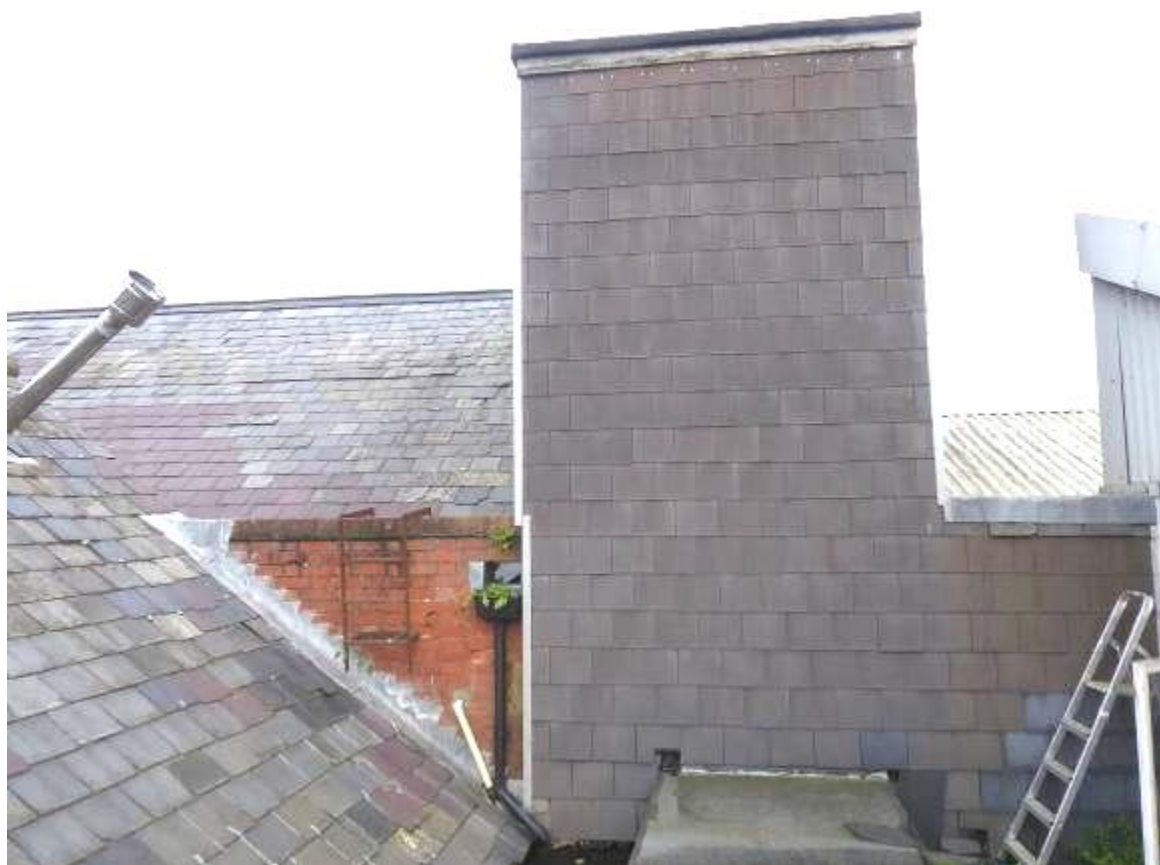
Fig 3.1.12: Lift shaft and south side of area 5 roof

- 3.1.12 The upstanding west side wall to area 1 roof is clad with vertical profile metal sheeting to the side of the north light roof. The windows in this are single glazed standard joinery storm proof units. The south side wall to the east end of area 5 and a section of that to area 1 is a mixture of construction. Part of this is double storey structure over the top of a lift shaft where the sides are clad with artificial slates, in a fair condition. The section of the wall to area 5 is in brickwork with the top capped with brick on edge to the valley gutter behind with lead flashings to the abutting roof over area 3.

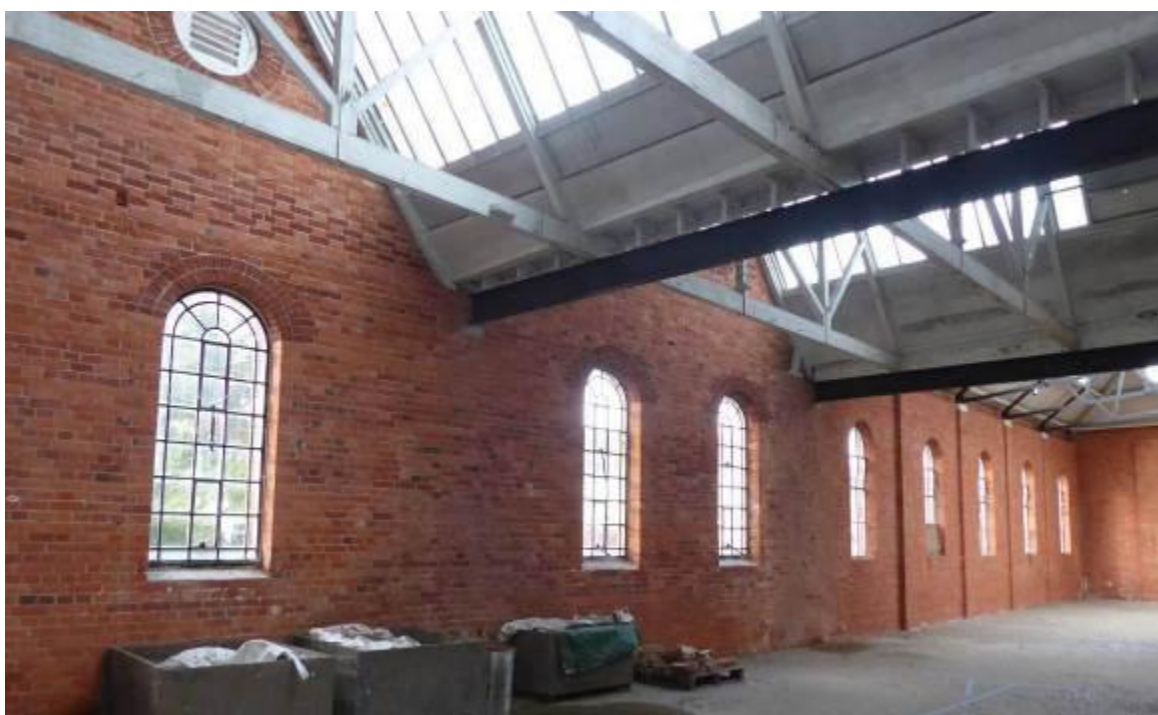
Fig 3.3: Area 3, looking in to area 4

#### 3.3.1 The ground floor is of solid construction.

- 3.3.2 Walls are all in brickwork, where the window openings on the south side are similar to those noted within the rear of area 2, but here the panes are larger and the frames are of a slightly different configuration.

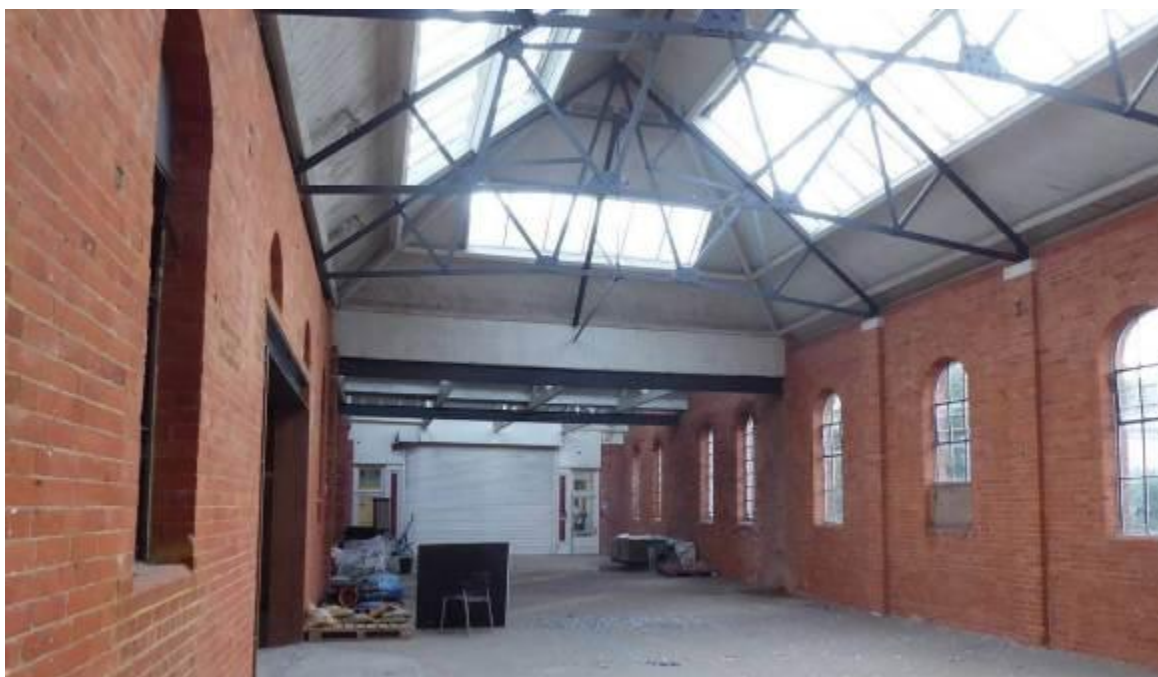
Fig 3.4: Area 4 looking in to area 3

- 3.4.3 The north is much the same as on the south with a construction joint at the junction to area 3. Some window openings have been blocked-up and adjusted, as well as where a large door opening has been cut through. Along the head of this wall, the space between the truss feet has been infilled with calcium silicate bricks, which are totally different to those seen elsewhere. This is possibly where timber ventilators were originally installed and have subsequently been closed-up.

- 3.4.4 The roof is supported on a series of steel flat and angle iron trusses with bolted gusset plates on the connections. This is a hip ended structure with timber purlins and hip rafters exposed and overlaid with diagonally set sarking boarding and with large areas of translucent glazing to all slopes.

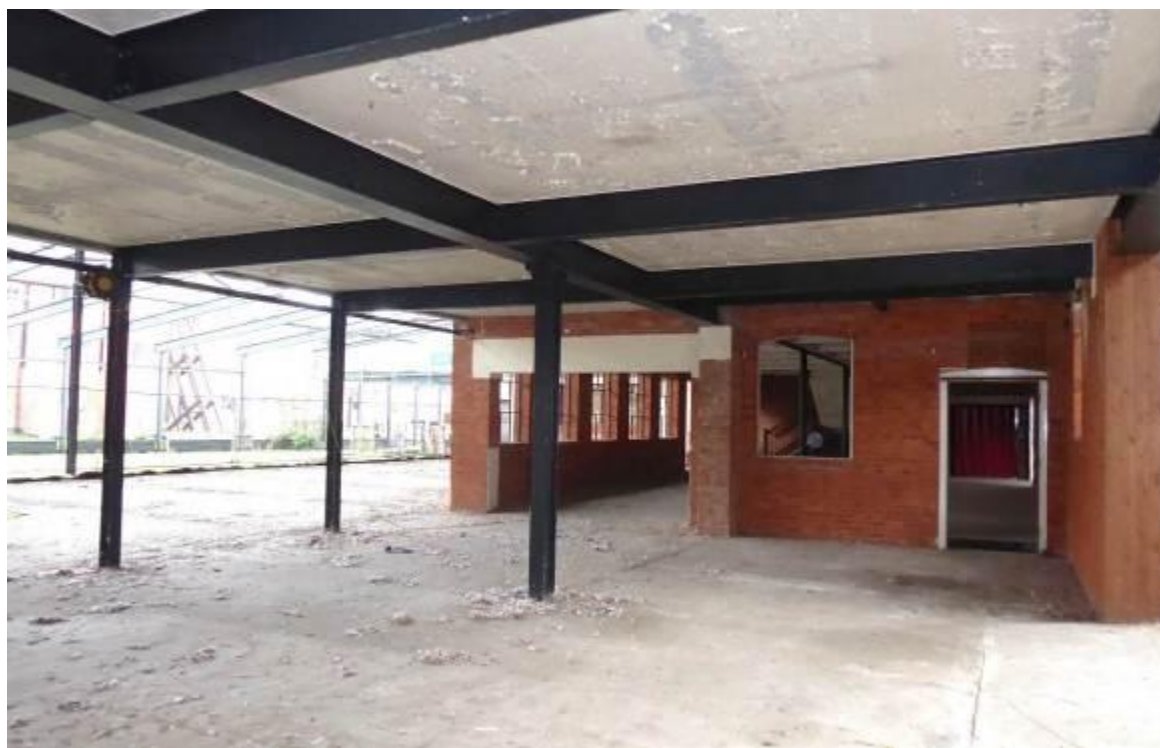
Fig 3.6: Area 6 ground floor

- 3.6.4 The south wall to area 4 shows where this has been raised and the original windows on that side blocked up, much as that described previously. No signs of structural movement in this or adjacent to the structure.

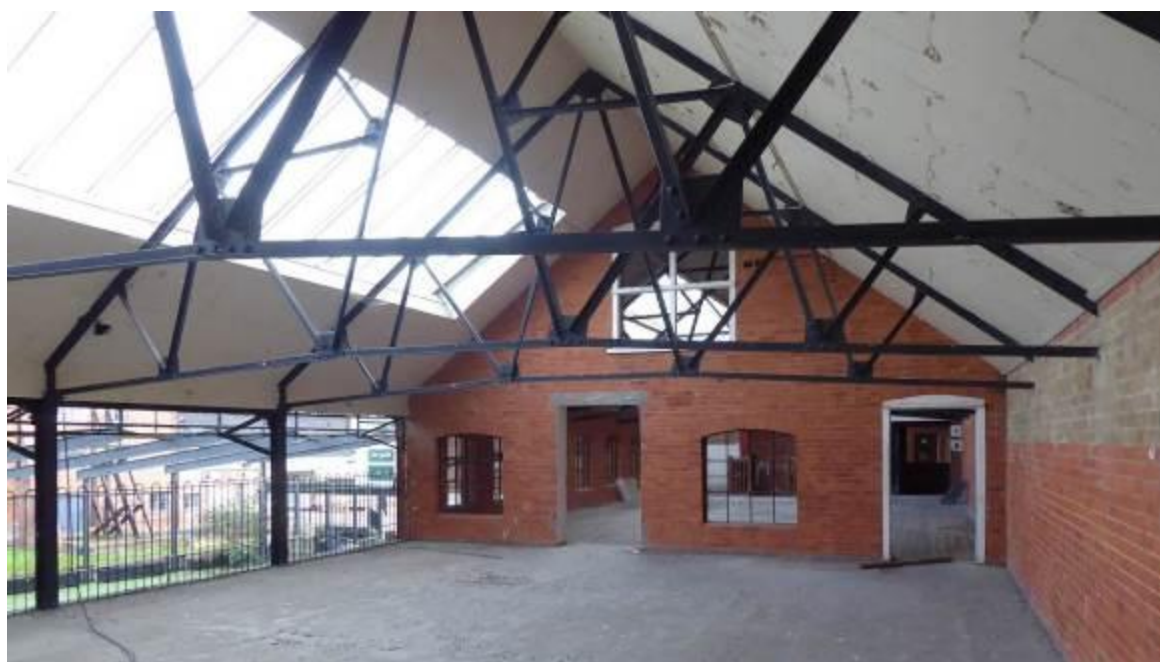
Fig 3.6.2: Area 6 first floor

- 3.6.3 The ceiling to the underside of the roof slope on the north side has a large glazed section within it and on the south side this is finished with some form of boarding.
