1 Shaftesbury Drove, Salisbury  
– Aerial tree inspection findings (23.06.26).

T1

T2

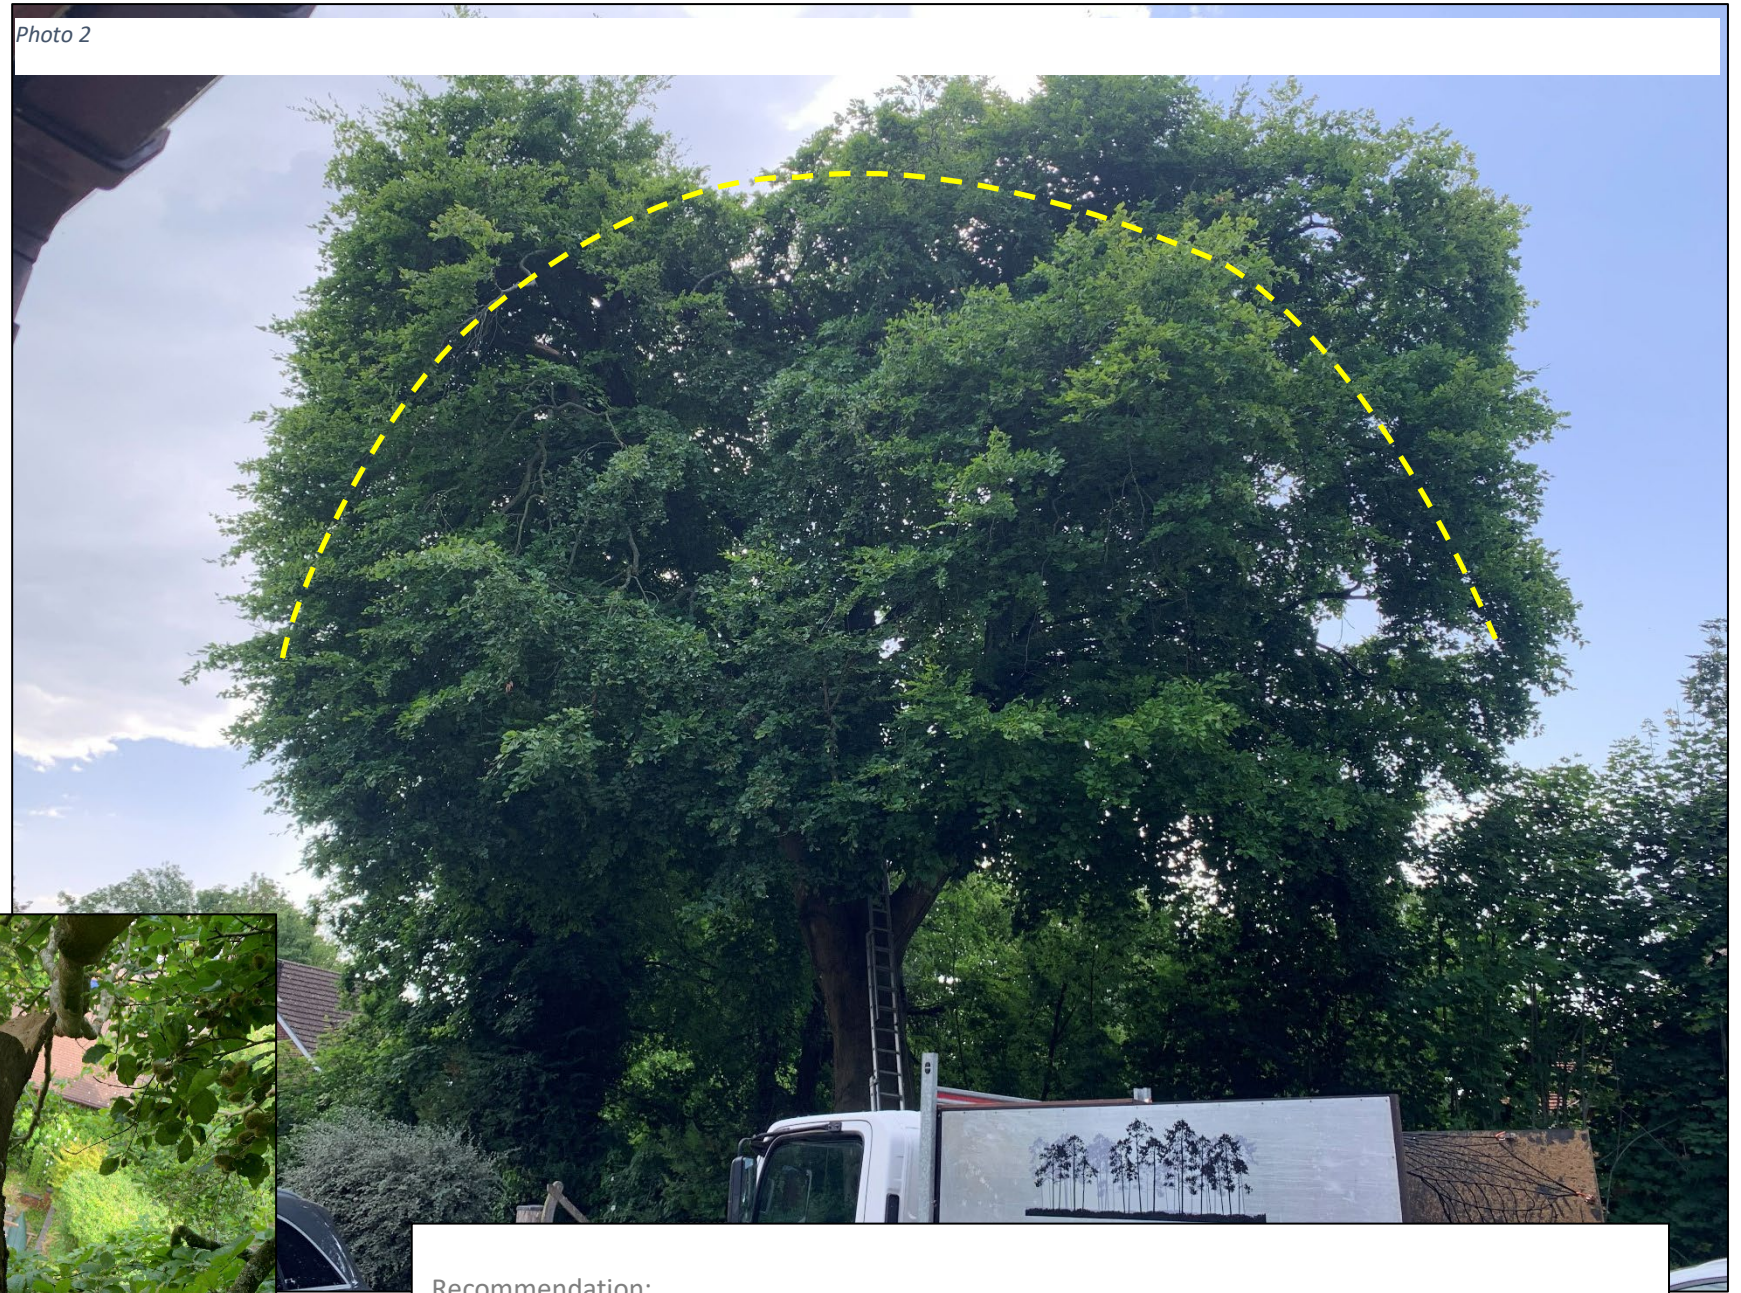
Photo 1

This tree has a history of branch failures. Historically, a large stem failed into the nearby footpath (see photo 10) and in recent years smaller branches have failed onto the driveway below. The reason for the recent failures is squirrel damage as seen in Photo 3. After conducting a climbing inspection, many more squirrel damaged branches have been found (Photos 4-9 on next page all show squirrel damage). Reducing the upper portion of the tree (where the damaged branches are) will significantly reduce the likelihood of future branch failure. The tree shows good vigour, and it is expected to tolerate the pruning.

Crown reduction to reduce sail area of upper canopy by 2-4m, tapering into the lower branches (lower branches can be retained with little pruning). An approximate pruning line is outlined in yellow on the above photo.
