MELKSHAM HOUSE, MELKSHAM,  
WILTSHIRE

Heritage Appraisal 2019 (with addendum for  
minor changes)

A statement to inform potential changes to the  
Grade II listed Melksham House, Melksham,  
Wiltshire

FEBRUARY 2025

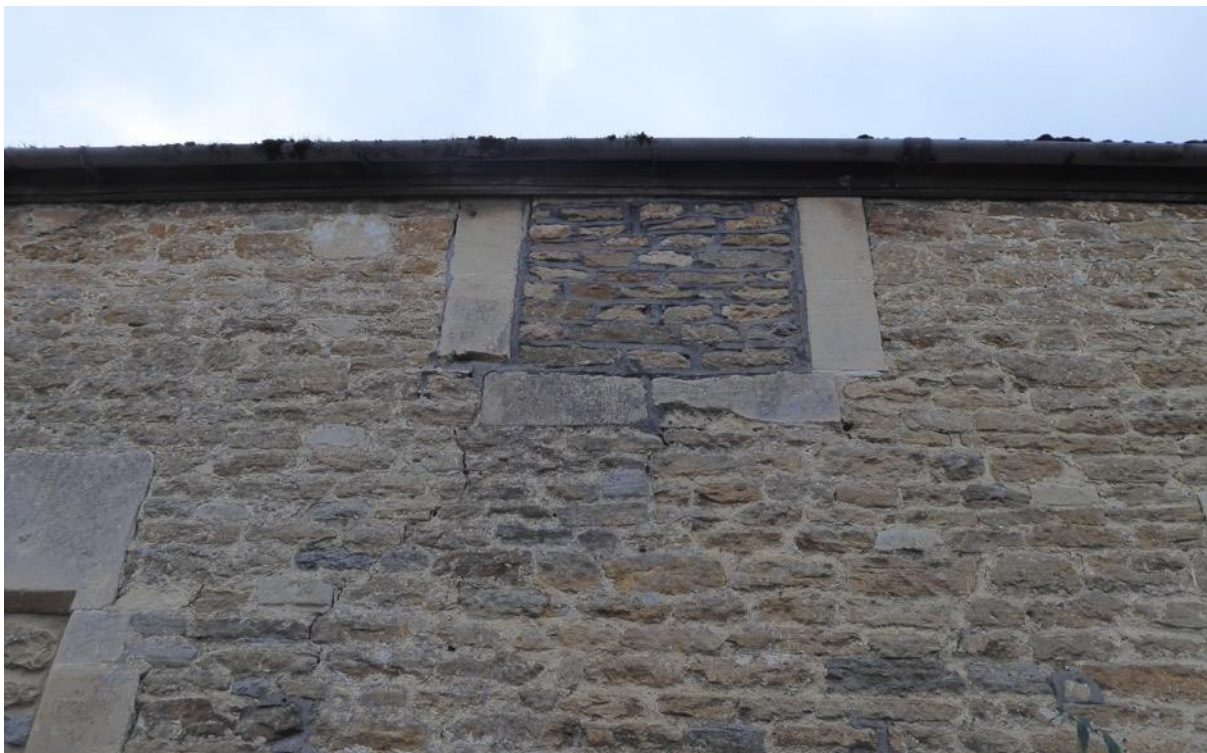
of blocked openings in brick. There was formerly a lean-to to this side (see Figures C6 and C7 **Appendix C**) which has been lost. There is a clearly defined straight joint with ashlar quoins denoting the former end of the building to the west. The later extension to the west is further terminated at the corner with stone ashlar quoins. The north elevation has a number of doors and blocked openings including what appear to be a former large carriage opening (defined by stone quoins) to its western end (**Figure 31 Appendix E**). This has a modern door opening inserted into the stone work. There is a re-used, possibly late 17<sup>th</sup> century, chamfered stone door surround (now blocked) (**Figure 32 Appendix E**) and a re-used, possibly late 17<sup>th</sup> century, stone mullion windows (now blocked) to ground floor (**Figure 33 Appendix E**). There is a further stone surround to a first floor window (of unknown date) also now blocked (**Figure 34 Appendix E**).

**Figure 34:** Blocked stone opening

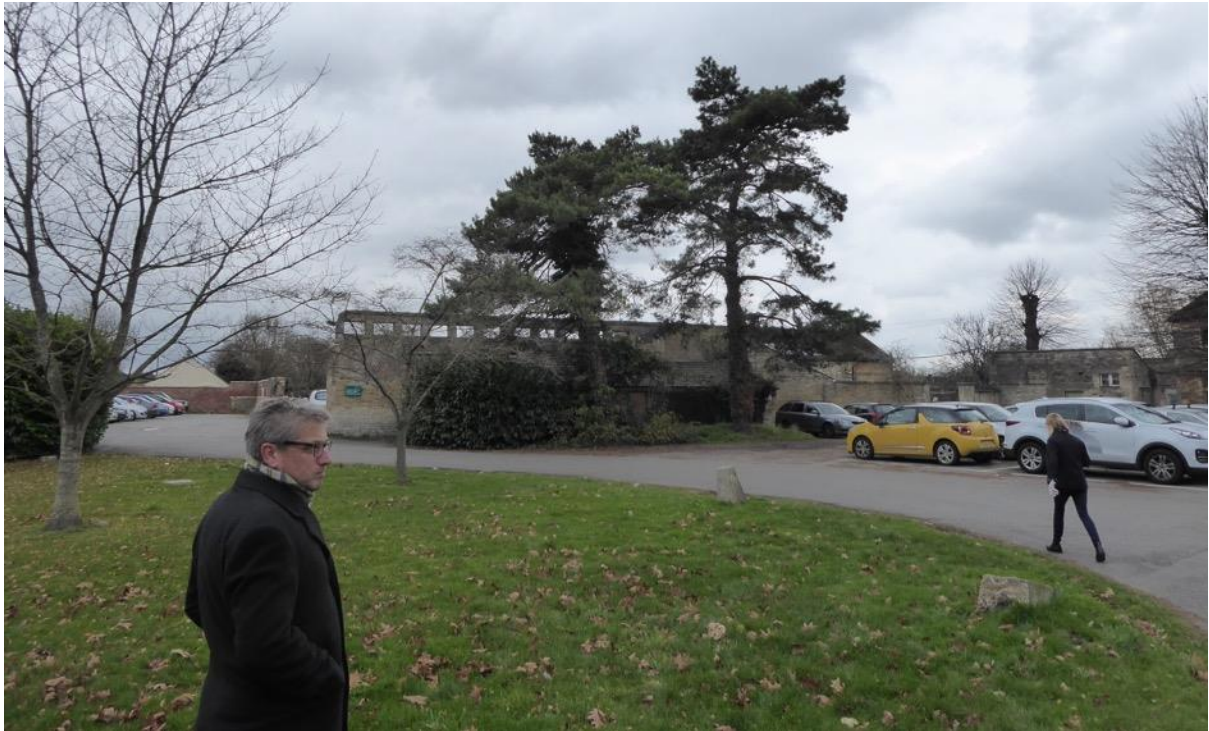
- 6.3 The survival of the former kitchen garden (**Figure 40 Appendix E**) and remnants of its associated outbuildings (**Figure 37 to 39 Appendix E**) are of evidential and historic value. These surviving structures are important in terms of providing a sense of the former grand scale and high status of the former private house. They are part of an important phase of building construction and remodelling and for this reason are considered to be of high significance in terms of the overall significance of the site.

**Figure 37:** Former garden buildings and spaces to south-east of house

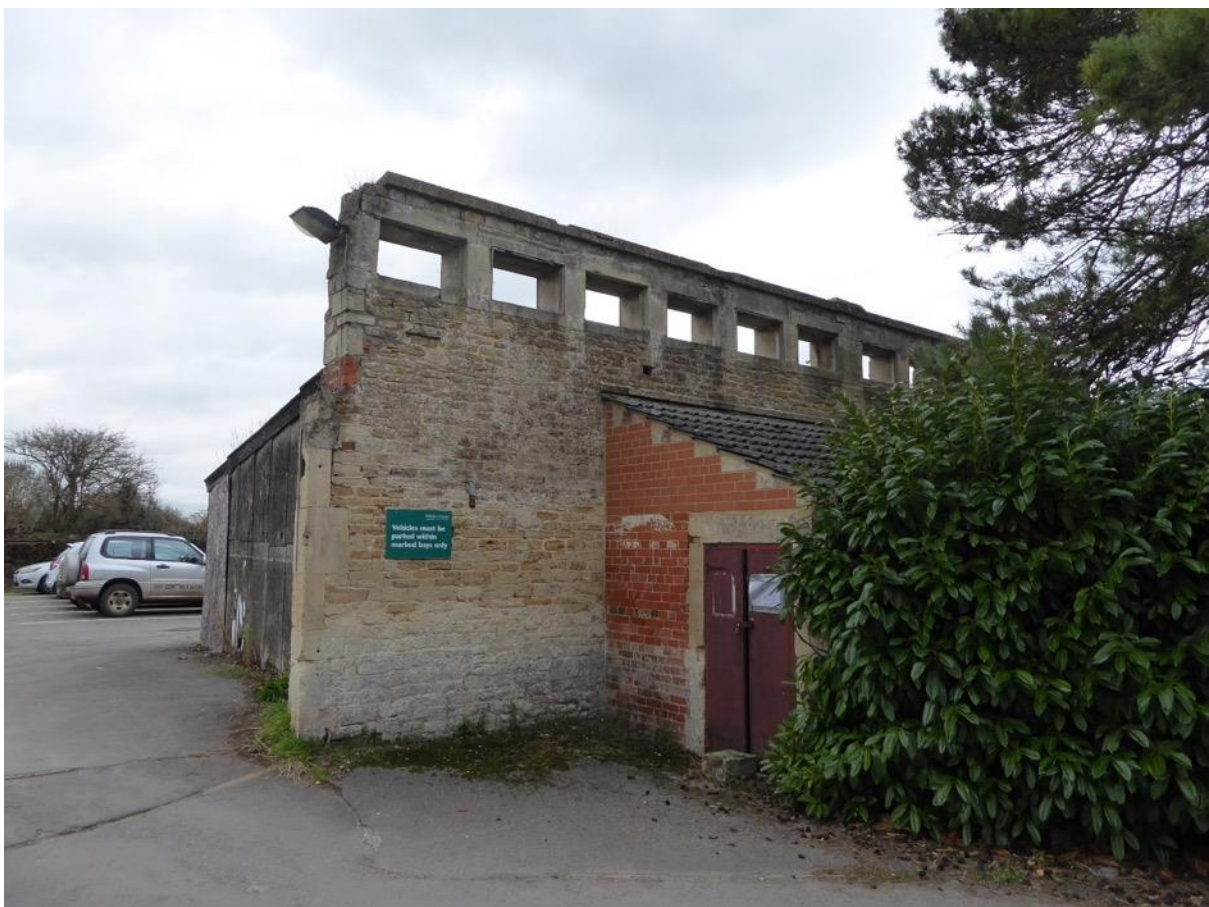
**Figure 38:** Possible former heated wall to former peach house to south-east of house

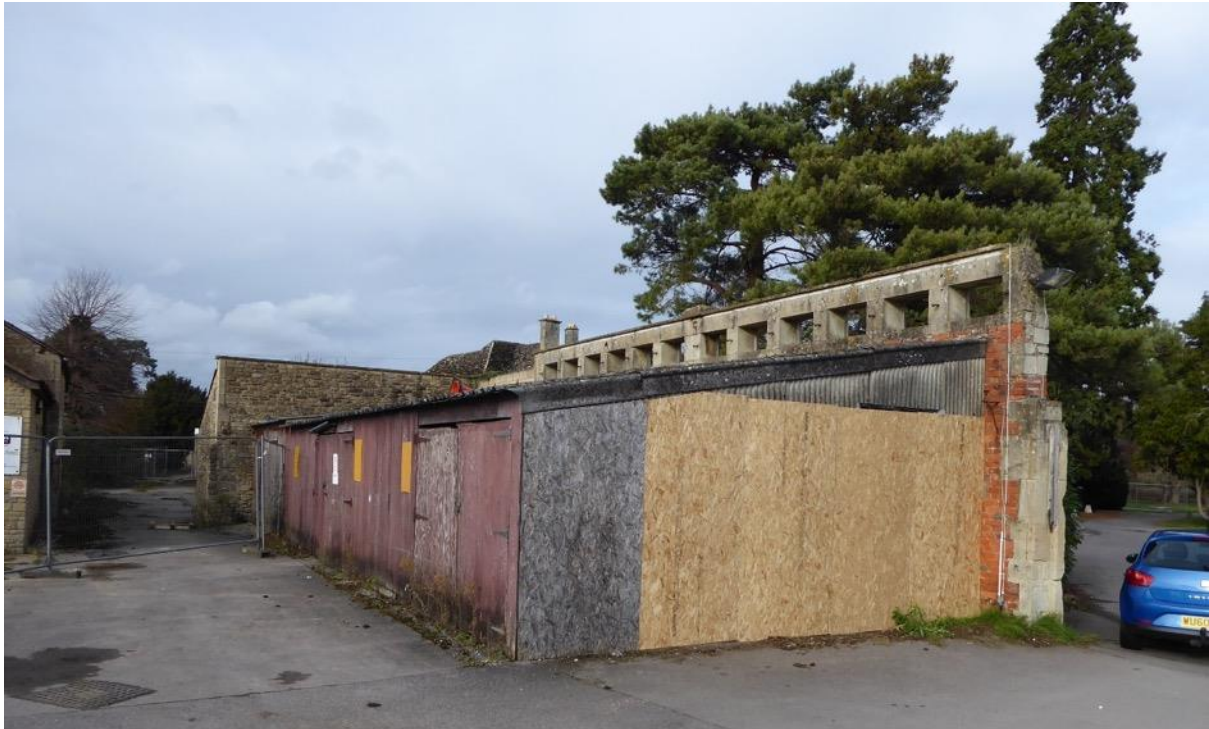
**Figure 39:** Possible former heated wall to former Peach House, now modern garages

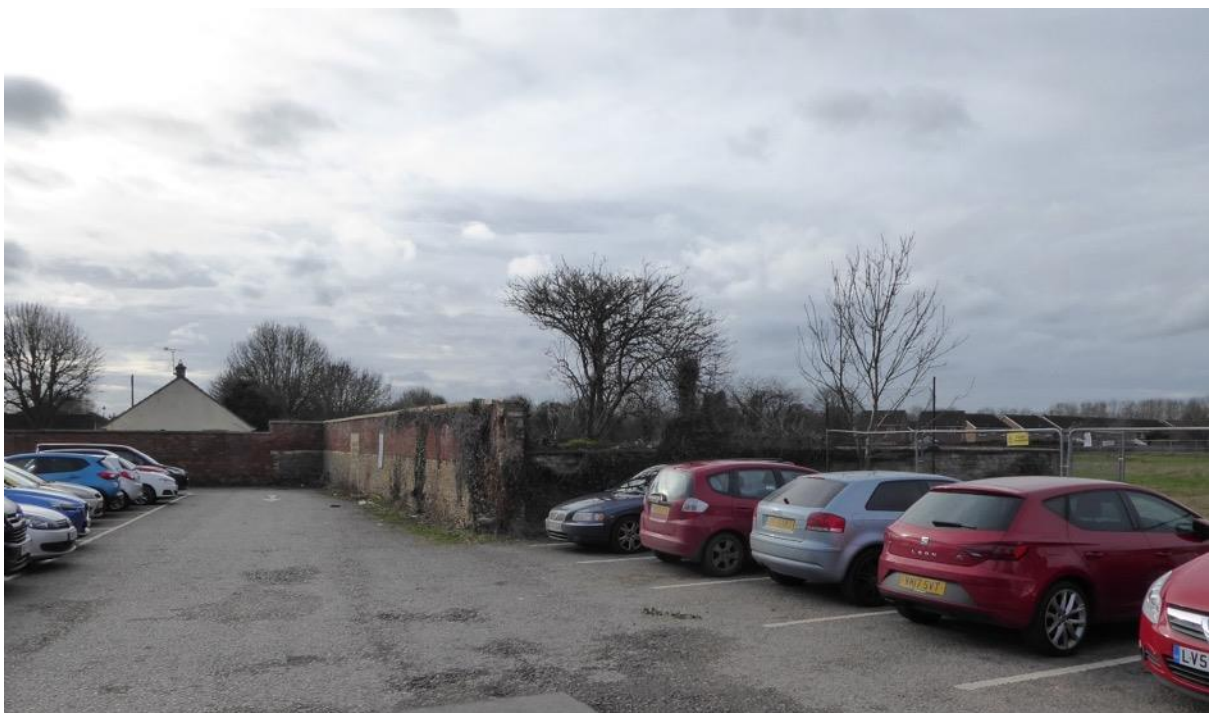
- 4.19 There are a series of former walls partially enclosing service yard spaces, parts of garden buildings and sections of the former kitchen garden wall itself (see **Figure 40 Appendix E**). These are generally stone rubble walls with stone copings, some of which have been built up in brick. The exception to this is the section of wall to the immediate north of the former stable and east of the house. This is stone rubble to the north side but brick to its southern elevation (**Figures 37 to 39 Appendix E**). The top of the wall is stone capped with the capping pierced with a series of rectangular stone openings (12 in total). To the centre of the openings there is a capping upon which there was a chimney (as evidenced in the c1933-5 aerial views – see **Figures C6 and C7 Appendix C**). This is probably the heated wall upon which the Peach House was set against (see **Appendix B** for historic maps and **Figures C6 and C7 Appendix C** for historic aerial views). There are likely to be a series of flues running through the wall. There is modern garaging set against the south side of the wall but the interior spaces were not inspected.

**Figure 40:** Remnant section of former kitchen garden walls (now enclosing car park)

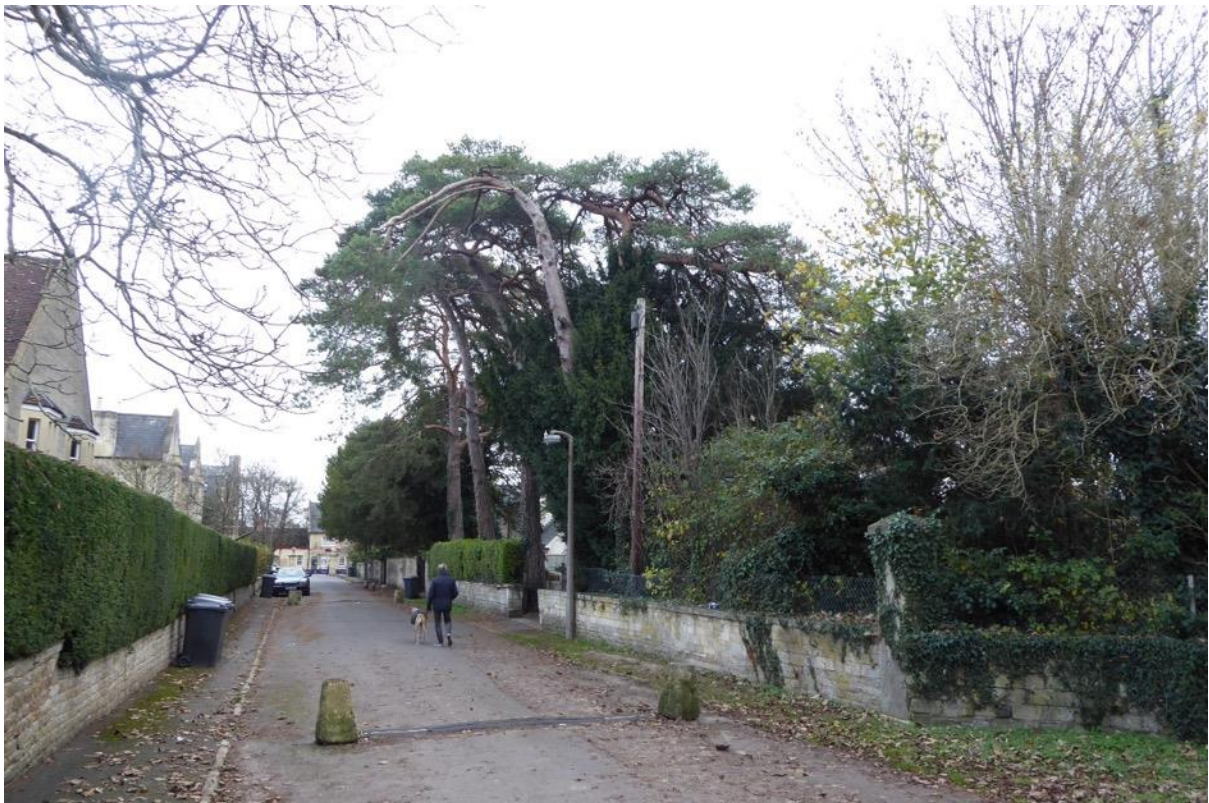
**Figure 44:** Attached walls to gate piers to east of gate piers (now separate gardens)

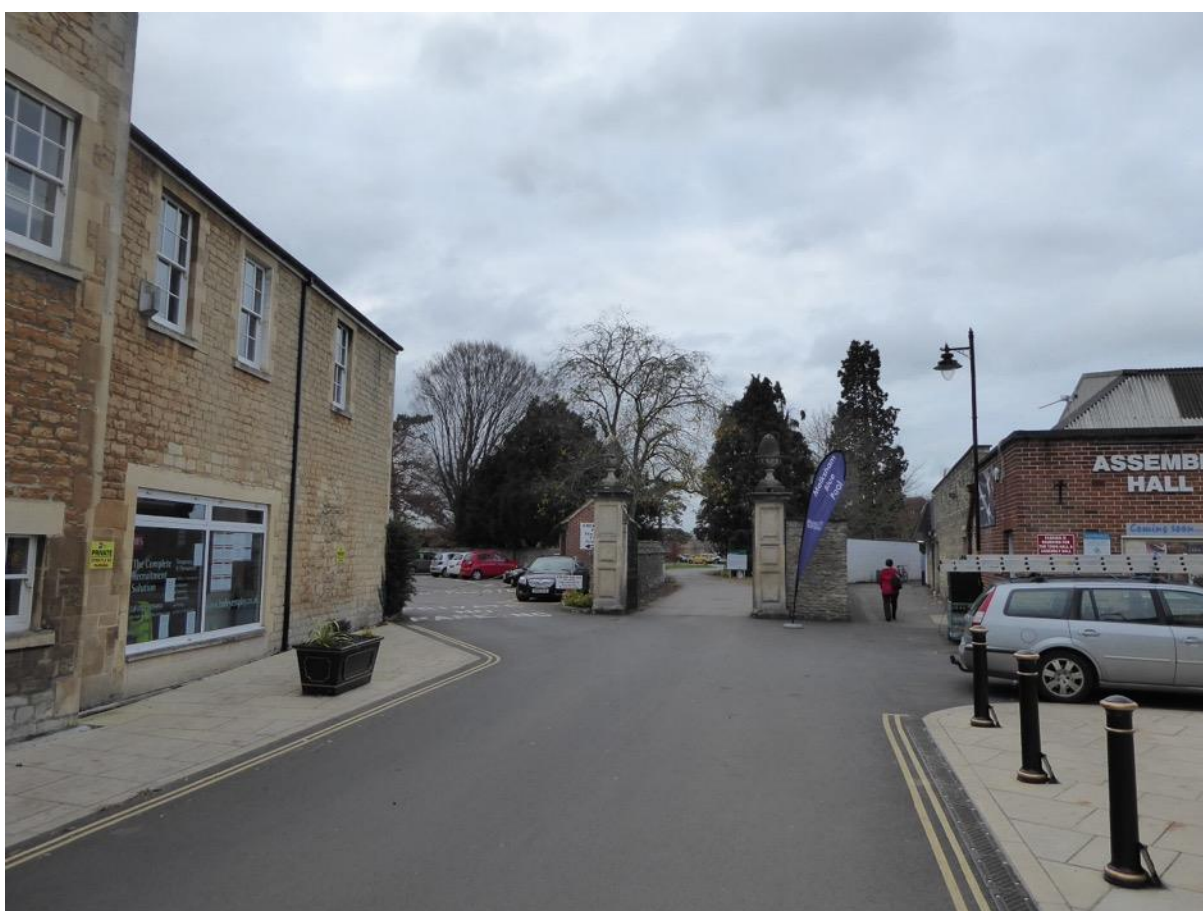
wall extending along the boundary with the swimming pool. The northern entrance has attached low rubble stone walls with stone coping. That to the west extends to the churchyard wall of the church of St Michael (**Figure 45 Appendix E**). That to the east extends to form the garden boundaries of the houses now fronting Place Road (**Figure 46 Appendix E**).

**Figure 46:** East entrance (from Market Place)
