### Project

**Project Name:** 5795C1 Scotland Road  
**Project Number:** 5795/C1  
**Project Date:** 11/05/2026  
**Inspection Standard:** MSCC5 Sewers & Drainage GB (SRM5 Scoring)

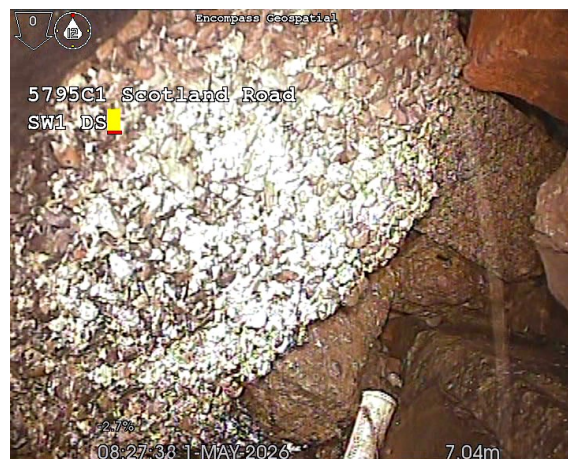
SW1X\_f00f008b-dcd5-4007-8d60-72967a9f89eb\_20260511\_100113\_230.jpg, 00:00:48, 7.04 m  
Finish node, manhole, reference: SW2

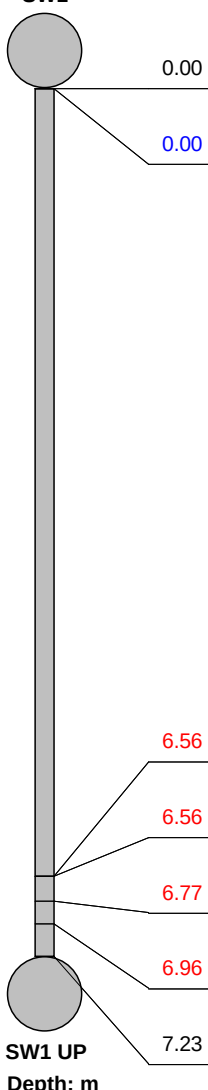
| Scale: | 1:63 | Position [m] | Code | Observation | MPEG | Photo | Grade |
|---|---|---|---|---|---|---|---|
| | | 6.56 | FCJ | Fracture, circumferential at joint from 5 o'clock to 8 o'clock | 00:00:40 | SW1<br>UPX_6abb<br>af7d-ad44- | 3 / 2 |
| | | 6.56 | CL | Crack, longitudinal at 12 o'clock | 00:00:40 | SW1<br>UPX_c683<br>9105-8111 | 2 / 2 |
| | | 6.77 | FC | Fracture, circumferential from 1 o'clock to 5 o'clock | 00:00:42 | SW1<br>UPX_51cc<br>50fa-c620- | 3 / 2 |
| | | 6.96 | FC | Fracture, circumferential from 7 o'clock to 5 o'clock | 00:00:43 | SW1<br>UPX_of25<br>320d-2a6a | 3 / 2 |
| | | 7.23 | OCF | Finish node, other special chamber, reference: SW1 UP:<br>FINISHES AT A LARGER BRICK PIPE | 00:00:45 | SW1<br>UPX_2323<br>81a4-88a6 | |

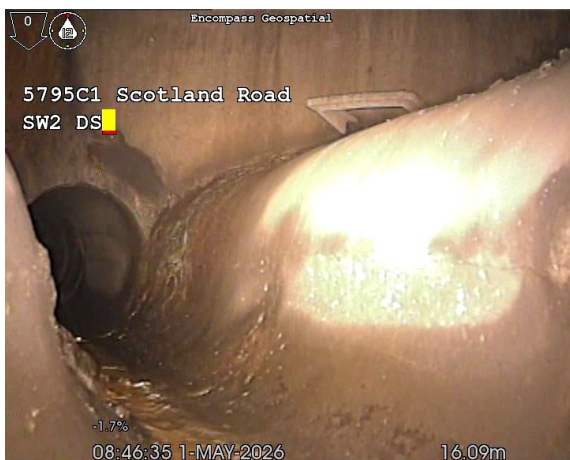
SW2X\_624844ef-bf42-4b27-ac53-343ca86acbf3\_20260511\_10  
 1118\_297.jpg, 00:01:18, 16.09 m  
 Finish node, manhole, reference: SW3

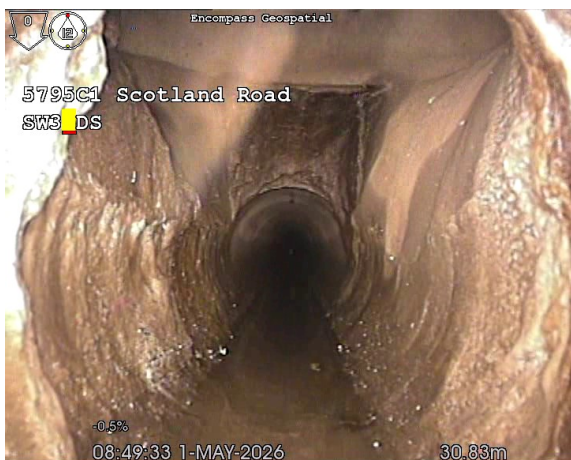
SW3X\_456b5955-6958-4710-b3a5-0fbdb89ace90\_20260511\_1  
 01526\_055.jpg, 00:02:33, 30.83 m  
 Finish node, manhole, reference: SW4

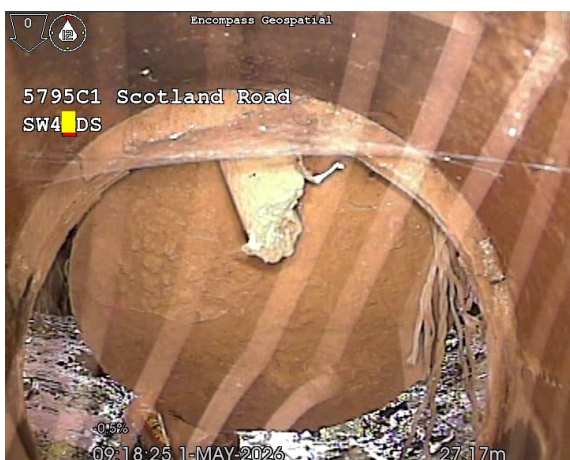
SW4X\_1f5fcba1-329f-41bb-9b90-7ef893cd1359\_20260511\_101  
 745\_238.jpg, 00:01:59, 27.17 m  
 Finish node, outfall, reference: SW4 DS

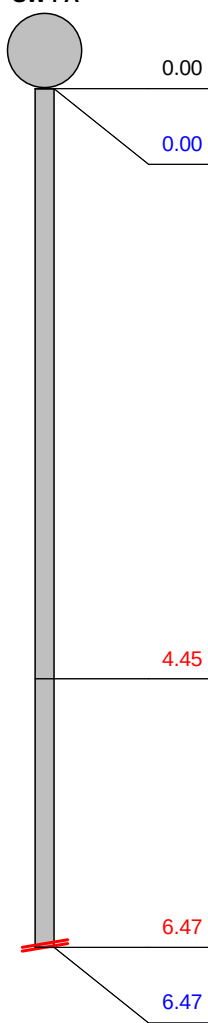
| Scale: | 1:57 | Position [m] | Code | Observation | MPEG | Photo | Grade |
|---|---|---|---|---|---|---|---|
| | | 0.00 | MH | Start node, manhole, reference: SW4 A | 00:00:00 | | |
| | | 0.00 | WL | Water level, 5% of the vertical dimension | 00:00:00 | | |

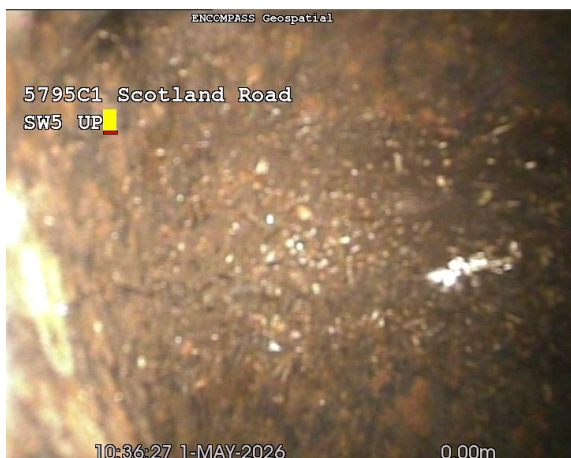
SW6X\_fb6ac484-cd73-496c-ac8e-7f61dc713fcd\_20260511\_09  
0428.jpg, 0.00 m  
Start node, manhole, reference: SW5

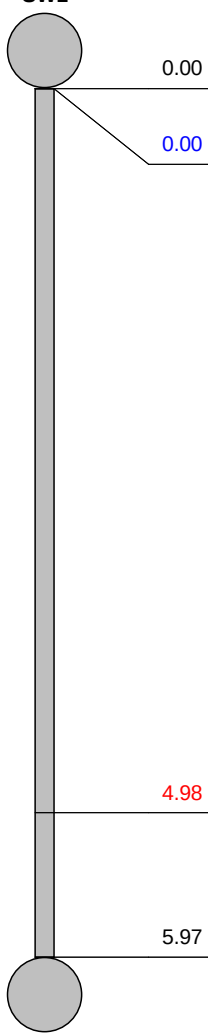
| Scale: | 1:52 | Position [m] | Code | Observation | MPEG | Photo | Grade |
|---|---|---|---|---|---|---|---|
| | 0.00 | MH | | Start node, manhole, reference: SW1 | 00:00:00 | | |
| | 0.00 | WL | | Water level, 0% of the vertical dimension | 00:00:00 | | |

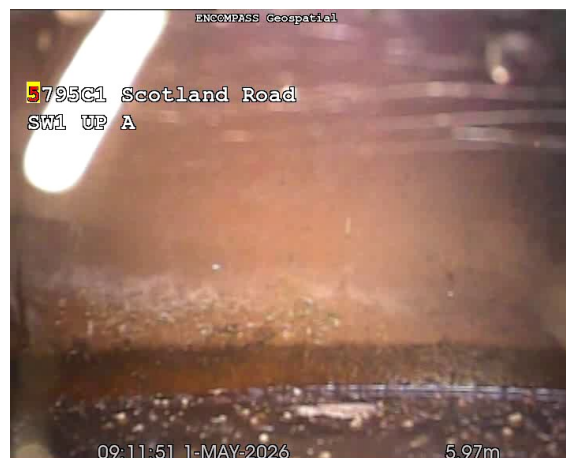
SW1 UP  
AX\_45194fd8-d74b-4e0c-92ef-a9e5812af181\_20260511\_10044  
4\_741.jpg, 00:00:45, 5.97 m  
Finish node, gully, reference: GY1

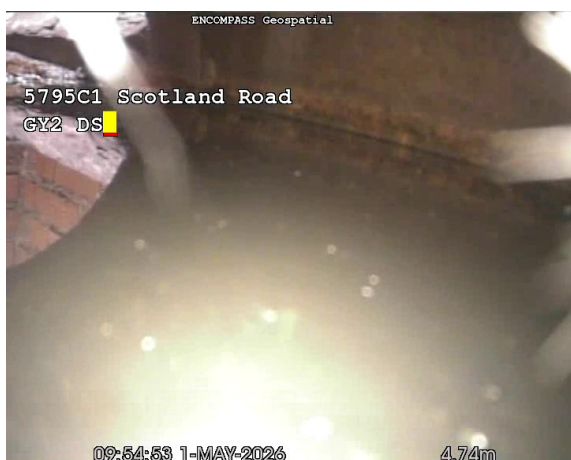
GY2X\_639b9972-dc19-44e8-9b3f-568854c69a04\_20260511\_1  
02137\_618.jpg, 00:00:26, 4.74 m  
Finish node, major connection without manhole, reference: GY2  
DS

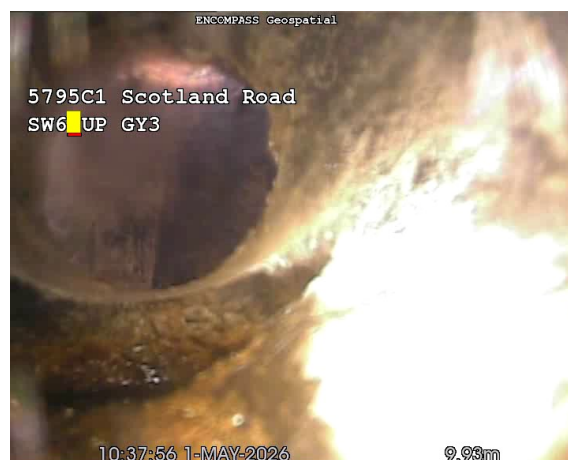
GY3X\_8cf6828c-6ae6-4e69-a66e-f067a6a7068c\_20260511\_10  
2324\_569.jpg, 00:00:37, 9.93 m  
Finish node, gully, reference: GY3
