TREE SURVEYING

The Old Smithy  
Holloway  
Malmesbury  
SN16 9HX

Findings of BS5837 Tree Quality Survey

Arboricultural Method Statement

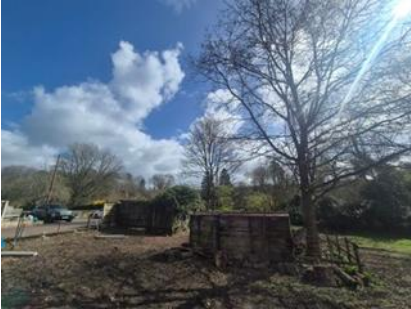
| Ref. | Species | Measurements | Survey Notes | Retention Category | RPA | Recommendations | Photo |
|---|---|---|---|---|---|---|---|
| T001 | Pedunculate oak<br>( <i>Quercus robur</i> ) | Height (m): 12<br>Stem Diam(mm): 350<br>Spread (m): 5N, 6E, 5S, 6W<br>Crown Clearance (m): 4<br>Lowest Branch (m): 2.5(S)<br>Life Stage: Semi Mature<br>Rem. Contrib.: 50+ Years | Physiological Cond: Good<br>Structural Cond: Good | B2 | Radius: 4.2m.<br>Area: 55 sq m. | No tree pruning works required.<br>Pre Construction fencing to protect RPA. | |
