# Technical Note

| <b>Project:</b> | Land at Blackmore Farm, Melksham |
| <b>Title:</b> | Update Bat Roost Survey |
| <b>Reference:</b> | 260110_P1476_Bat TN_Final |

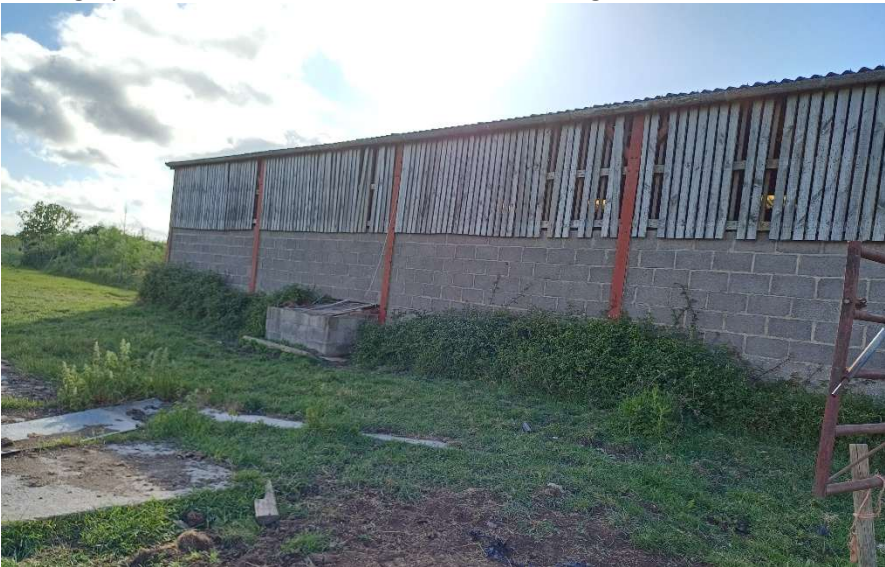
| Building reference | Building description | Roost suitability |
|---|---|---|
| | <p data-bbox="352 981 986 1010">Photograph 10: Southeastern elevation of Building 9.</p> | |
