## Off Mains Drainage Survey Report Prepared For:

The School House, 30 Kingston Deverill  
Warminster  
BA12 7HE

**Date of Survey:** 30/10/2024

## Drainage Survey

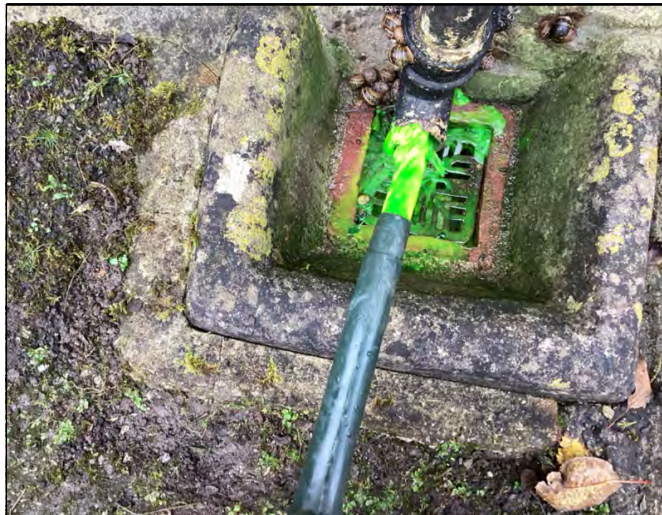
**Photograph of dye test undertaken**

**Were there any cross connections found between the rainwater system and the foul system?**

No

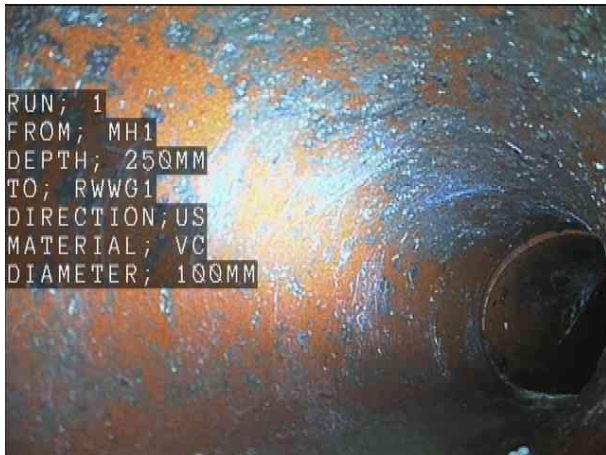
RWWG1X\_49ad36ae-da7d-49ee-94b4-dde70e189bdf\_20241106\_121936\_081.jpg, 00:00:00, 0.00 m  
Start node, manhole, reference: MH1

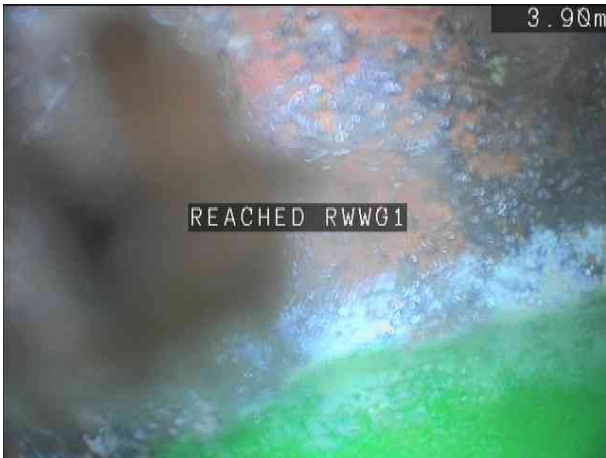
RWWG1X\_4384b2d3-2055-4029-b383-258737eb219b\_20241106\_122159\_184.jpg, 00:01:19, 3.90 m  
Finish node, manhole, reference: RWWG1

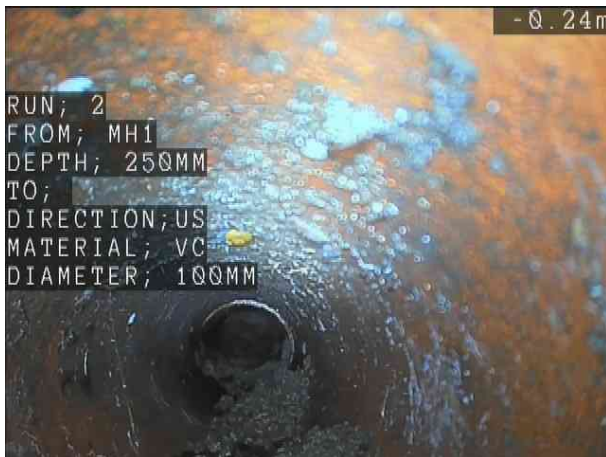
UnknownX\_279483a8-278f-4339-bbc0-710ba6033481\_20241106\_122259\_767.jpg, 00:00:00, 0.00 m  
Start node, manhole, reference: MH1

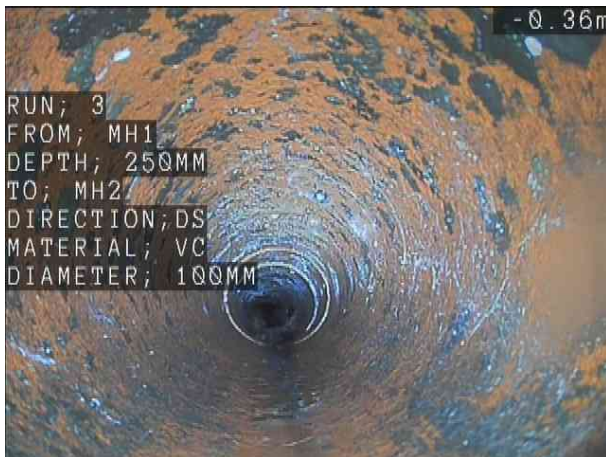
MH1X\_86c46113-21a2-4684-b4e9-b0185ecbb131\_20241106\_122638\_196.jpg, 00:00:00, 0.00 m  
Start node, manhole, reference: MH1

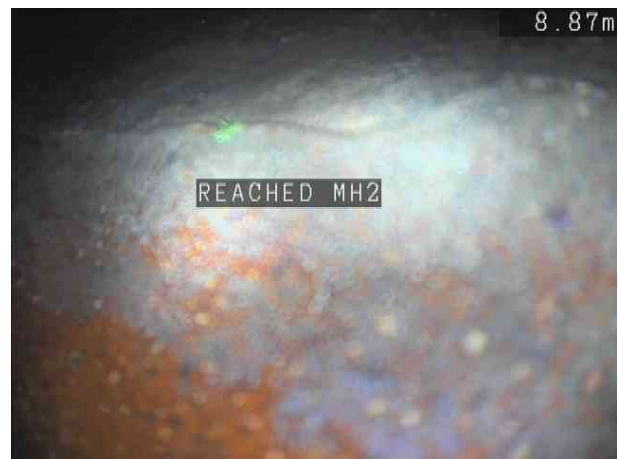
MH1X\_769edb1c-839f-4c4d-9e71-f085b70d640a\_20241106\_123002\_979.jpg, 00:02:43, 8.87 m  
Finish node, manhole, reference: MH2

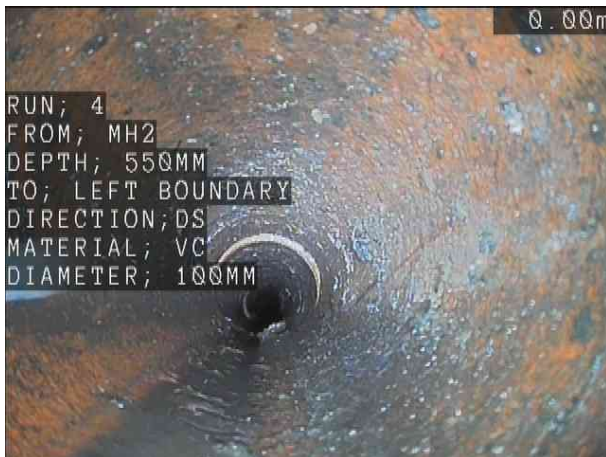
MH2X\_e7169c84-3170-4491-9726-611e78b67932\_20241106\_123105\_207.jpg, 00:00:00, 0.00 m  
Start node, manhole, reference: MH2
