**PHOTOGRAPHIC SCHEDULE OF WORKS  
FOR  
137 High Street Marlborough, Wiltshire, SN8 1HN**

**Tenant:** *Nova Fine Art*

**Date of inspection:** Thursday 26<sup>th</sup> September 2024

**For the attention of:** James Hay Pension Trustees Ltd

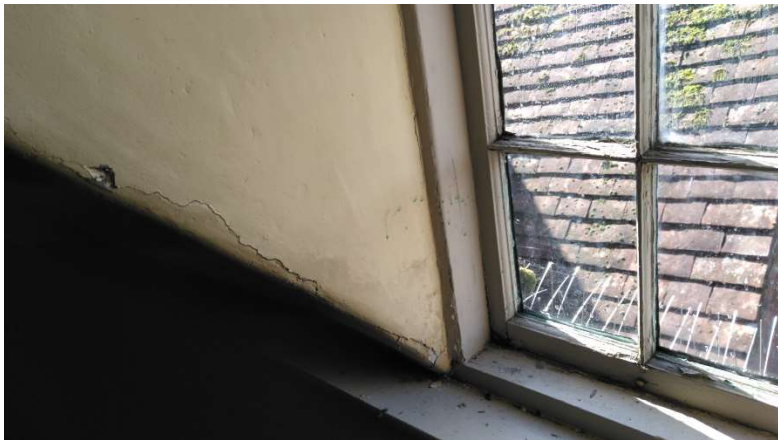
4.

It was also observed that the property's gutters are clogged with moss, leaves and grass, and with the gutters blocked, the water is spilling out and charting its course down into the fabric of the building. Many of the internal walls around or in close proximity to the windows, gutters or gullies are showing decay and patches of increasing damp/water penetration. See picture 4 on the next page. There are areas of the roof where tiles have become dislodged and vegetation has taken root, again causing issues of water to build up and soak down into the structure of the building, see picture 5 and 6. Water is also pitching on the roof of the bay windows where the water has nowhere to go, owing to the gutters blocked see picture 7. Some of the windows now have glass that is visibly insecure on touch, see picture 8. Between the adjoining properties there is a roof gully, and this is

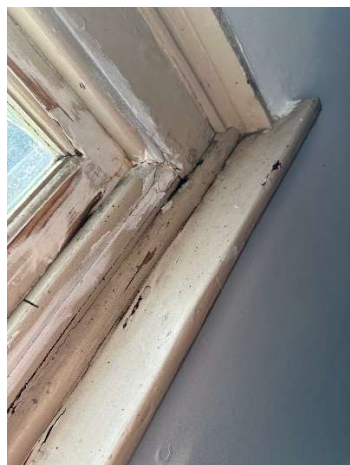
**15.**

Due to the amount of water and damp that is penetrating the building, the walls throughout the third and second floors are struggling to maintain their structure. From pictures 11 to 15, you can clearly see the effect the water ingress has had on the interior of the property. If this is not tackled

within the next six months or so, this issue will worsen and begin to affect the gallery that is seen by the public on the ground and first floors. The electrics will also be compromised throughout if no action is taken promptly.

At some point, there has been some modest repairs to the window frames where sections of wood have been cut out and replaced or the window putty has been renovated. Unfortunately, we now have gone beyond the point of where basic/moderate patching repairs will suffice.
