# **Historic Building Heritage Assessment**

**Melbourne House, The Nursery,  
Devizes, Wiltshire.**

Reference: 251006A

**Historic Building Heritage Impact Assessment**

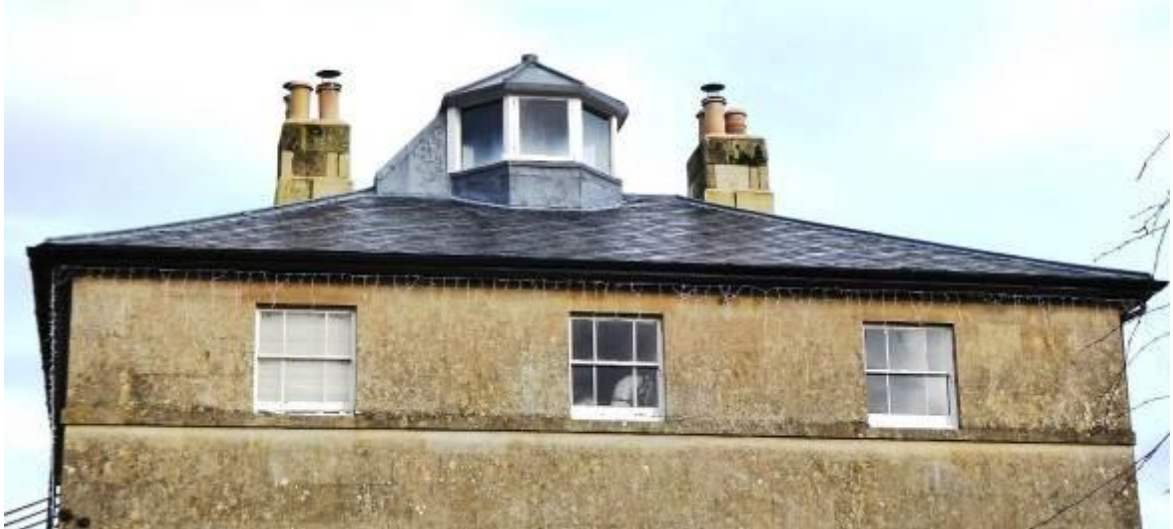
Fig 3.1: Main roof

- 3.1.1 The roof to the main part of the house is a hip structure covered in natural slates, with the ridge and hips all dressed over in lead.
- 3.1.2 Projecting up through the ridge is an octagonal cupola that is capped by an octagonal lead covered roof with lead rolls on the hips. Below that is painted timber glazing and the sides are dressed in lead as well as the housing to the stair housing on the west side.

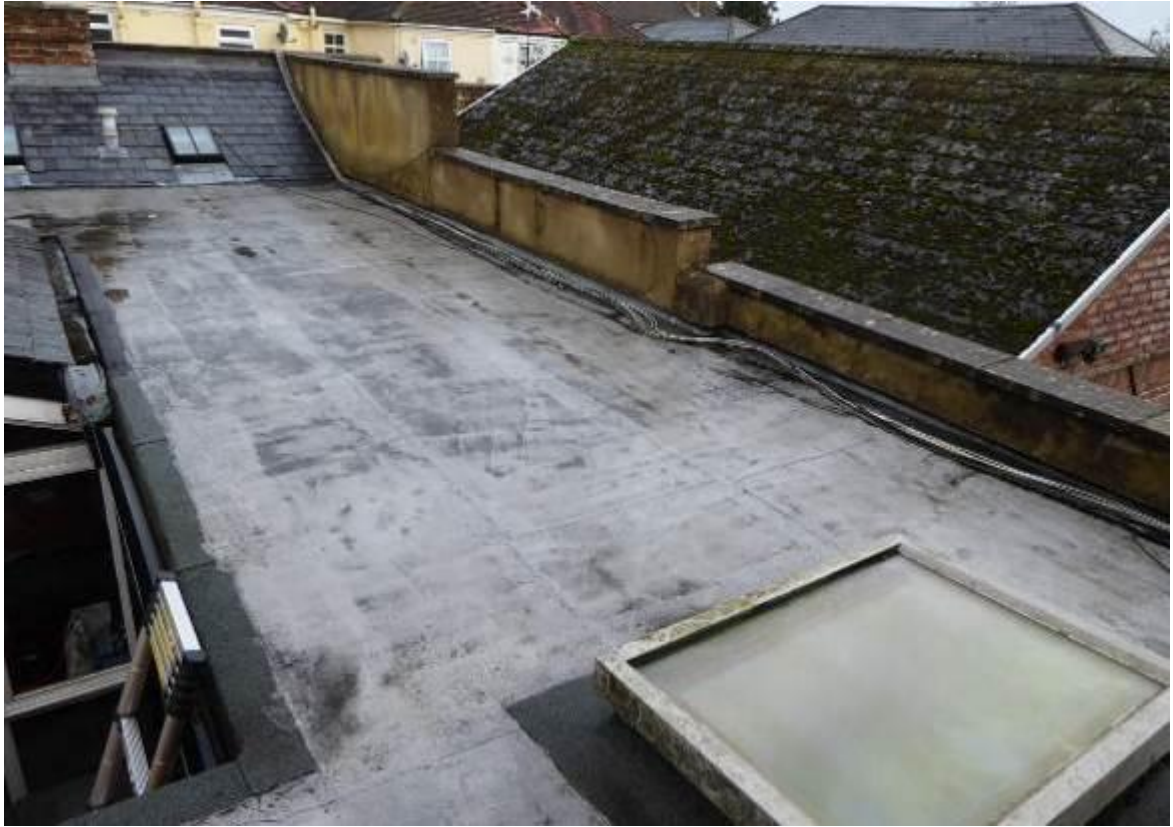
Fig 3.14: East side flat roof over existing kitchen

- 3.1.6 Over the link block long the east side, between the single story roofs and the east boundary wall, is a flat roof finished with bituminous felt and similar upstands to the side wall and the north end of the two storey modern wing. Set into this is a small fixed light roof lantern.

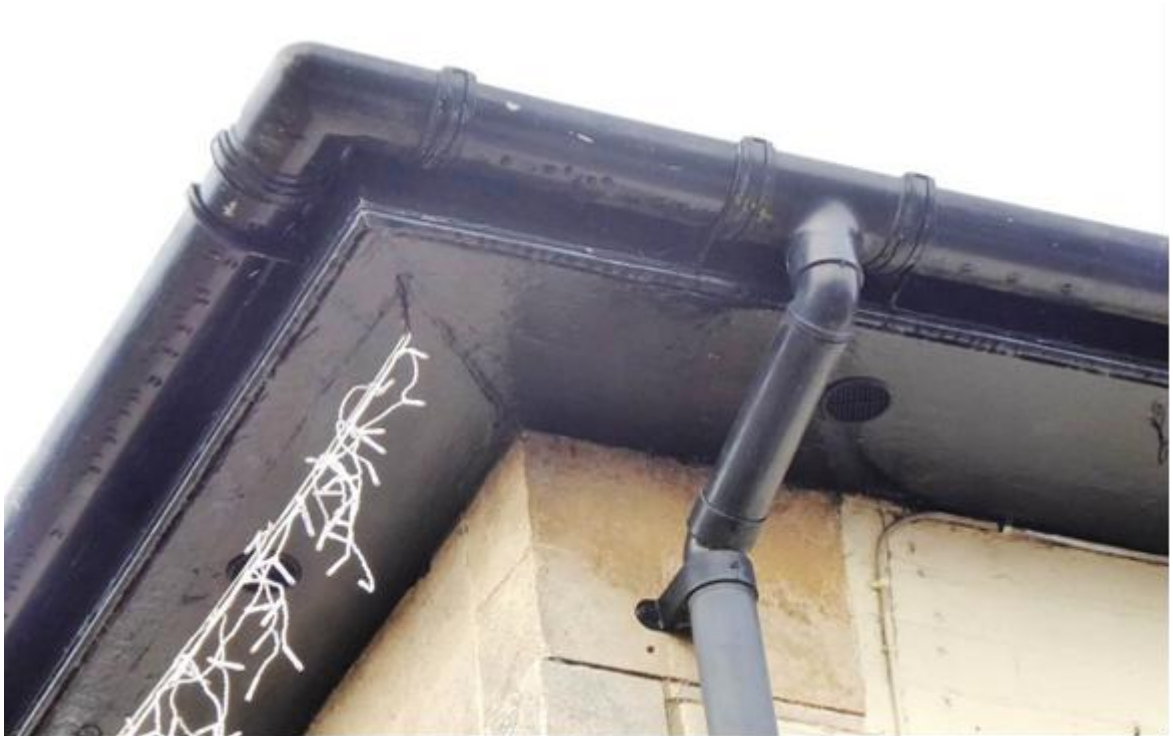
Fig 3.3: Eaves to main house

- 3.3.1 To the main house these have wide painted timber soffits and painted timber fascia boards that support half round section uPVC guttering, which empty into to circular section uPVC downpipes that run down to below ground level. All the soffits have modern ventilator grilles set within in, presumably to allow for cross flow ventilation within the roof space.

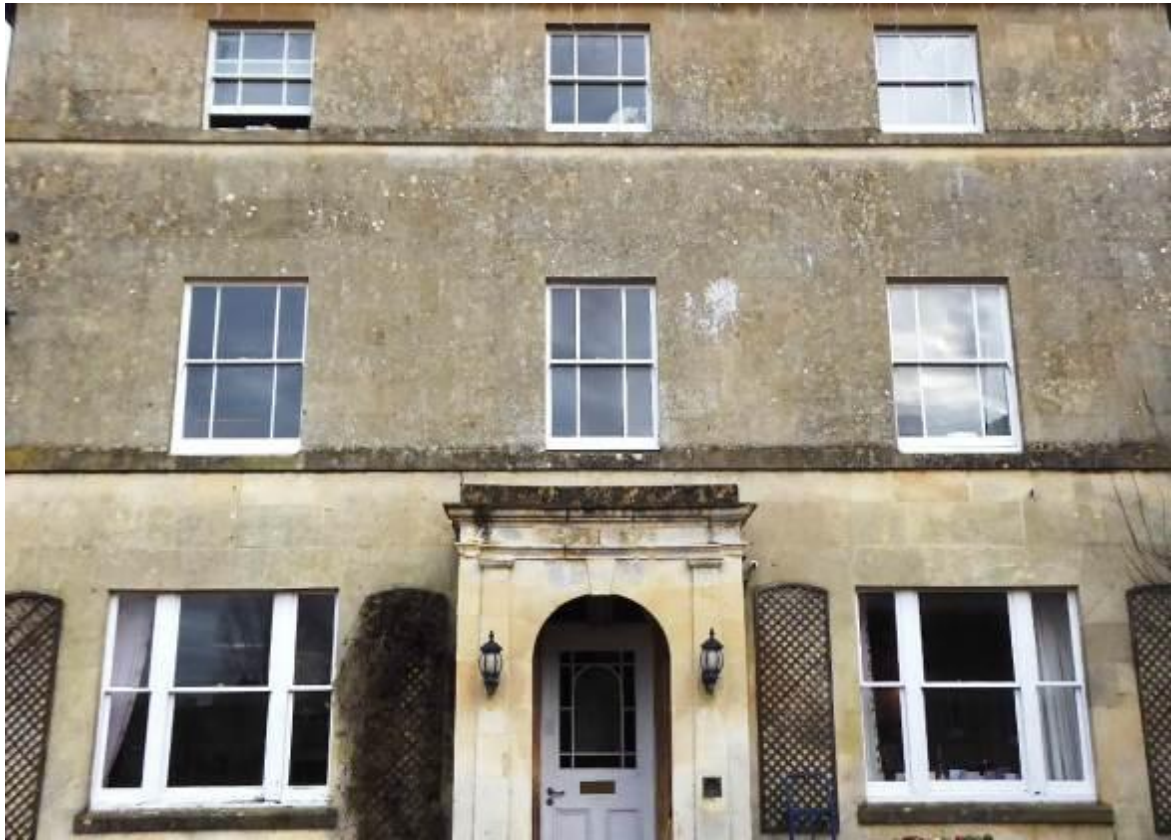
Fig 3.5.2: South elevation windows

- 3.5.3 Those to the front of the main block of the house are of mixed types of single glazed vertical sliding sashes. The second floor windows are three-over-three windows, which appear to be late 20<sup>th</sup> C reproductions as evidenced by the horns to the windows and the quality of the glazing bars. Larger three-over-three paned windows are fitted to the first floor, where some of these are replacements, such as that on the west side and possibly to the centre, whilst the east side window appears to contain some historic glass. In all cases the outer panes are slightly narrower than the central panes.

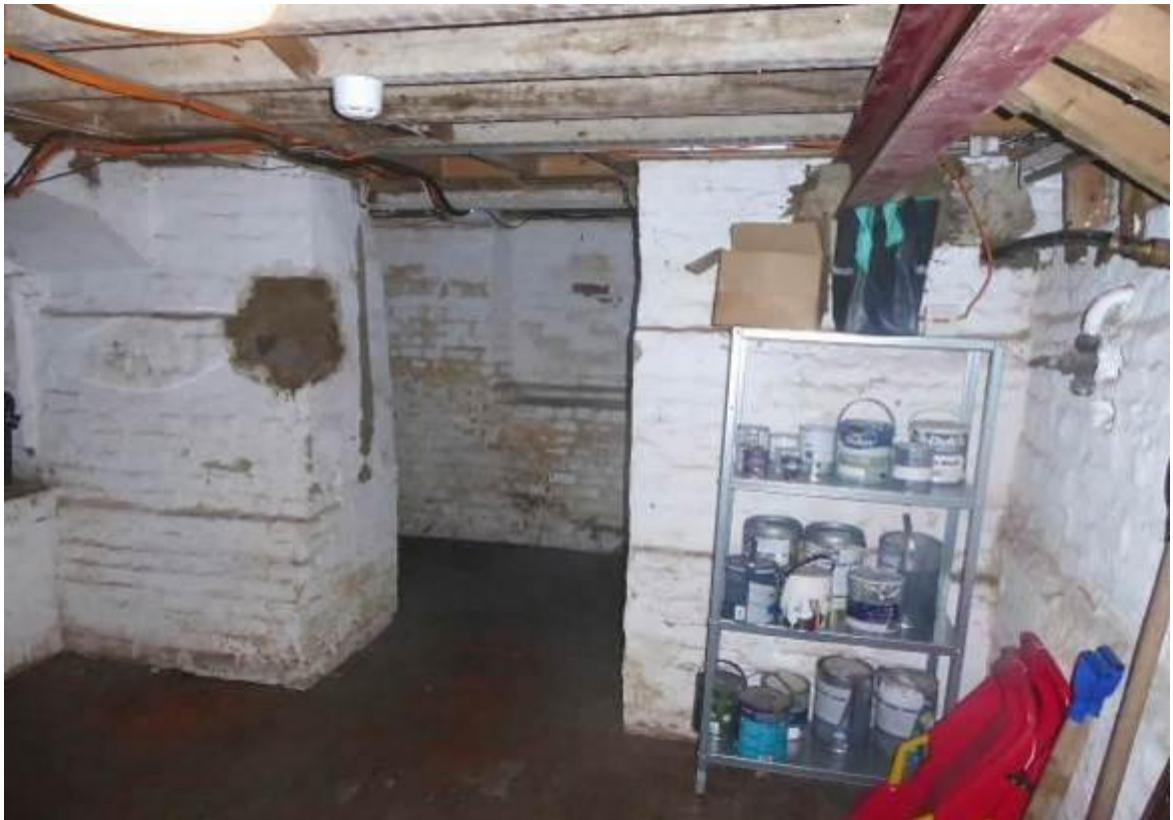
Fig 4.1: Cellar

- 4.1.2 This comprises multiple areas and levels below the ground floor under and to the west side of the central ground floor entrance hall with a section extending to the external wall of the west wing, where on the north side there appears to be a blocked up access to the floor above and also a closed up window on the west side. This is section is under the main part of the house where modern steel beams have been inserted in a central position running front to back. There are other beams that pick-up the ground floor against the north wall, with additional support taken over the head of the stairs.
- 4.1.3 Through this area the floor is all in traditional brickwork laid flat.

- 4.1.4 The walls all of brickwork with paint finish, although there are sections of more modern work towards the base, possibly where these have been stabilised using late 20<sup>th</sup> C concrete blockwork.
- 4.1.5 The door at the head of the stairs to the cellar is a modern timber four panel fire door fitted with intumescent stripping.

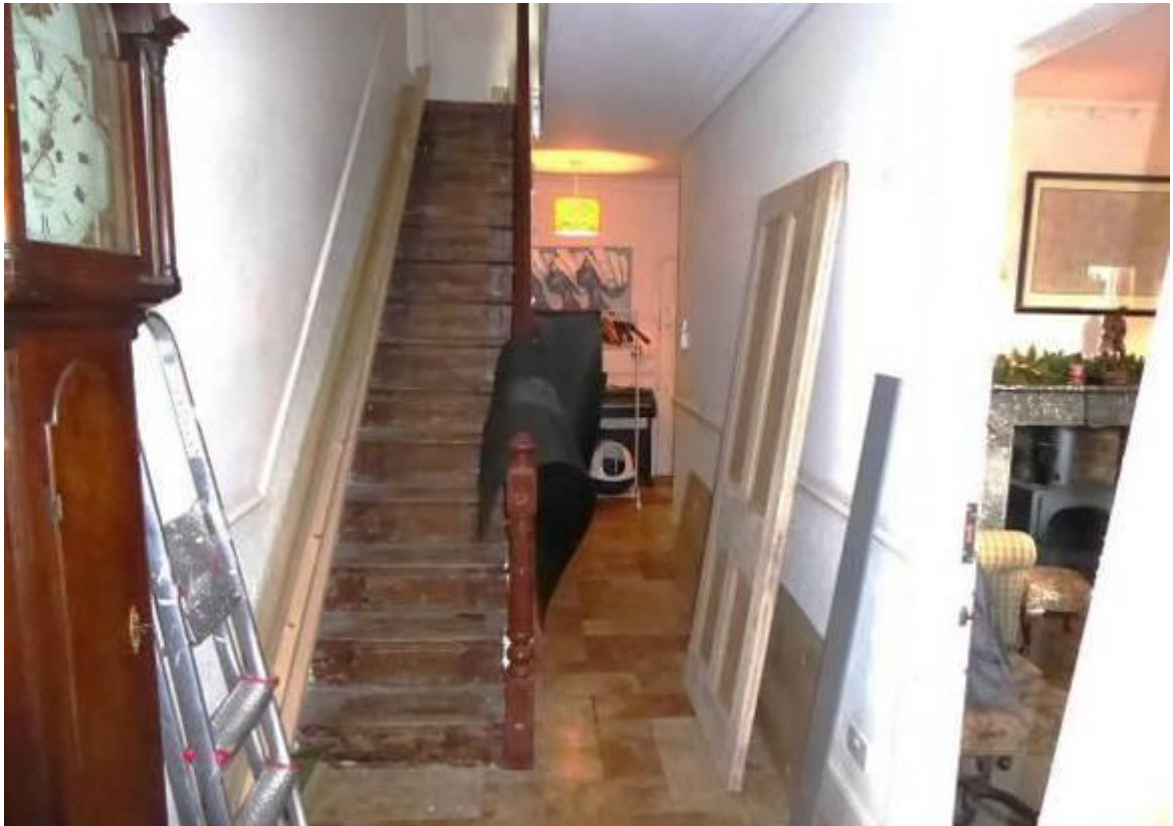
Fig 4.2: Entrance hall

- 4.2.1 This extends from the front door, though the centre of the original part of the house to the rear, where it then turns across the back of the house to the kitchen lobby at the east end.
- 4.2.2 Most of this area has a floor of suspended timber construction over the cellar below, where this is covered with stone tiles. The floor across the back part is of solid structure with tile coverings as that to the front part.
- 4.2.3 The walls to the dining room side to the front part of the hall are all of solid construction and those to the sitting room side are apparently of lath and plaster construction, but may be lath and plaster lining to solid construction. In the rear

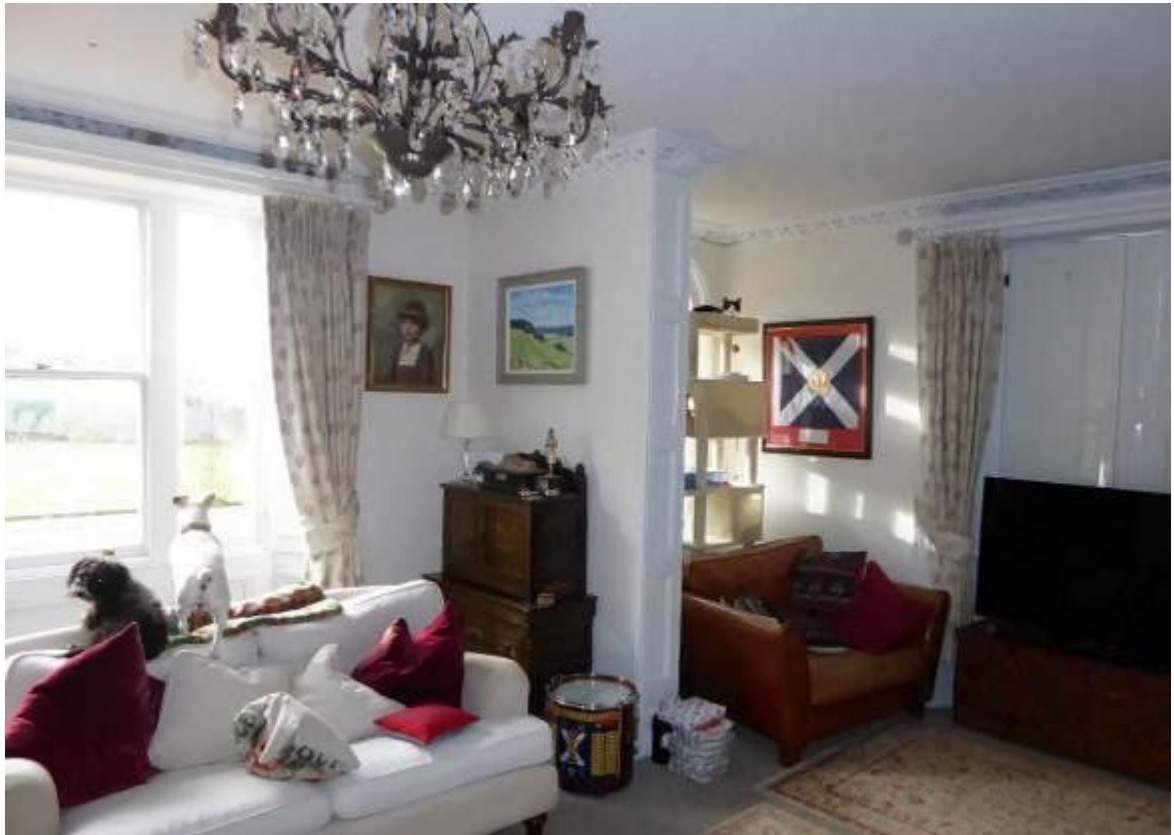
Fig 4.3: Sitting room

- 4.3.1 The main part of this room is within what can be considered to be the original core block of the house and is connected to the section within the west side extension with an opening cut through the side wall.
- 4.3.2 The floor is of suspended timber construction covered with fitted carpets.
- 4.3.3 The walls are of solid construction apart from that to the entrance hall as noted previously, with painted timber torus profile skirting boards to the base.
- 4.3.4 Running up the wall to the ground floor north room is a chimneybreast with white marble fire surround and mantle shelf around a brick fire opening over a modern ceramic tile hearth. Within the opening is a small modern wood burning stove.

- 4.3.5 The ceiling is a flat soffit with decorative vine leaf pattern decoration of a late 19<sup>th</sup> C style coving to the perimeter. This extends in to and around the part within west side extension, so giving an indicative dating as to when the room was restyled.
- 4.3.6 The inner face of the main windows are panelled around with timber shutters fitted to those on the south side, but on the west window these appear to have been lost.

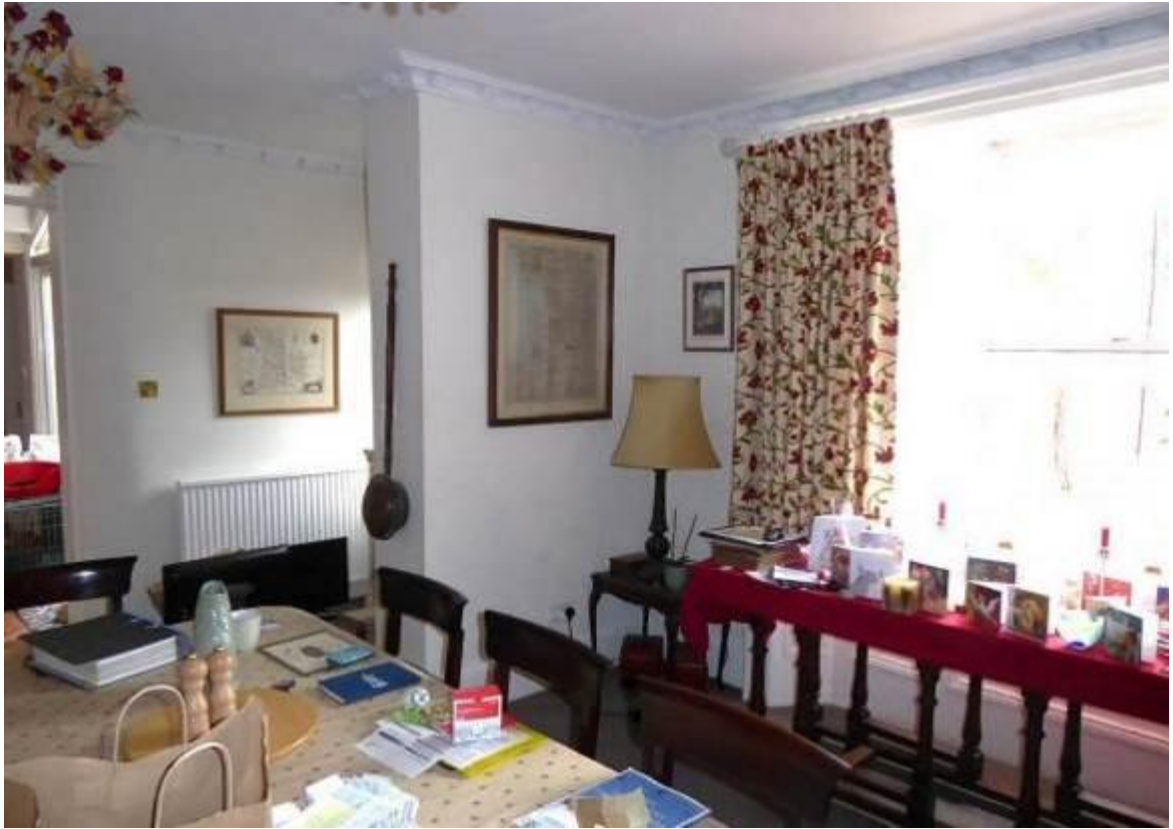
Fig 4.4: Dining room

- 4.4.1 The floor is of suspended timber construction covered with fitted carpets.
- 4.4.2 The walls are all of solid construction with painted timber torus pattern skirting boards to the base.
- 4.4.3 A chimneybreast runs up the wall to the rear part of the hall and is fitted with a grey marble fire surround and is generally as that described for the sitting room.
- 4.4.4 The ceiling is a flat soffit, possibly of lath and plaster construction with cornice to the perimeter that has floret pattern applied decoration.

- 4.4.5 There are radiused reveals to the door opening from this area into the kitchen and an applied timber threshold within the opening with a rise of approximately 75 mm.
- 4.4.6 To the right hand side of the fireplace in the section into the east single storey addition is a cupboard, with modern fire door fitted to the front.

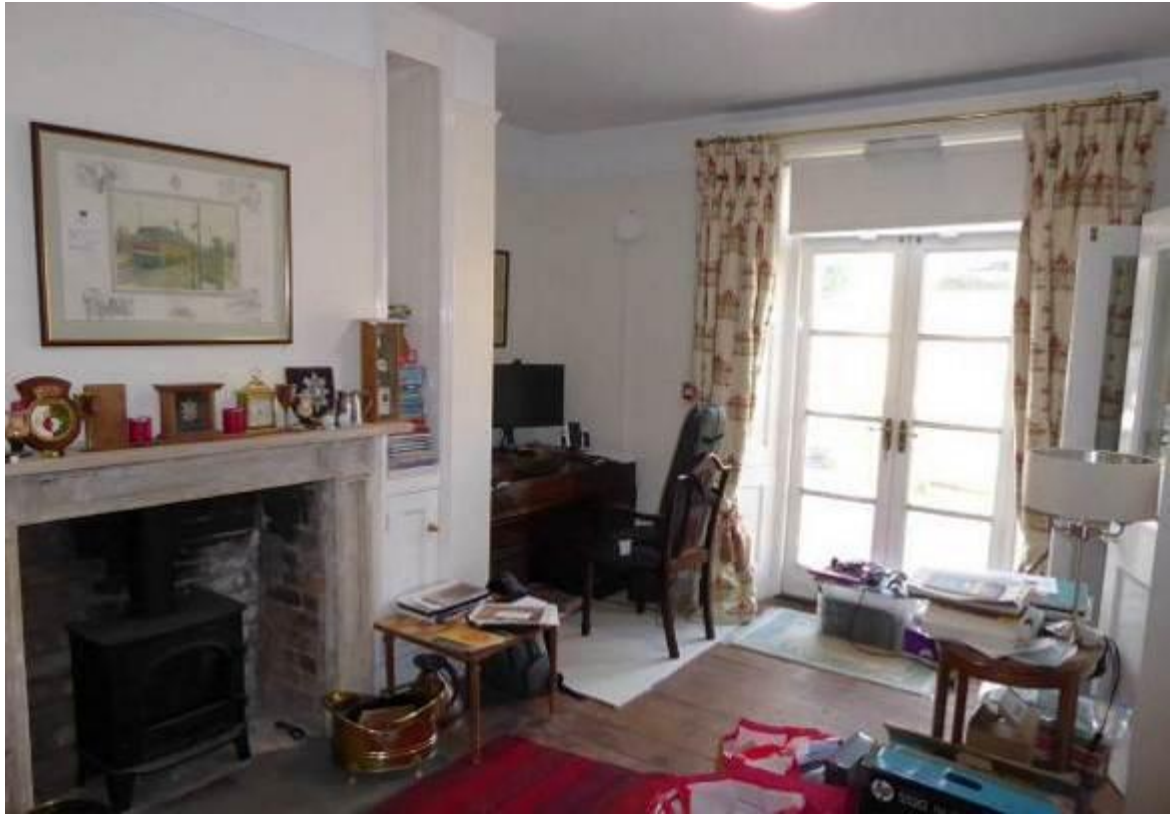
Fig 4.5: Study

- 4.5.1 This has suspended timber floor with a board width that is typical of the mid - late 19<sup>th</sup> C. Within the single storey west extension the boards run the in a different direction to the original part, showing this part is a later addition.
- 4.5.2 The walls are apparently of modern hollow construction to the interior as well as internal cupboards, hollow lined to the north side, and then solid to the external west and internal firebreast. A picture rail runs round the room just below ceiling level.
- 4.5.3 A chimney breast runs up the wall to the sitting room and in the base of which is a fire opening, with concrete hearth, brick interior and moulded stone surround and mantel shelf over it.

- 4.5.4 To the left hand side of the firebreast is a small narrow cupboard formed and a larger safe cupboard in the left hand side.
- 4.5.5 There are shutters fitted to the window opening to the upper part, where this has been adapted to form French doors.
- 4.5.6 The ceiling itself is a flat soffit, probably of lath and plaster.

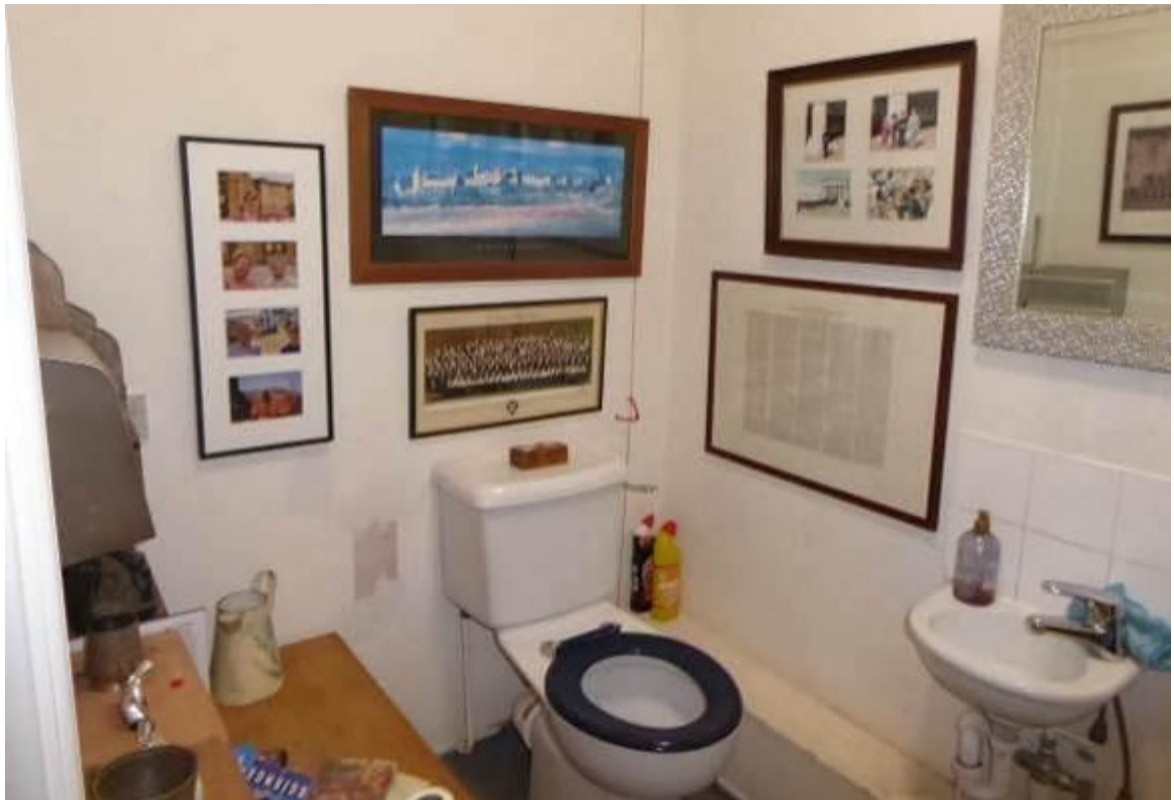
Fig 4.6: Ground floor cloakroom

- 4.6.1 This has evidently been formed as a disabled toilet in recent times, as intimated by door size, internal width and fittings within it.
- 4.6.2 The floor is of solid construction covered with modern vinyl non-slip sheet flooring.
- 4.6.3 The walls are all of modern hollow construction or modern hollow lined to the exterior.
- 4.6.4 The ceiling is a flat soffit of plasterboard.
- 4.6.5 Sanitary fittings comprise; DDA compliant low level WC suite, low level hand rinse basin and a modern extractor fan to the external air.

- 7.2.2 At the rear of the original part of the house, beside the cellar stairs lobby, a cloakroom of a size to make it fully access for disabled person was formed when this used by the County Council. This is constructed as a lightweight structure as noted above and is to be replaced by a smaller enclosure to provide a ground floor cloakroom that is more appropriate for a family house. In doing so it will enable a larger utility room to formed with the removal of the wall forming the kitchen lobby

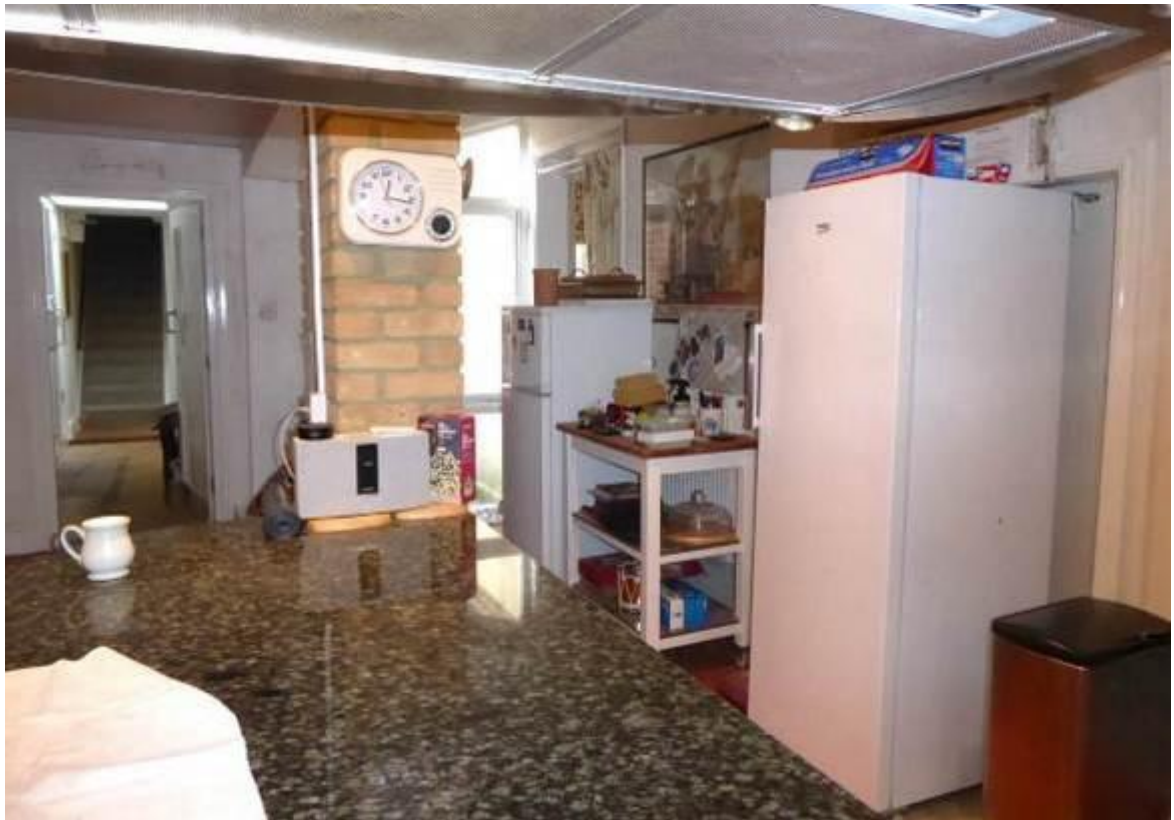
Fig 4.8: Kitchen

- 4.8.1 The floor is a solid construction covered with diagonally set large format quarry tiles of a modern type.
- 4.8.2 The walls to the link block are part solid and part hollow construction, where it would appear that the doorway to the link position has been altered or the opening reduced in size to what it is now. In the base of the north wall there is the remains of a fire opening and chimney breast behind the kitchen units.

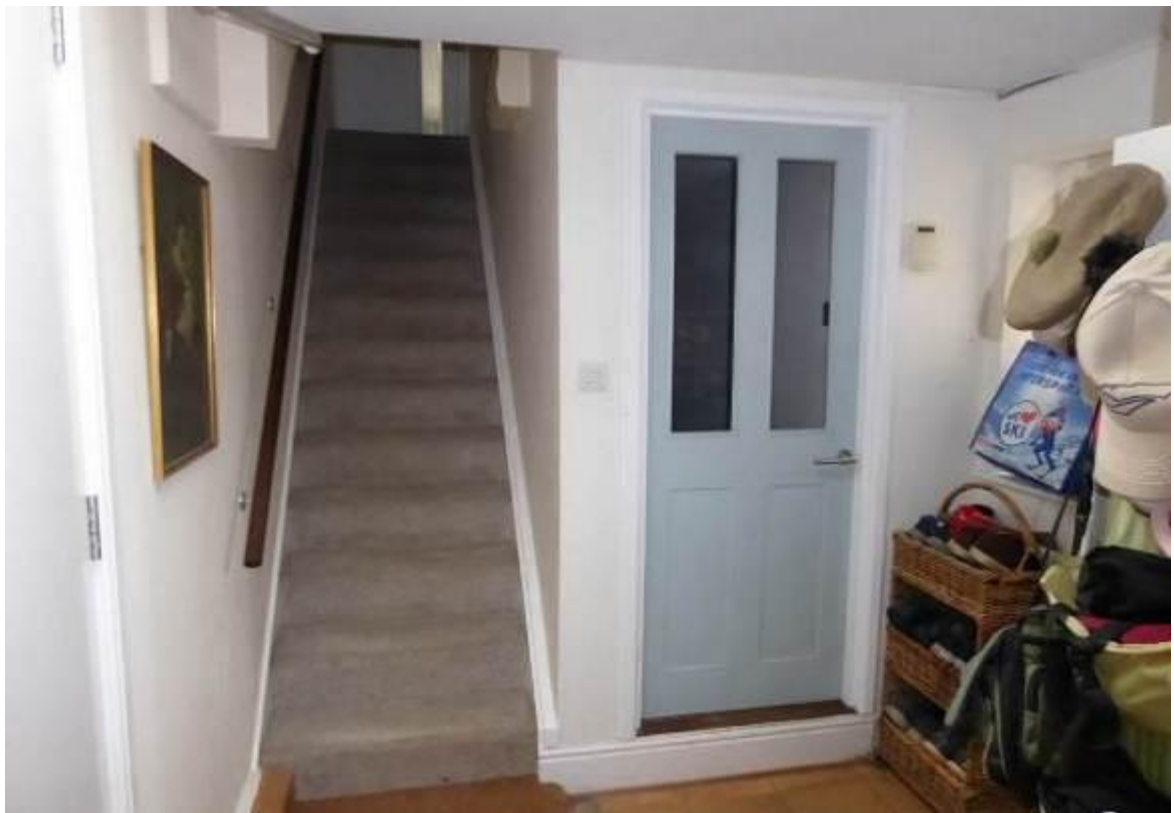
Fig 4.9: Link corridor

- 4.9.1 This is within the modern addition associated with the building of the two storey rear wing.
- 4.9.2 The floor is of solid construction where the surface shows patterning of where walls have been removed between the kitchen and base of the stairs. It would suggest that there were previously cupboards along the east wall.
- 4.9.3 The door between this area and the kitchen is a modern fire door.
- 4.9.4 The walls are of solid construction with modern torus profile skirting boards.
- 4.9.5 The ceiling is a flat soffit with down lighters fitted within it under the flat link roof.
- 4.9.6 Leading off this area is a flight of stairs to the first floor of the modern wing and a glazed four panel door to the ground floor of the modern block and to the exterior.

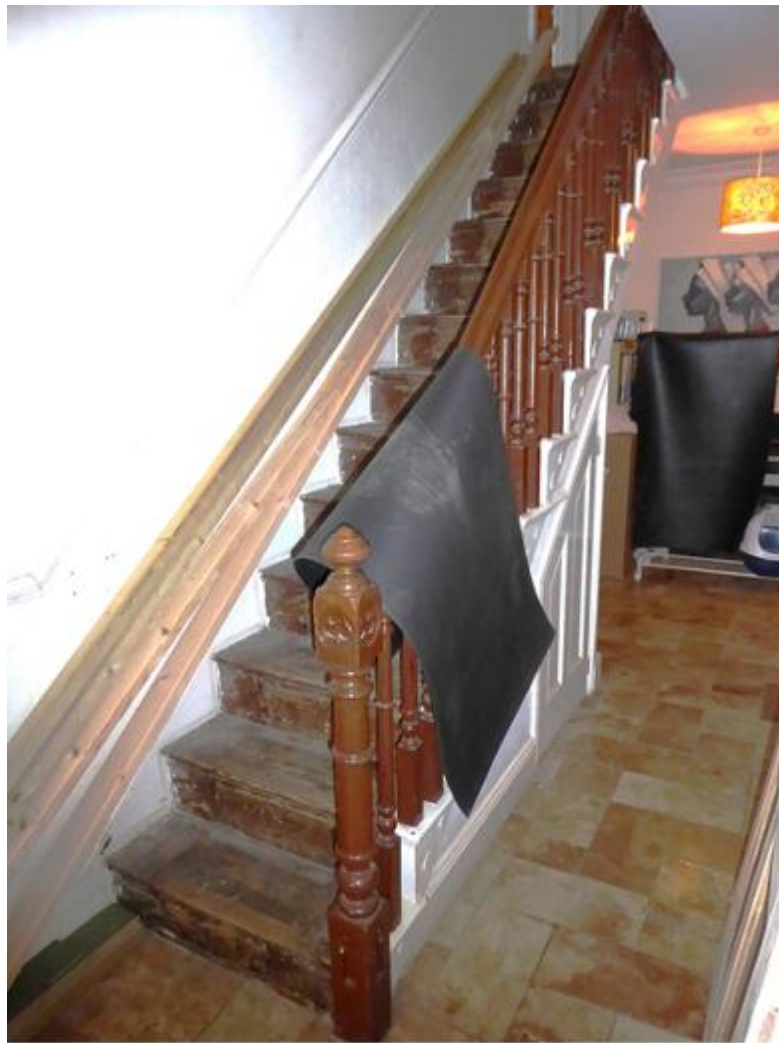
Fig 4.10: Main stairs to first floor

- 4.10.1 These are a timber structure that rise as a straight flight for their full length.
- 4.10.2 Their style would appear to be mid 19<sup>th</sup> C by the stair trim, turned baluster pattern to the timber balustrade on the open side under a timber handrail. This runs between a turned newel at the base and then a swept handrail at first floor.
- 4.10.3 The wall where it rises through the stairwell is of traditional construction and the ceiling over it is the underside of the staircase from first to second floor.

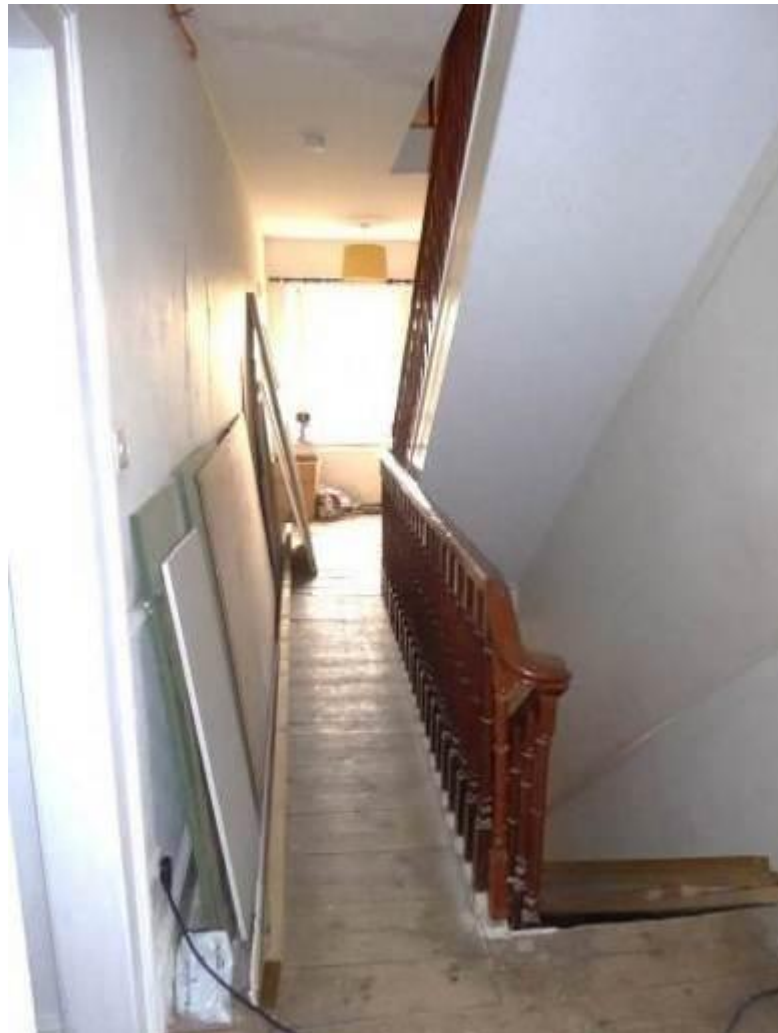
Fig 4.11: First floor landing

- 4.11.1 The floor is a suspended timber structure covered with timber boards.

- 4.11.2 The walls are all of solid construction at the front end and then lath and plaster towards the rear.
- 4.11.3 The ceiling is a flat and even soffit, possibly of plasterboard.
- 4.11.4 Leading off this area to the bathroom is a modern four panel door and the other door openings have no doors fitted owing to renovation works.

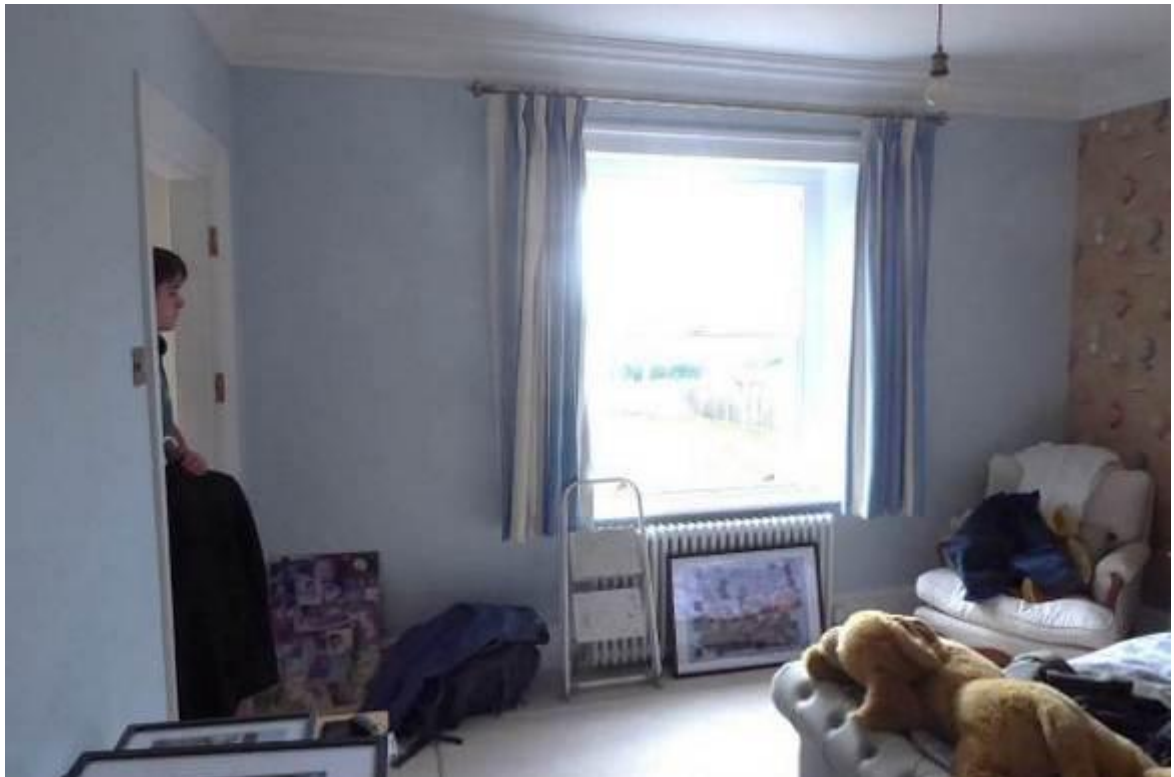
Fig 4.12: First floor southwest bedroom

- 4.12.1 The floor is a suspended timber construction covered with fully fitted carpets.
- 4.12.2 The walls are of solid to the exterior and to the front, landing and to the back with some areas of lath and plaster of a traditional nature.
- 4.12.3 The ceiling is a flat soffit with a simple moulded cornice to the perimeter. This includes being wrapped around the head of the wardrobes to the side of the fireplace, which runs up the north wall indicating that this is all a modern installation.
- 4.12.4 The balustrade to the stairwell is similar to that to the stairs from the ground floor to this level. There has been some adaptation to this at the newel to the bottom of the stairs to the second floor.

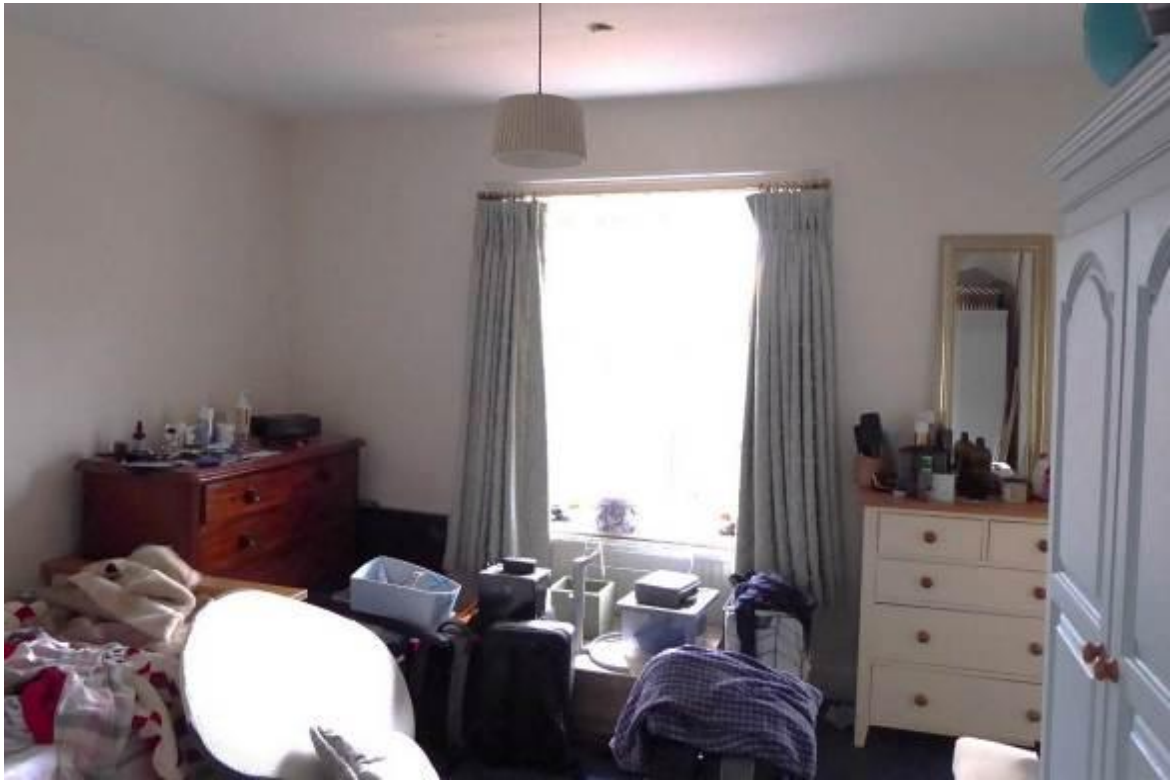
Fig 4.13: First floor southeast bedroom

- 4.13.1 The floor is a suspended timber structure covered with carpets.
- 4.13.2 The walls are of solid construction, including a chimneybreast running up the north wall. This has a cupboard formed in the recess on the left hand side with modern four panel door to the front.
- 4.13.3 The ceiling is a flat and even soffit of lath and plaster, with no cornice to the perimeter.
- 4.13.4 Leading off this room is a modern four panel door to the en-suite.

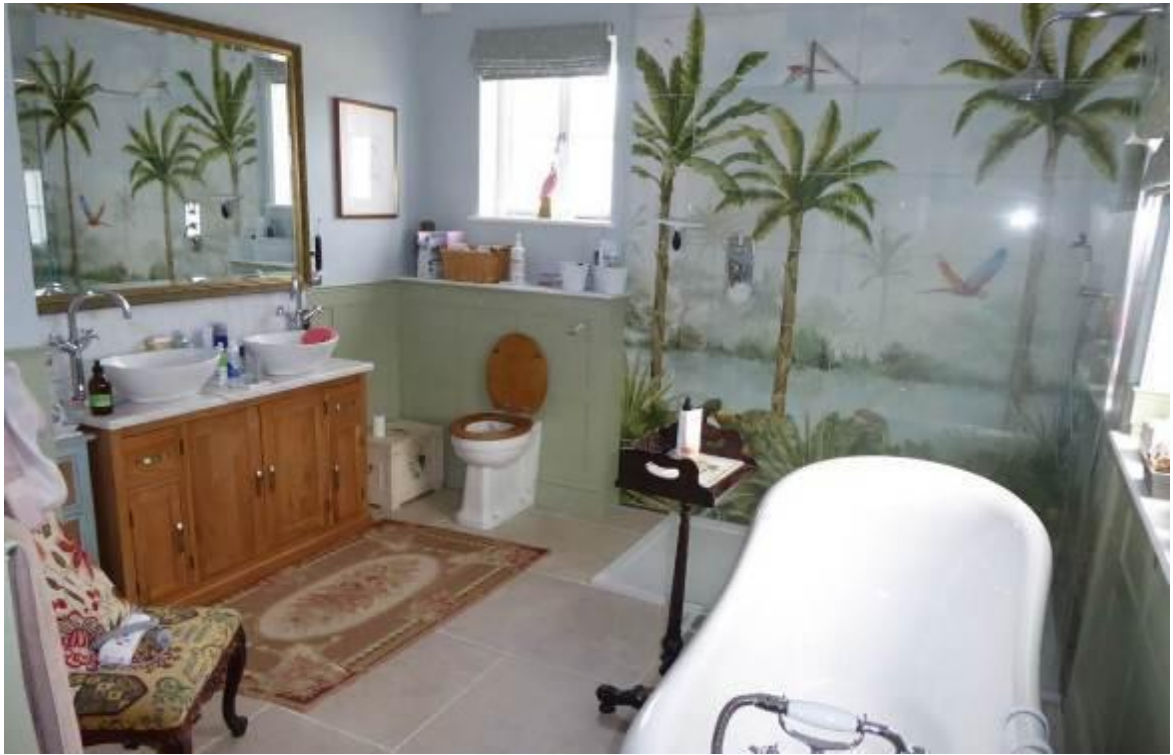
Fig 4.14: First floor southeast bedroom en-suite

- 4.14.1 The floor is a suspended timber structure covered with large format ceramic tiles.
- 4.14.2 The walls are either of traditional solid construction, and where these are to the interior are of modern hollow construction where these are to the interior of the building.
- 4.14.3 The ceiling is a flat and even soffit with down lighters fitted within it.

- 4.14.4 Sanitary fittings comprise; modern acrylic claw foot bath, low level WC suite with cistern duct and ceramic wash basins over a vanity unit base.

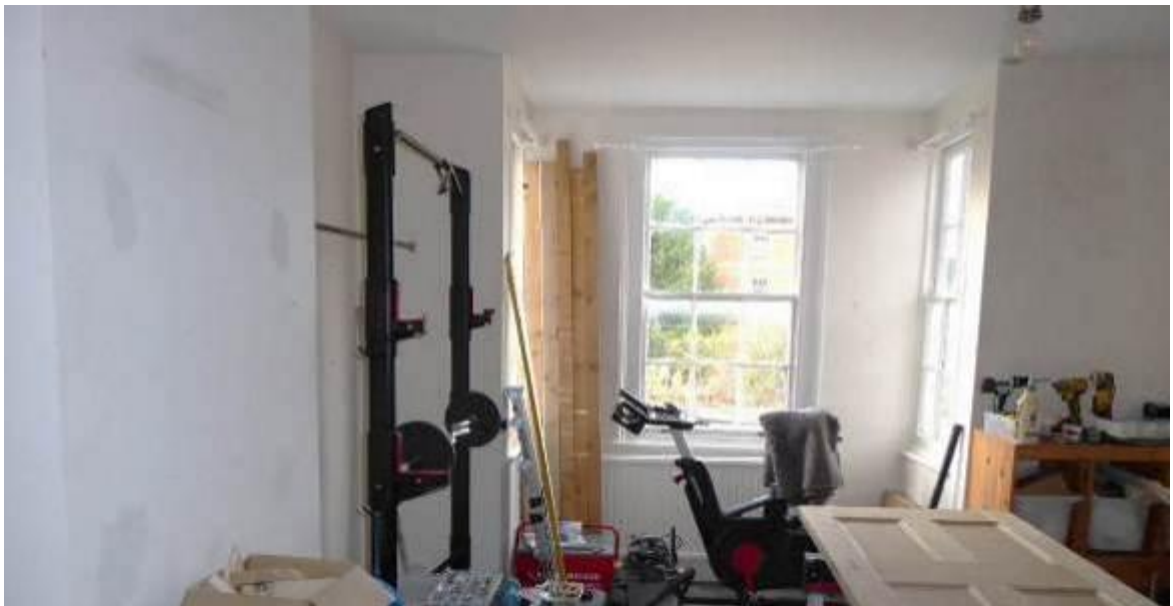
Fig 4.15: First floor northwest bedroom

- 4.15.1 The floor is a suspended timber structure with softwood boarding of a size and type typical of the mid to late 19th C, where this changes as it goes into the bay window, suggesting that this is a later addition.
- 4.15.2 The walls are of solid construction with painted plaster finish and plain timber skirting boards to the base. Running up the wall to the first floor southwest bedroom is a chimneybreast with no opening in the base.
- 4.15.3 The ceiling is a flat and even soffit of lath and plaster.

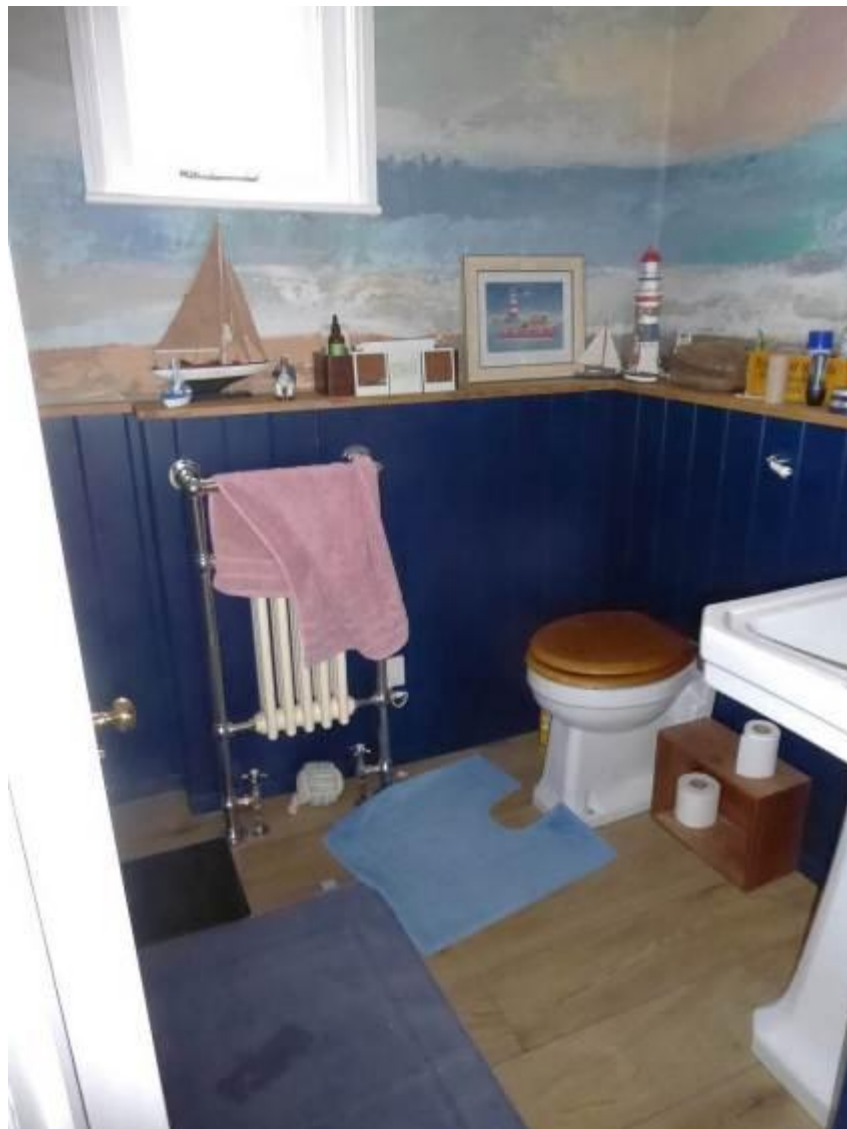
Fig 4.16: First floor bathroom

- 4.16.1 The floor is a suspended timber structure covered with modern simulated timber plank boarding.
- 4.16.2 The walls are of solid construction to the exterior, modern hollow partitioning to the interior and traditional lath and plaster to the first floor northwest bedroom. The lower parts of the walls are finished with dado boarding.
- 4.16.3 The ceiling is a flat soffit, most probably of lath and plaster with down lighters fitted within it.
- 4.16.4 Sanitary fittings comprise; low level WC suite with cistern in duct, pedestal wash basin and shower with glass enclosure.

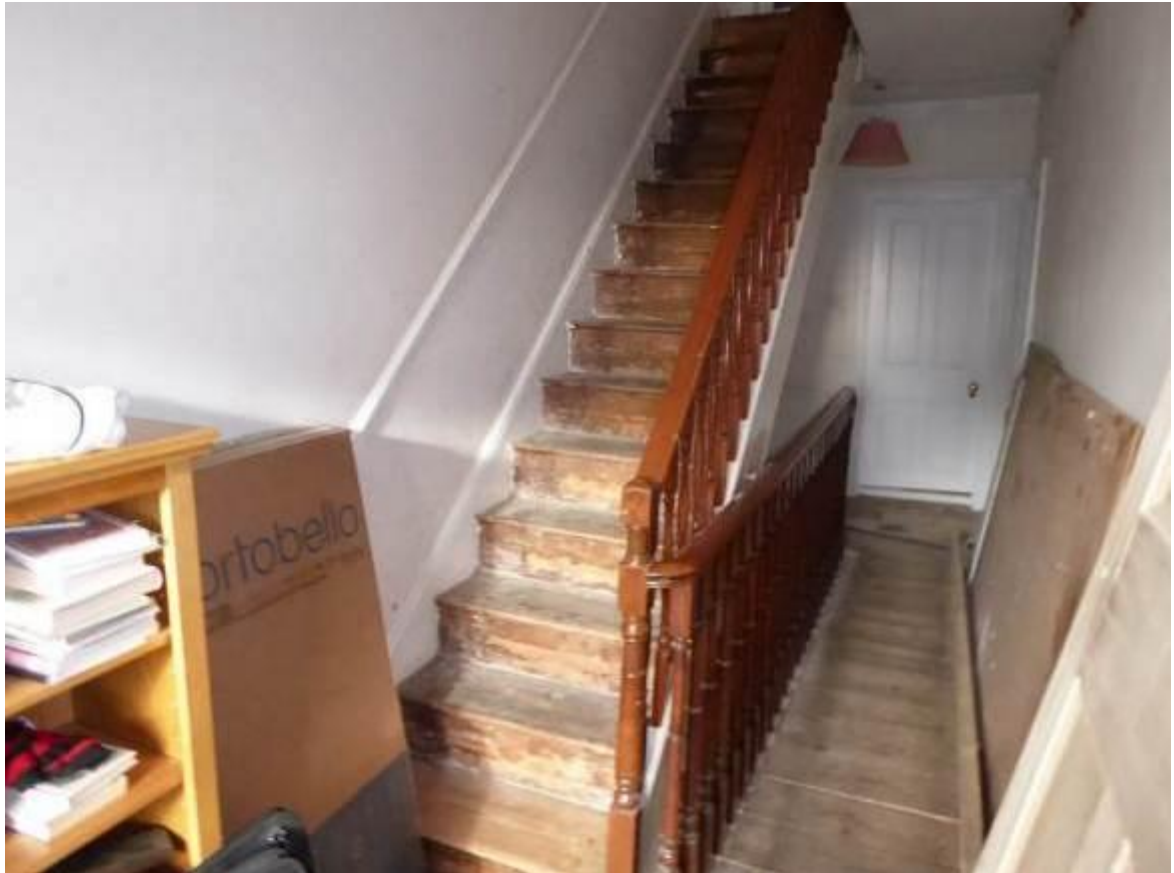
Fig 4.17: Stairs from first to second floor

- 4.17.1 In terms of general construction these are as noted for those from the ground to first floor, but the external string is plainer and is more typical of those to a service stair.
- 4.17.2 The handrail to the balustrade is of a modern replacement, where there has been changed from the lower newel and a different pattern of balusters.
- 4.17.3 The walls where they rise through this are generally as that described on the floor below.
- 4.17.4 The ceiling is a continuation of the landing above.
