# **Historic Building Heritage Assessment**

**Melbourne House, The Nursery,  
Devizes, Wiltshire.**

Reference: 251006A

**Historic Building Heritage Impact Assessment**

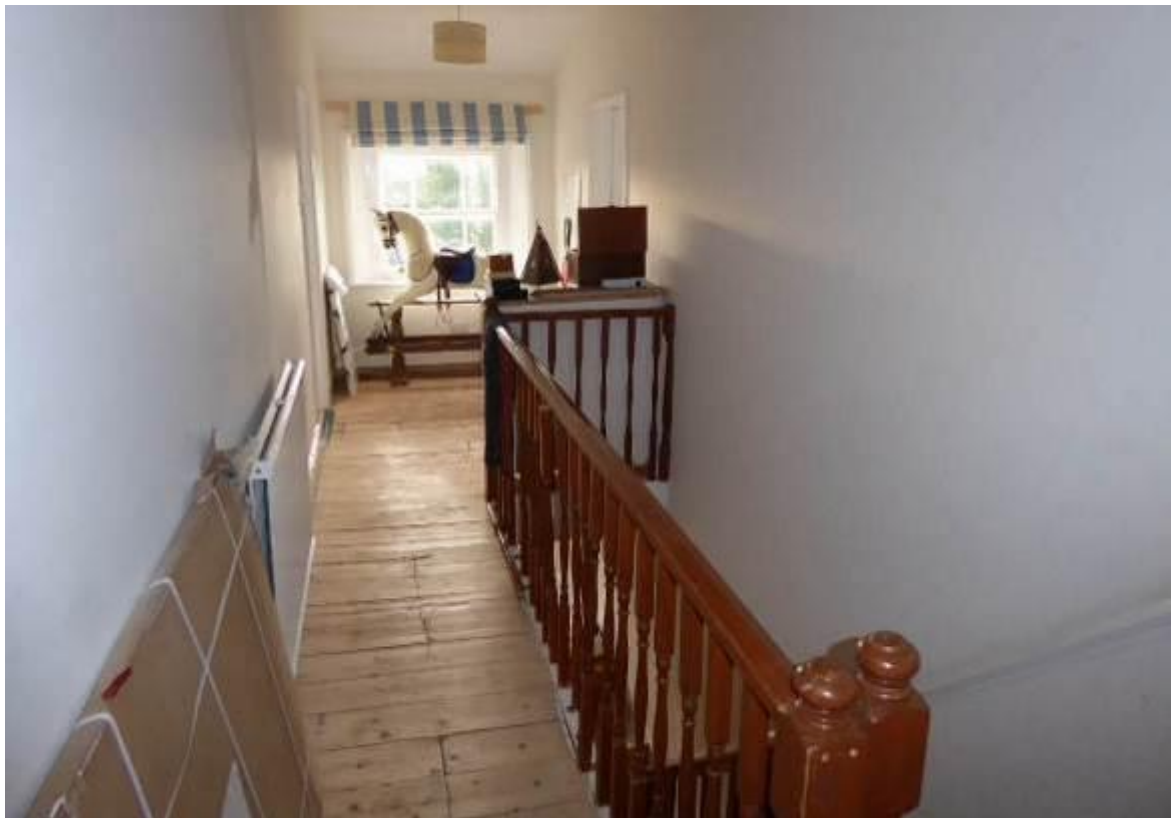
Fig 4.18: Second floor landing

- 4.18.1 In general terms this is as that described for the first floor landing and about which, similar comments apply. The floor boarding is of softwood of possibly late 19<sup>th</sup> C or early 20<sup>th</sup> C, possibly being replacement.

- 4.18.2 The walls are of solid construction to the exterior and hollow construction to the interior, possibly with some modern facings to these all the way through. On the

east side is a blocked up doorway to the southeast second floor bedroom where there was previously two smaller rooms

- 4.18.3 At the south end the ceiling has a slight section of skeling, where this is on the eaves of the main roof, and is flat to the reminder of the area.
- 4.18.4 The open side of the stairwell is guarded by a balustrade similar to that from the stairs from the first floor.

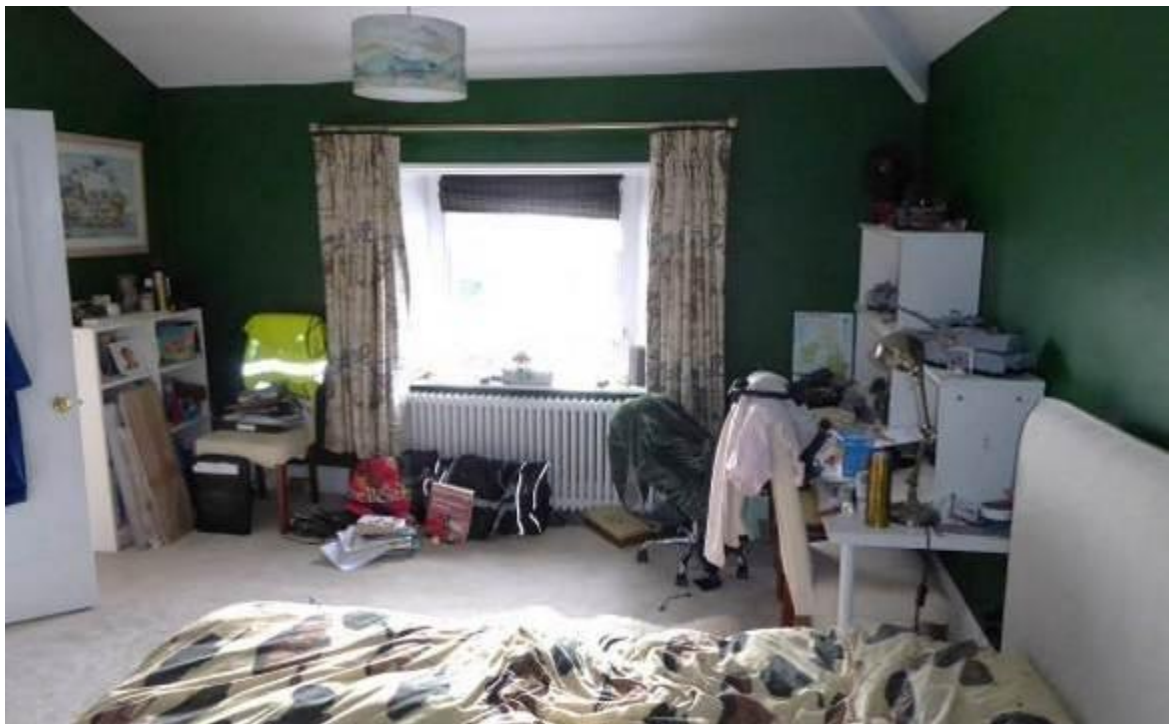
Fig 4.19: Second floor southwest bedroom

- 4.19.1 This has a suspended timber floor covered with fitted carpet.
- 4.19.2 The walls are of solid construction to the exterior and hollow construction to the interior with simple painted torus skirting board to the base.
- 4.19.3 Running up the wall to the second floor northwest bedroom is a chimneybreast with no fire opening from what we could ascertain. To the right hand side of that is a door opening to a cupboard to the understairs space to the cupola and on the left hand side a door opening into the second floor northwest room.
- 4.19.4 The ceiling is a flat soffit with skeling to the perimeter on the south and west sides and in the southwest corner hip rafter projects down through this.

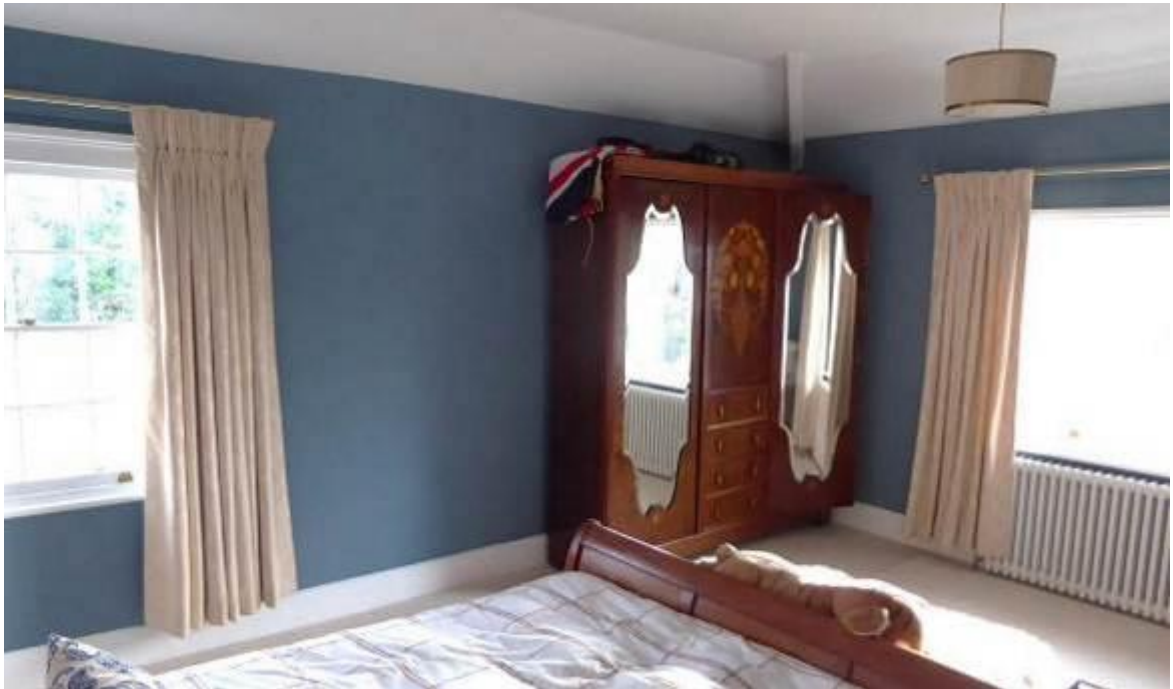
Fig 4.20: Second floor southeast bedroom

- 4.20.1 Generally this is as that described for the second floor southwest room in terms of construction, although with no cupboards to the sides of the firebreast on the north wall.
- 4.20.2 In the east wall, to the right hand side of the east window, there is some slight disruption seen in the plaster finish to the wall in that position, that could indicate where there may have been a dividing wall across the room in that position, corresponding with the blocked up doorway to the landing in the opposite wall. This would have then been the escape stairs window from this level, as noted externally.

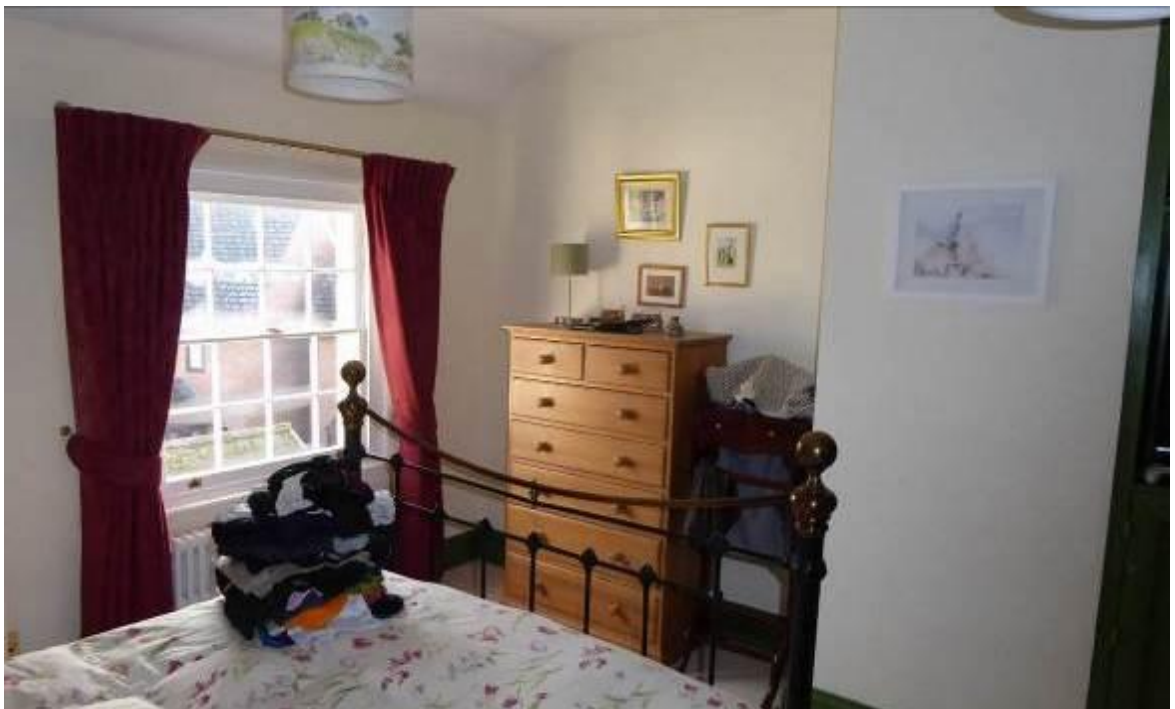
Fig 4.22: Second floor northeast bedroom

- 4.22.1 This is effectively the same as that to the second floor southwest bedroom in terms of walls, floor and ceiling.
- 4.22.2 Dropping down on the skelining on the north side is the underside of a truss rafter, similar to that noted within the northwest bedroom ceiling.
- 4.22.3 Running up the wall to second floor southeast bedroom is a chimneybreast with no fire opening in the base.

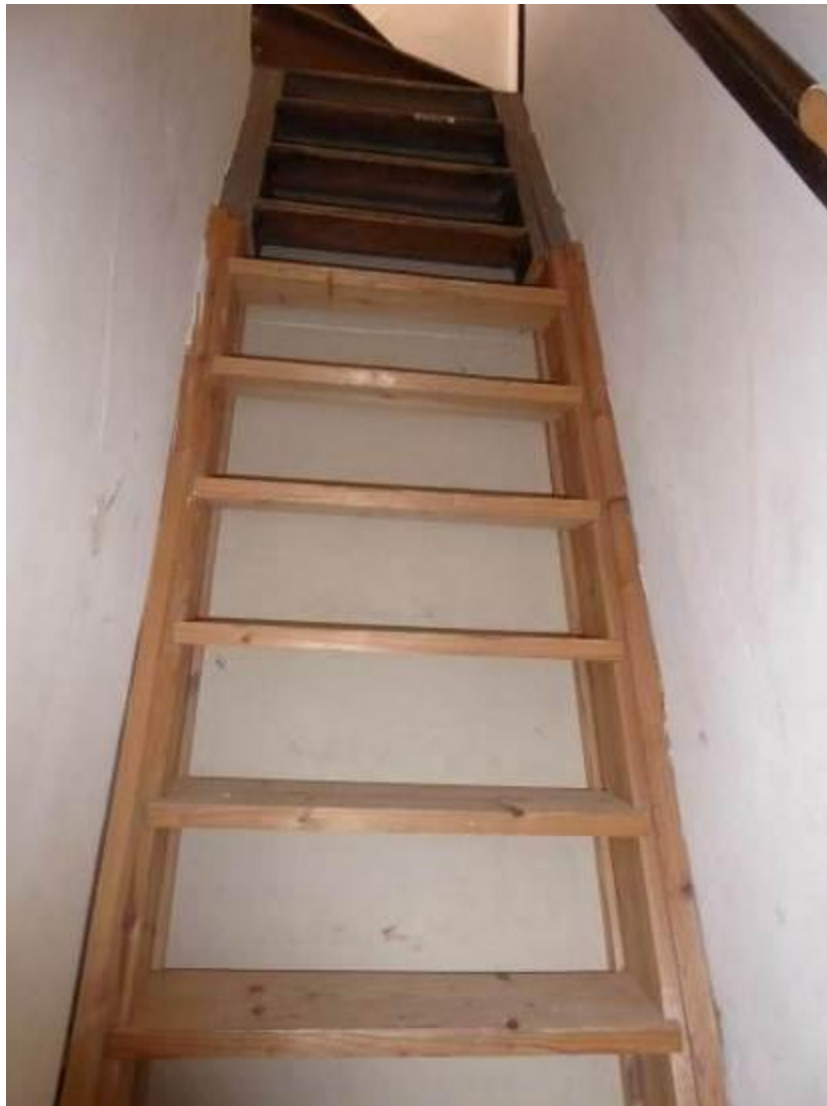
Fig 4.23: Stairs to cupola

- 4.23.1 These are effectively ladder stairs with a set of winders or tapers steps at the top as they turn to the interior of the cupola. It is in two sections, which show how these have been altered and realigned, with a change of pitch angle between the lower and the upper parts. The lower section would have continued out further onto the second floor landing than presently. This is also indicated by the pitch of the handrail on one side, which has been adapted and would correspond to the change of wall construction noted around the landing and the second floor northwest bedroom.

- 4.23.2 The walls where these rise to the cupola are as that noted for the floor below.
- 4.23.3 There is a panel door with glazing in the upper section closing off the cupola from the top of the stair.

- 4.23.4 Adjacent to the head of the stairs there is an access hatch into the roof space to the main part of the house.
- 4.23.5 The ceiling over this area is of lath and plaster, where this rises up through the adjoining roof space and the underside of the external housing.

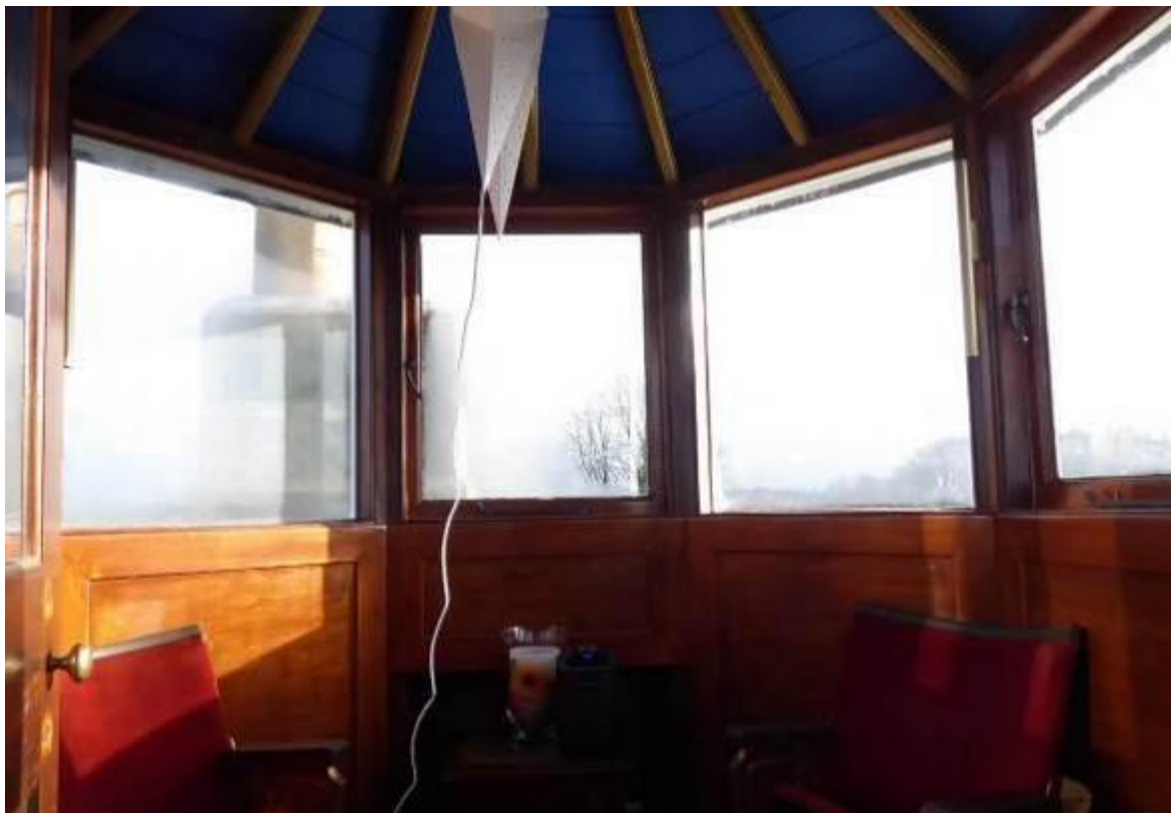
Fig 4.24: Cupola interior

- 4.24.1 The floor is a suspended timber structure covered with parquet type timber boarding.
- 4.24.2 The walls are timber panelled all the way around, apparently of plywood or similar, with timber battens covering the joints to the lower part. The upper part is a series of single glazed windows all the way round apart from to the stairs access.
- 4.24.3 The ceiling is a vaulted timber structure, where this rises to a central drop pendant with the rafters exposed supporting sarking boarding above that and to the lead work.

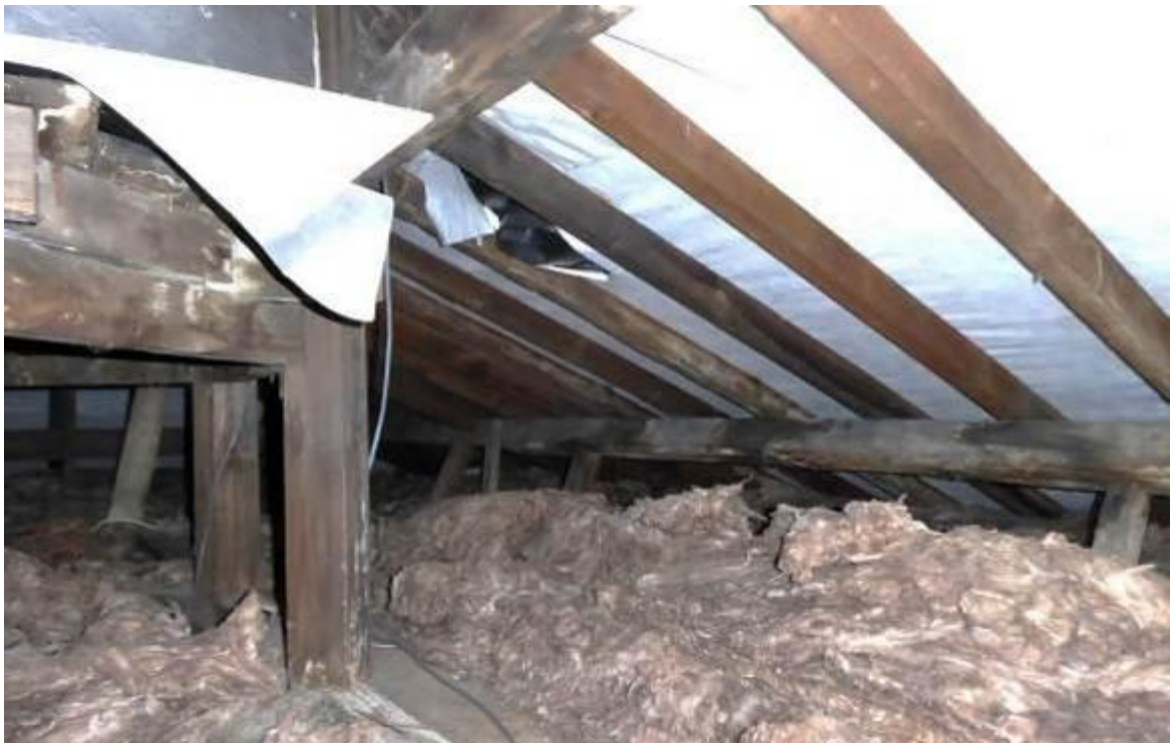
Fig 4.25: Roof space

- 4.25.1 This is a fairly simple structure, being primarily a purlin type roof based around the main hips and the two principal chimneystacks project up through it, where the base of these are all in brickwork of a colour and type noted on the east side. The rafters span up from the eaves over the purlins to the hips and the ridge board at the top, where they intersect.
- 4.25.2 The underside of the roof coverings are lined with what appears to be a breathable type sarking felt suggesting it has been stripped and re-slatted within the last 30 – 40 years, although, into this additional ventilator tiles have also been inserted. There is then mineral wool insulation quilt over the ceilings to the second floor.
