## Arboricultural Appraisal Report

### Subsidence Damage Investigation at:

Glebe House  
Hilmarton  
Calne  
SN11 8SB

| MWA REF: | SUB260512-18715 |

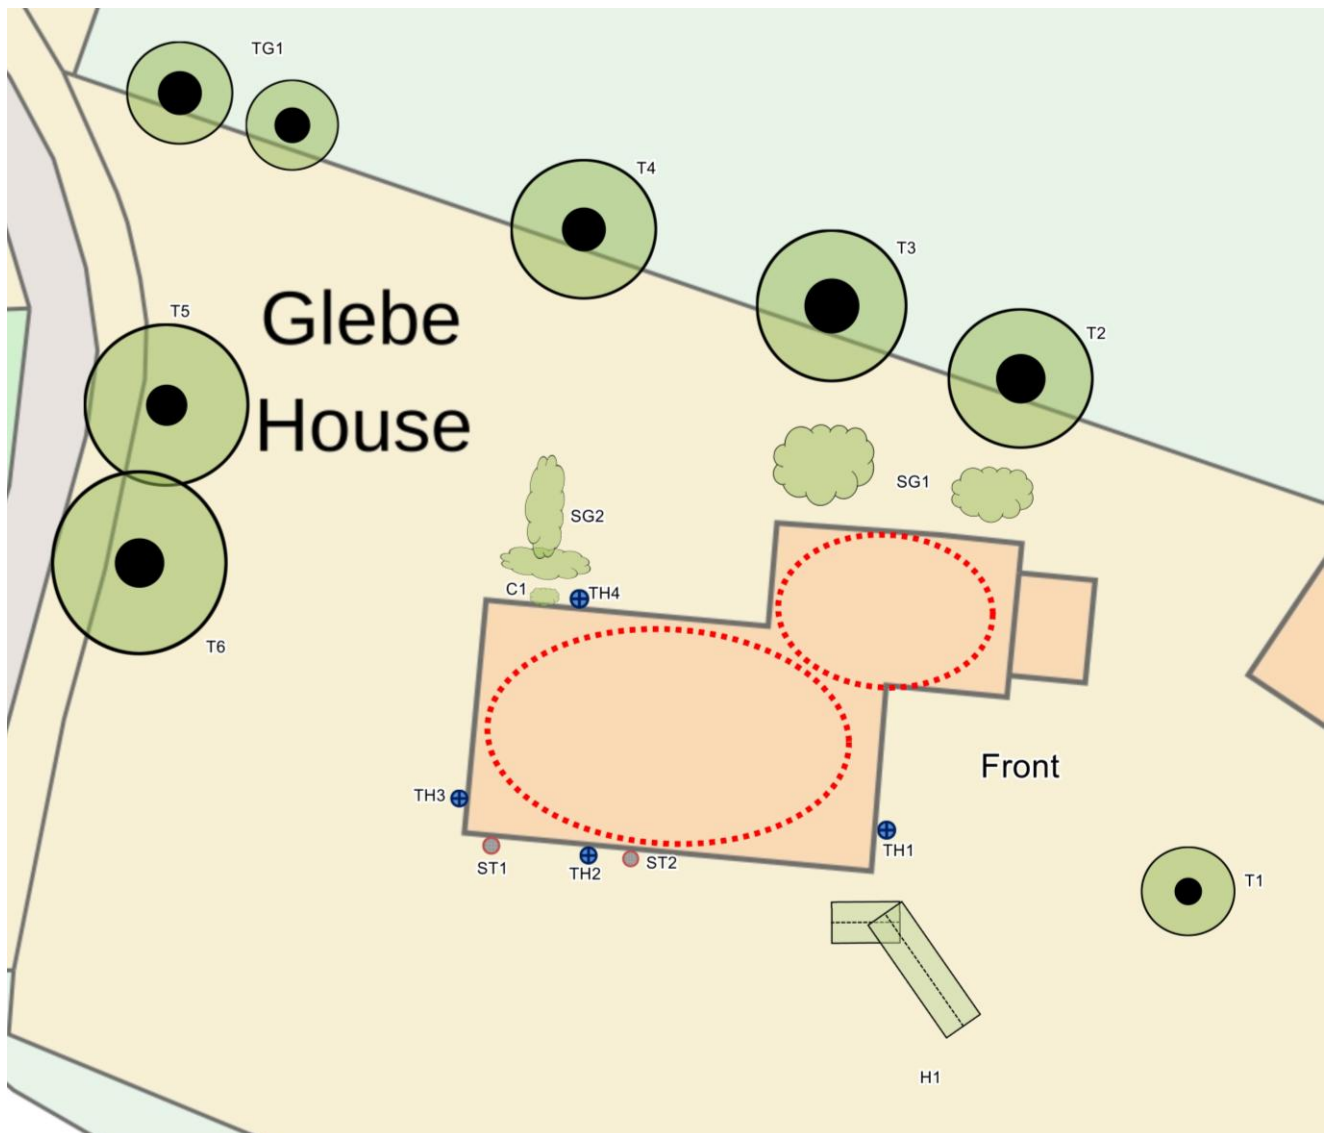
## Site Plan

Based on the information currently available and our own site assessment we conclude there is damage with the potential to be linked to shrinkage of the clay subsoil exacerbated by the soil drying effects of vegetation.

Approximate areas of damage

If an arboricultural solution is to be implemented to mitigate the influence of the trees/vegetation considered to be responsible for the movement/damage, works set out at Table 1 below are recommended.
