# DESIGN, ACCESS & HERITAGE STATEMENT

Rainwater Disposal Improvements at:

## The Yelde Hall, Chippenham, SN15 3HL

For: Chippenham Town Council  
Date: Tuesday, 13 October 2026  
Ref: 24-04-RS3

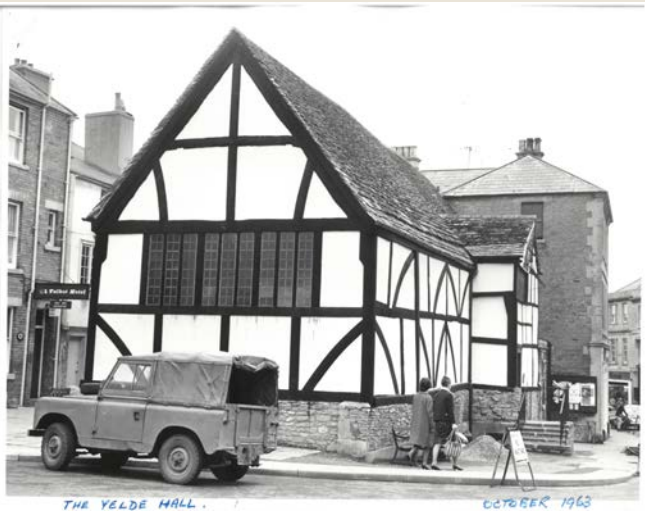
Figure 2: Yelde Hall, 1963. Before the installation of the large oak doors to the East elevation

- 5.5. By 1999 the museum moved to larger premises and the building went through a period of renovation between 2000 and 2003 when the large oak doors (that exist today) were installed in the south east gable (see fig. 2 & 3).
