**Subject:** PL/2023/07503 Variation of conditions 5, 6, 7 of 15/11604/OUT - OBJECTION

## OBJECTION

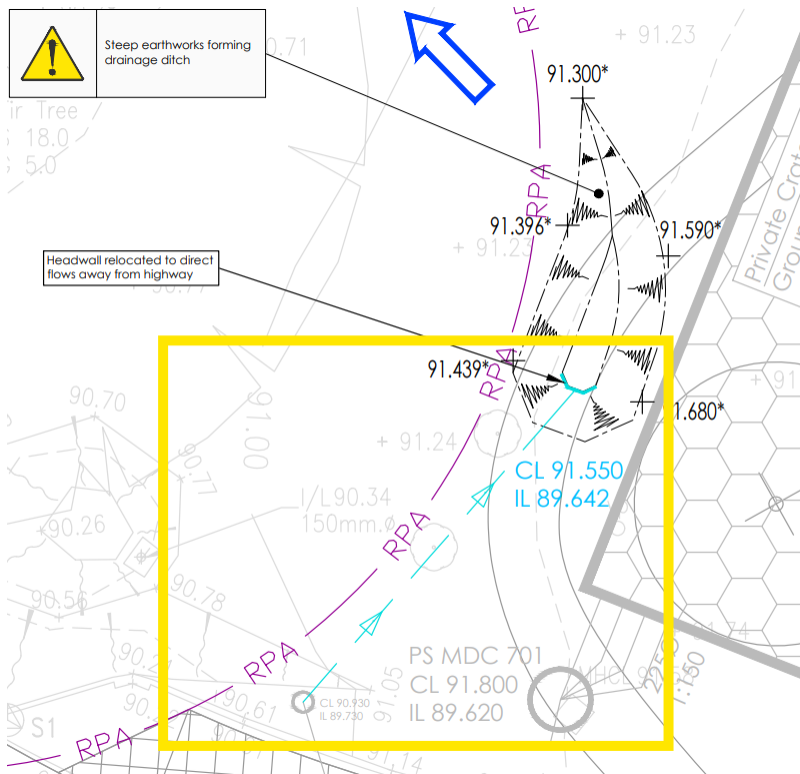
Image: Extract 1 - extract of Headwall Relocation Plan 0654-SK-301-B dated 12-08-24

7. There has been no reason given why the land-drain and the headwall for the overflow were moved from the approved position. Although it is now proposed to move the headwall and overflow to higher up in the open space, and construct a new earthwork, will water flow uphill from the land drain's current position (shown in the yellow box in the image 'Extract 1' below)?

9. The ground in the area around the public art bench, and the new earthwork detailed in the Headwall Relocation note and plan, is heavy clay and quickly becomes waterlogged after even short periods of heavy rain. Is this really suitable ground conditions for natural infiltration?

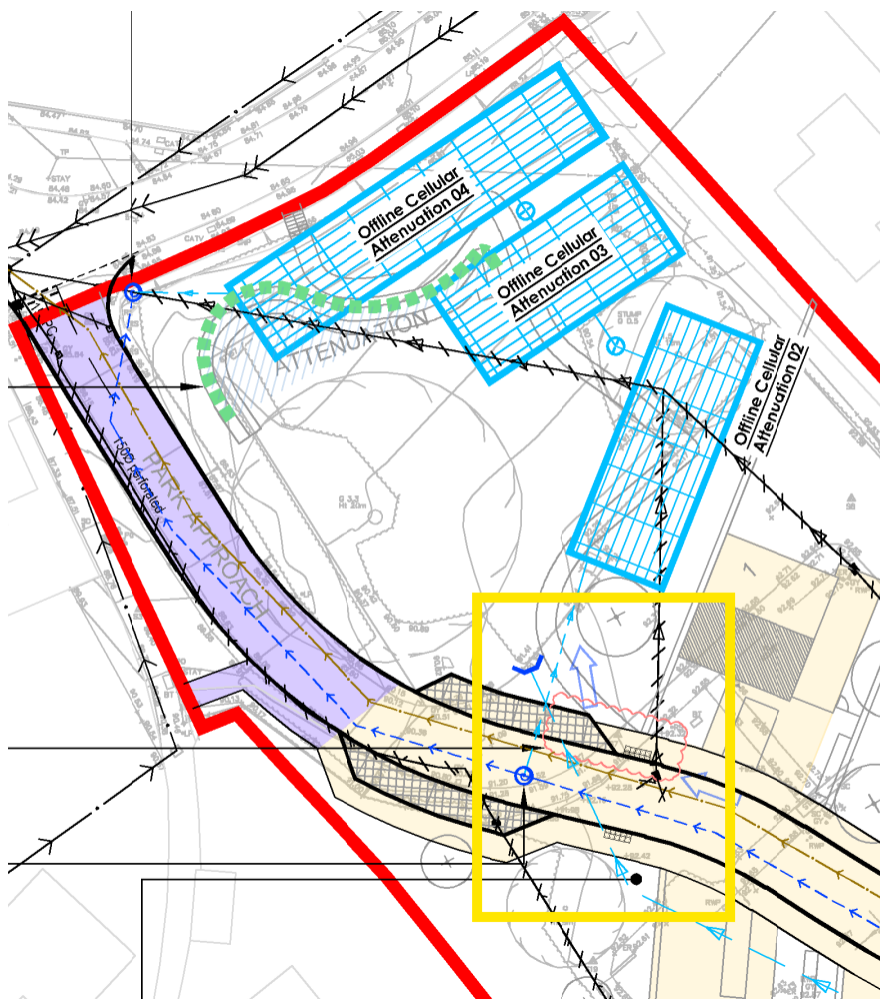
*Image: Extract 2 -extract of approved plan Preliminary Drainage Layout plan reference 0654-PDL-101-D dated 07-02-18, taken from approved Drainage Technical Note 0654 version D dated 07-02-18.*

10. As the applicant has to re-build the headwall for the overflow, why are they not implementing the original approved scheme, by re-locating the land drain and headwall to the already approved positions (shown in the yellow box in the image 'Extract 2' below)? We assume this would also remove the need for new earthwork detailed in the Headwall Relocation note and plan.

11. The bunding at the site entrance, shown as green dotted lines on the image 'Extract 2' above, has not been built. Without this, the overflow from the land-drain will just run off the bank and onto highway at the Butts and then into the highway drains, albeit at a different point to currently.

13. There has been no reason given why the "combined kerb and drainage system" that is intended to "take exceedance flows off the carriageway and into the open space in the north-west corner of the site" were moved from the approved position (shown within a red cloud-like outline in Extract 2 above) to the bottom of the visitor parking bay (shown within a pink cloud-like outline in the image 'Extract 3' below). Unless water flows uphill, this could never work. However, as the kerbs in the visitor bay look just like normal kerbs, has this even been built?
