## HERITAGE STATEMENT

**REPAIRS TO BARN AND CHANGE OF ROOF MATERIAL**

**LOWER BRIDMORE FARM, BERWICK ST JOHN, SP7 0HG**

**June 2025**

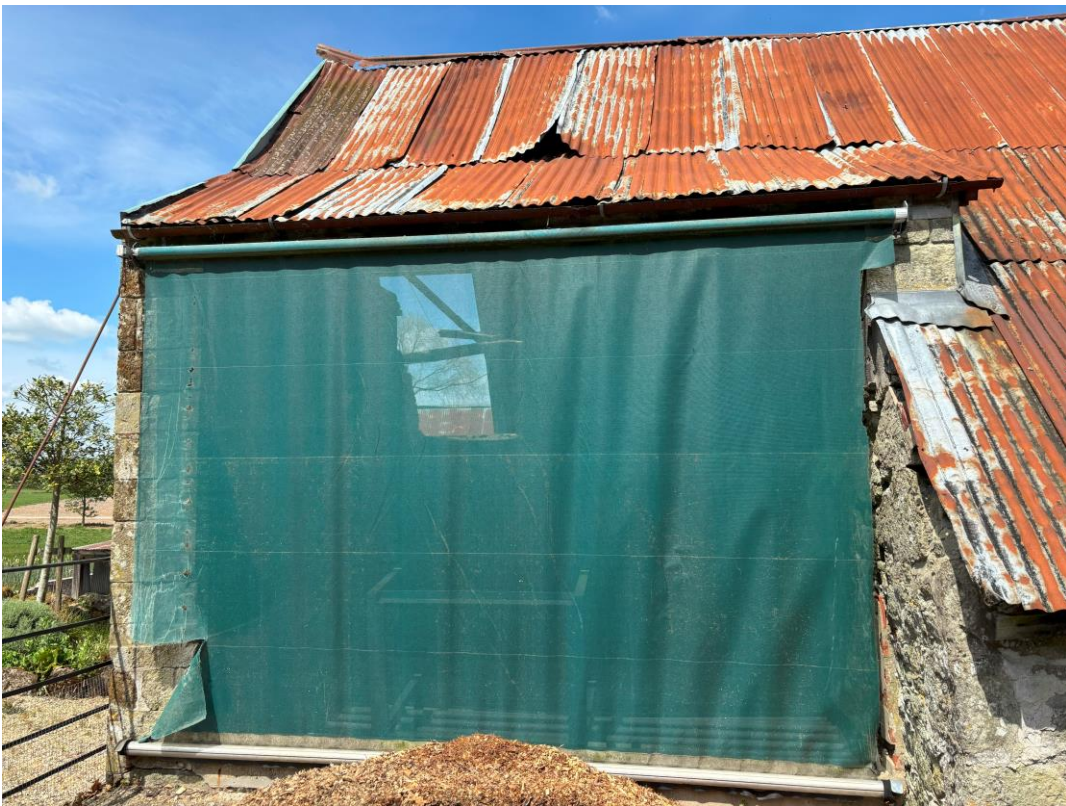
*Large opening on the south side of the western room*

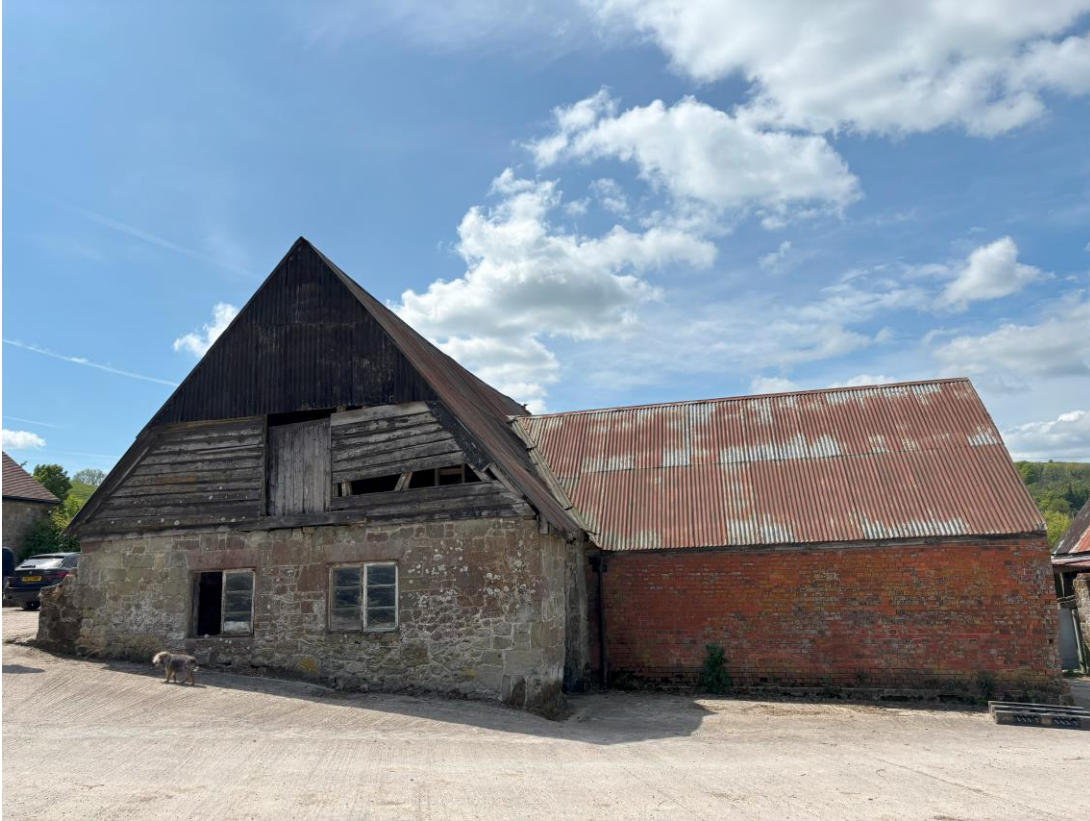
*East side of Barn 3*

- 2.7 Apart from the outer stone and brick walls, little historic fabric of the barn has survived. While the openings in the east gable are probably original (as evidenced by the large stone lintels) the windows themselves are mid-20<sup>th</sup> century Crittal replacements. The high-level multi-pane timber window in the north range could be original although is in poor condition.

- N elevation – replace the existing high-level timber window with a new one to match, install new timber plank double-doors and a new half-glazed timber door
- E elevation – replace the 2 No. Crittal windows with 2-light timber casements having central glazing bars and replace the loft door with a plank door to match
- S elevation – install oak plank double-doors in the large opening
- W elevation – reopen blocked opening at high level and install plank double-doors and replace timber casement window with one to match
