Baldham House, Seend, Melksham, SN12 6PW

## INTRODUCTION

Various minor applications have been submitted in previous years, however the main roof is now in need of urgent repairs, and this listed building application seeks permission to use reproduction stone roof slates in part to make up the short fall supply of reclaimed natural stone.

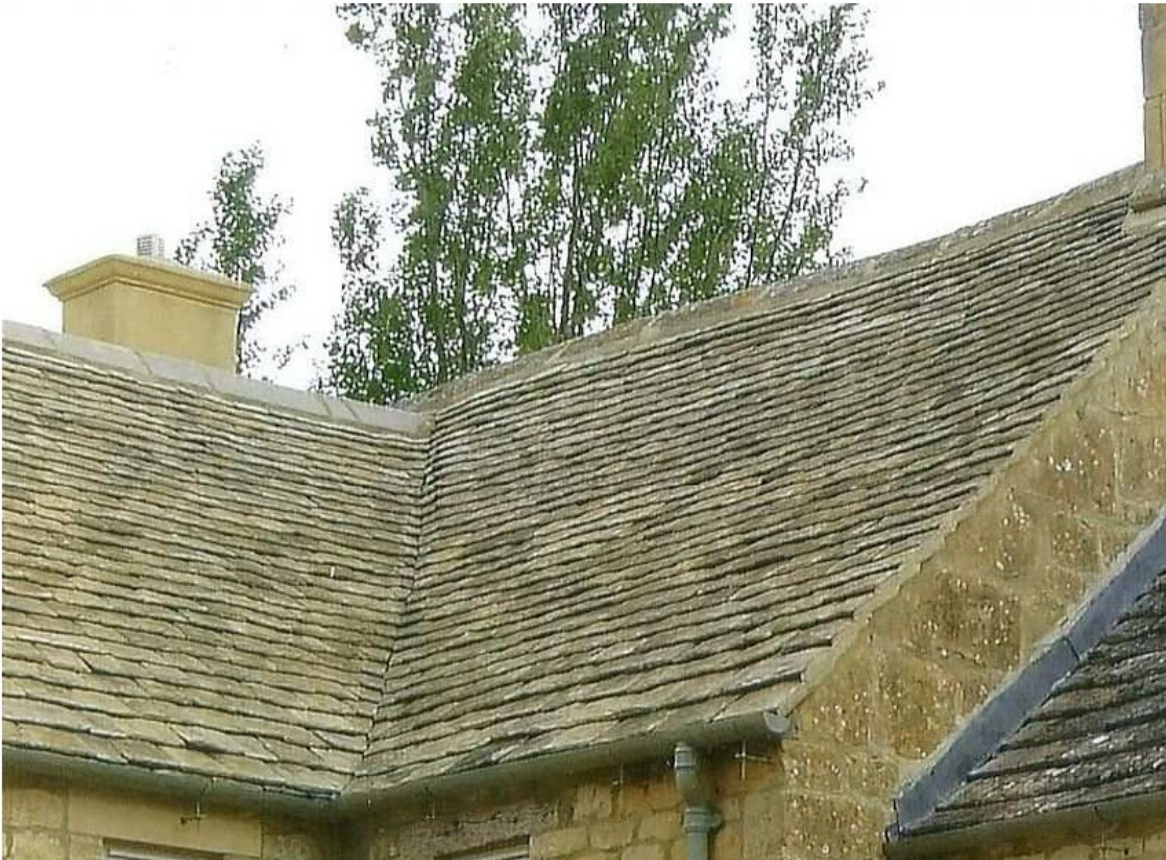
Examples of Listed Building projects where Cardinal slates have been used successfully.

Examples of reproduction stone slates are available from various suppliers and have been used successfully in AONB's, Conservation areas and on Listed Dwellings. Cardinal Slates are one example where reproduction slates have been used successfully on Listed Building and examples are listed below.
