**Fives Court, Mere**

## **Sustainable Drainage Strategy and Flood Risk Statement**

Client: Wiltshire Council

Project No: SKEL\_0374

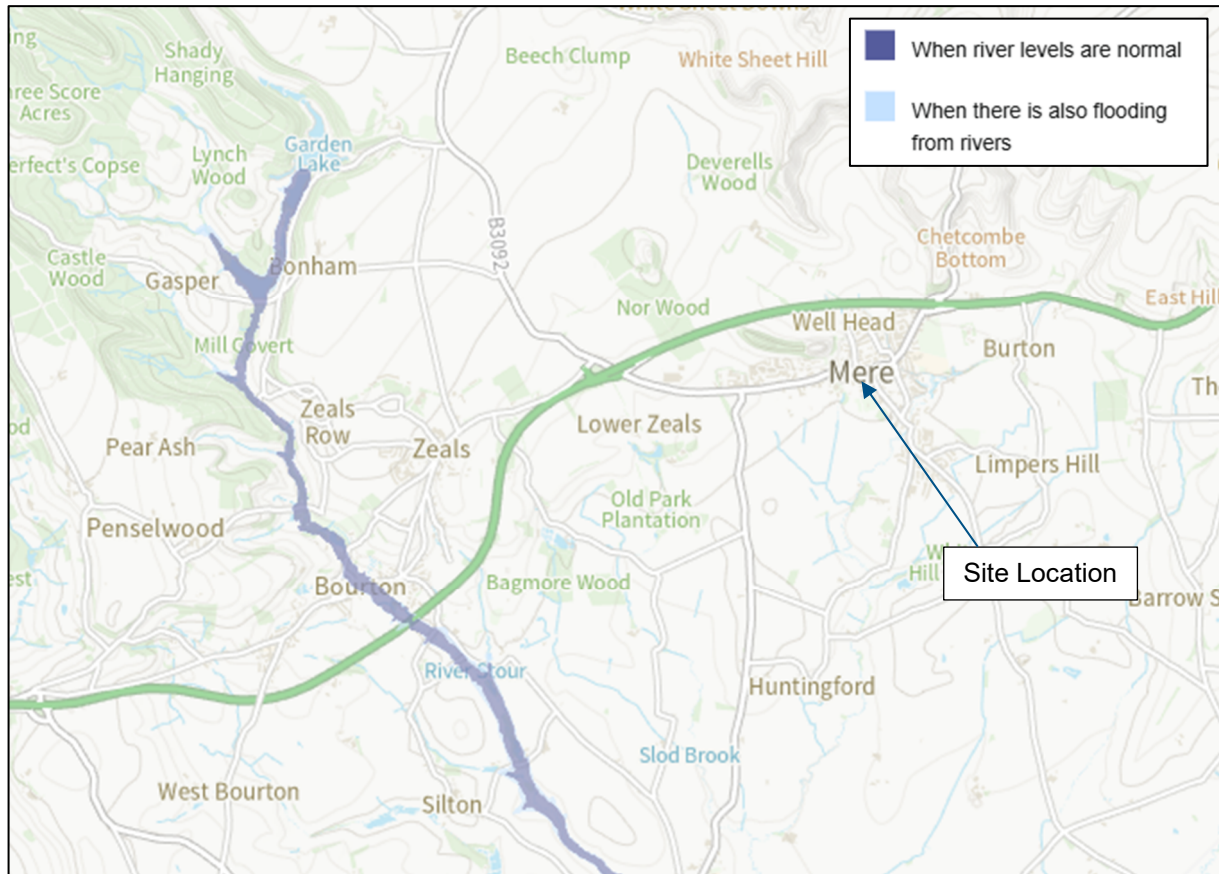
Figure 6 - Reservoir Flood Risk

According to the UK Government's 'Check Your Long Term Flood Risk' online tool, flooding from reservoirs is unlikely in this location, both when river levels are normal and when there is also flooding from rivers.

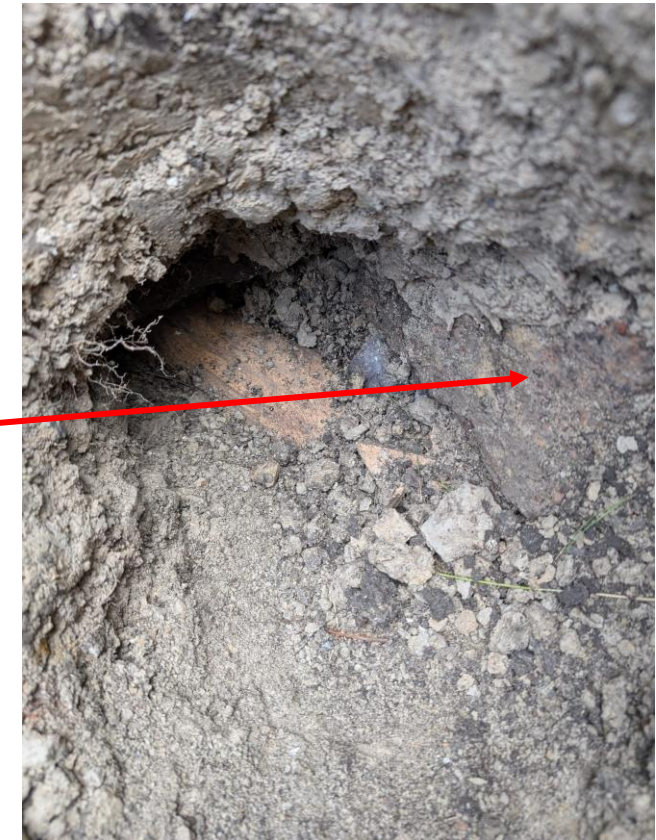
## SK2 - Five Courts, Mere – Plan View

Pipe exposed at 1.10m bgl and found to be cracked and 'crushed' by overlying bricks and rubble. GPR did not find any evidence of the assumed soakaway

End of trace and where pipe was exposed and found broken. Location of SK2 not found with GPR and assumed beyond depth of hand digging tools

Cracked and 'crushed' stormwater pipe running north west to south east at 1.10m bgl. Could not trace further SE due to depth beyond reach of hand digging tools

Overlying rubble appears to have cracked/crushed storm pipe

SK2, which is currently a crushed stormwater pipe discharging into soil below soft landscaping, shall be replaced with a small crate soakaway.

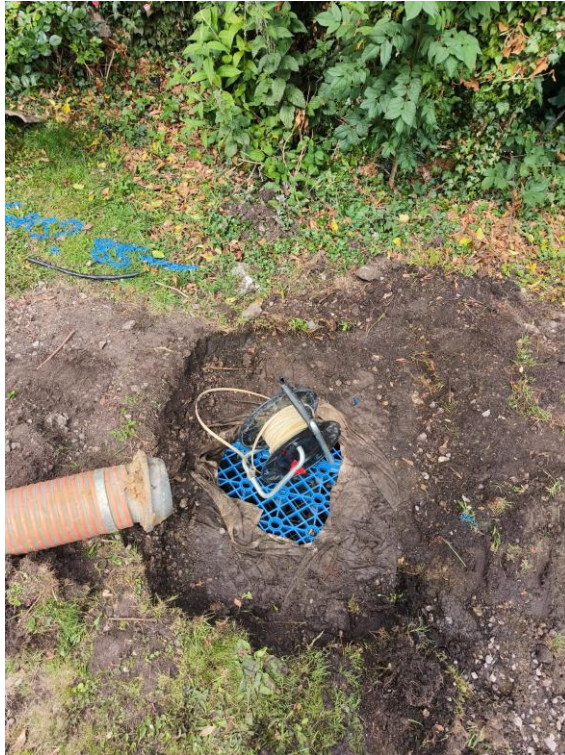
## SK4 - Five Courts, Mere – Plan View

Accurate location of soakaway. Soakaway comprised blue crates measuring 1.00m long, 0.80m wide and 1.00m deep.

SK4 (plastic crate soakaway) shall be abandoned and replaced with a small crate soakaway within the access road as shown in the drainage strategy plan. The new location ensures the soakaway is at least 2.5m away from the site boundary and 5m away from buildings, as required for point soakaways in Part H of the Building Regulations. This new soakaway shall sit directly below the permeable paving, ensuring silt is not able to enter the crate system. The depth of this soakaway shall exceed the depth of the existing SK4.

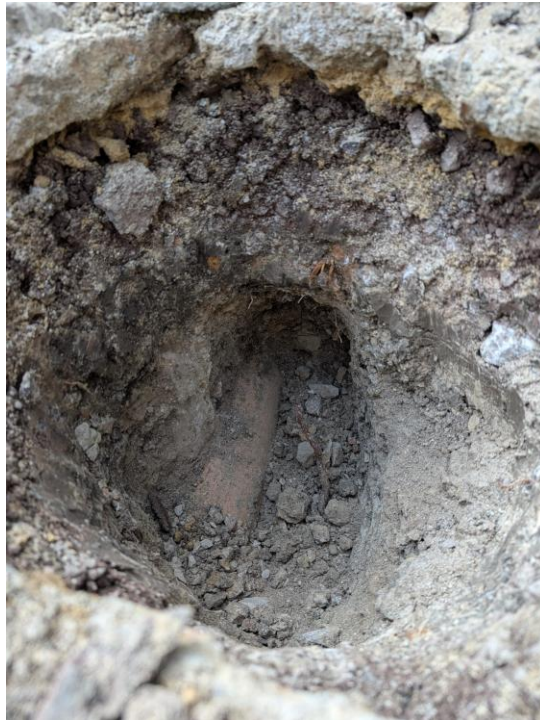
## SK6 - Five Courts, Mere – Plan View

Pipe traced and exposed at 0.65m bgl. GPR did not find any evidence of soakaway pit location nearby

End of trace and where pipe was exposed. Assumed blocked. GPR did not find any evidence of soakaway location in the nearby vicinity.

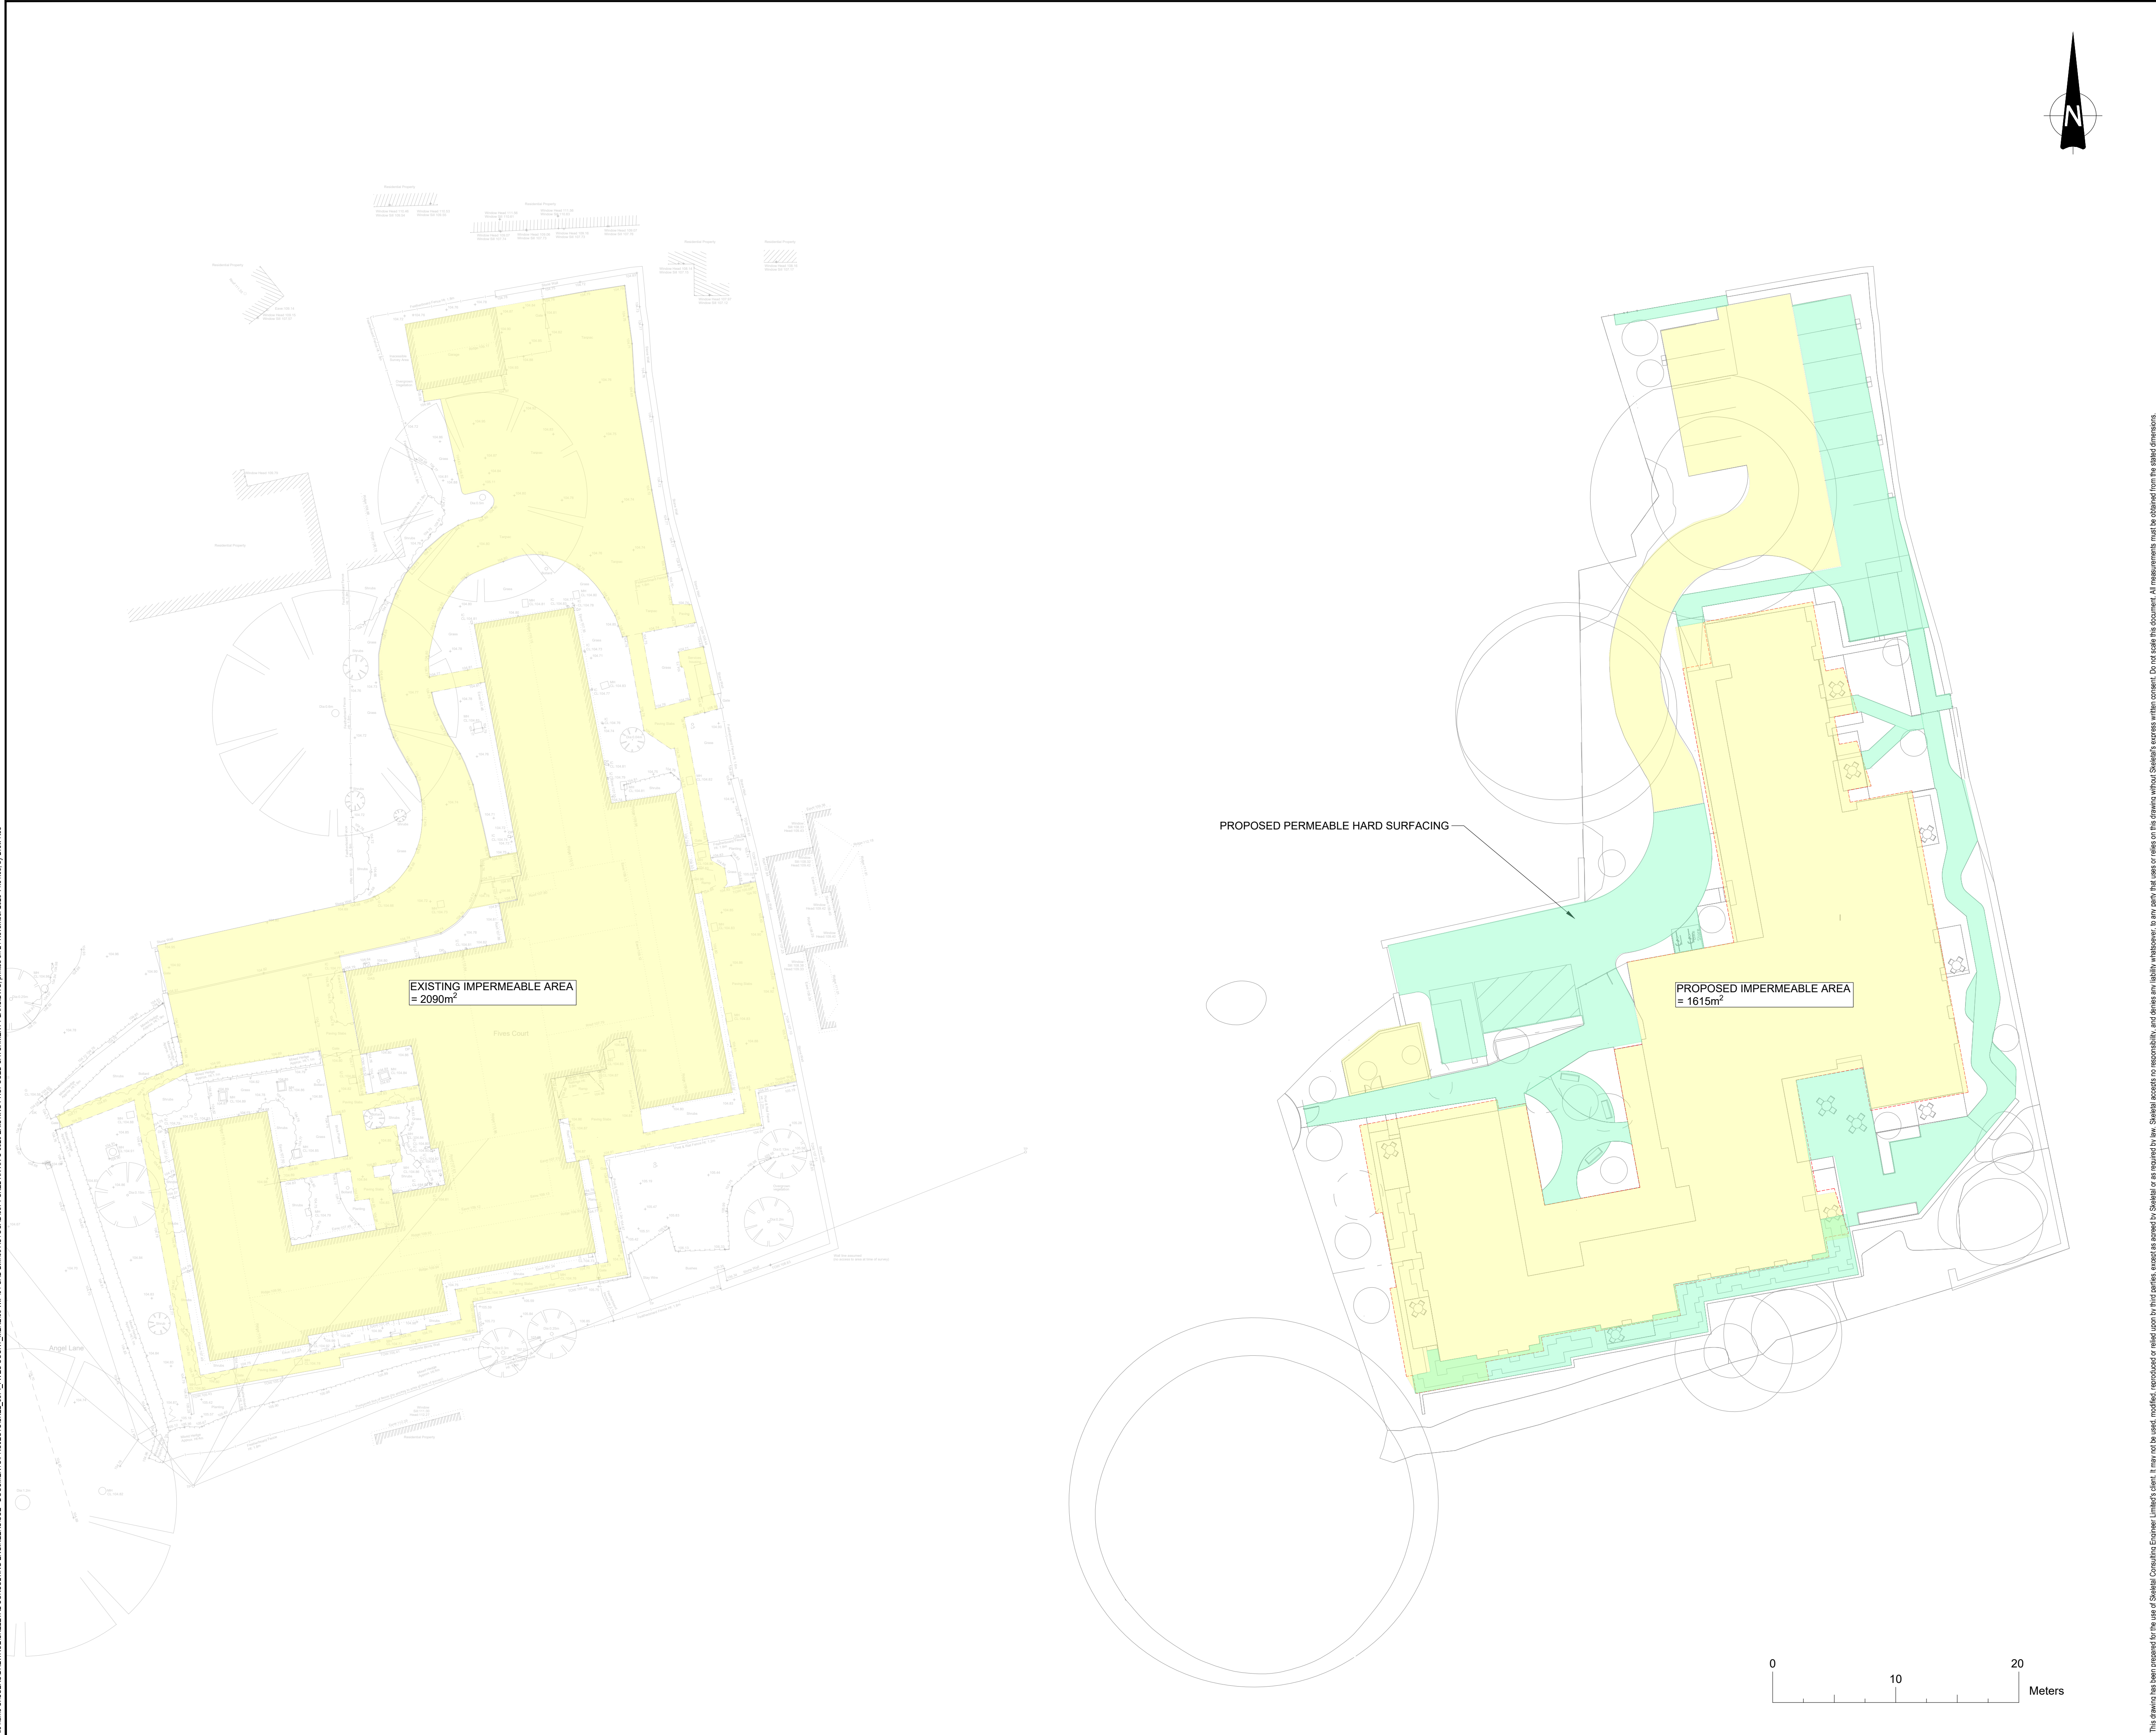
| DRAWING NUMBER: 0374-SKEL-XX-XX-C-5926 | REV: P03 |

File name: C:\Users\DW\OneDrive\SKELETAL CONSULTING\ENGINEERS\SE - DOCUMENTS\PROJECTS\SKEL\_0374\_FIVES COURT\_MERE\0374 CAD BIM\03 AUTO\03\0374 SKEL-XX-XX-C-5926 EXISTING PROPOSED CATCHMENT PLANS.DWG, printed on 24 November 2025 14:53:03 by Drew Roe

## **Appendix D – Drainage Strategy and Catchment Plans**
