**DESIGN, HERITAGE AND ACCESS STATEMENT**

**REPLACEMENT EXTERNAL RENDER**

**15 HIGH STREET, LACOCK, CHIPPENHAM, WILTSHIRE, SN15 2LQ**

**Ref: 4460.STAT**

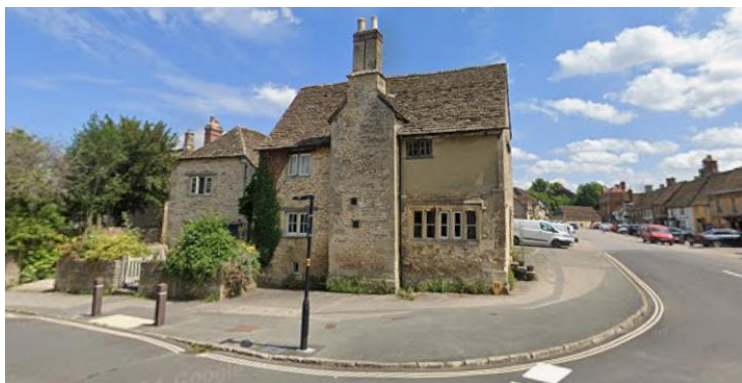
*West Elevation of 15 High Street -  
Image from Google Street View  
<https://www.google.com/maps/place/High+St,+Lacock,+Chippenham+SN15+2LQ/@51.4147709,-1.1231819>*

The area of proposed works is the First Floor rendered timber frame section on the West Elevation. The render is in a state of disrepair and has potentially caused damage to the historic timber frame behind.

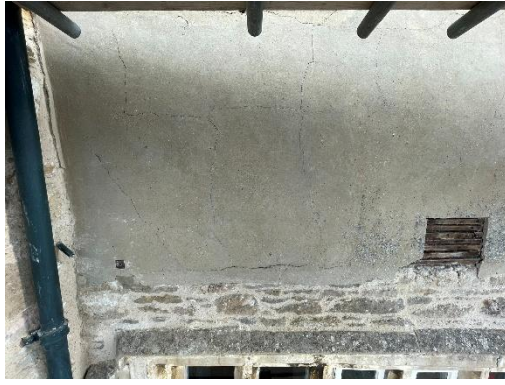
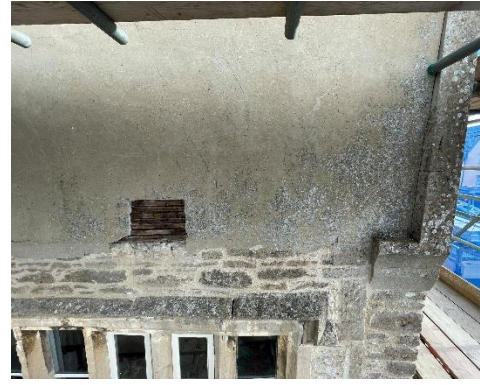
*Close up images of Render(taken from scaffold erected for pointing repairs to stonework) - Image by Dolman*

The render and the lathes have previously been replaced with sand and cement render and contemporary machined lathes (presumably in the mid-late 20<sup>th</sup> Century), this render is cracking in numerous locations. The wall would have originally been rendered with a lime-based render, allowing the wall to 'breathe' and any moisture within the building or the wall would be able to escape the wall externally. Due to the current cementitious render, the wall is retaining moisture and the lathes and timber frame behind are damp which gives cause that the historic timber frame will decay.

The existing sand and cement render is defective, with cracks to multiple locations of the rendered portion of the wall. More significantly it is reasonably believed to be causing damage to the historic fabric behind, due to the render retaining moisture within the wall.
