Our Ref: 18067/EO/RPT/04/01  
Date: July 2025

**Re: 18067 – Old Manor Farm, Wedhampton, SN10 3RR – Barn 4**

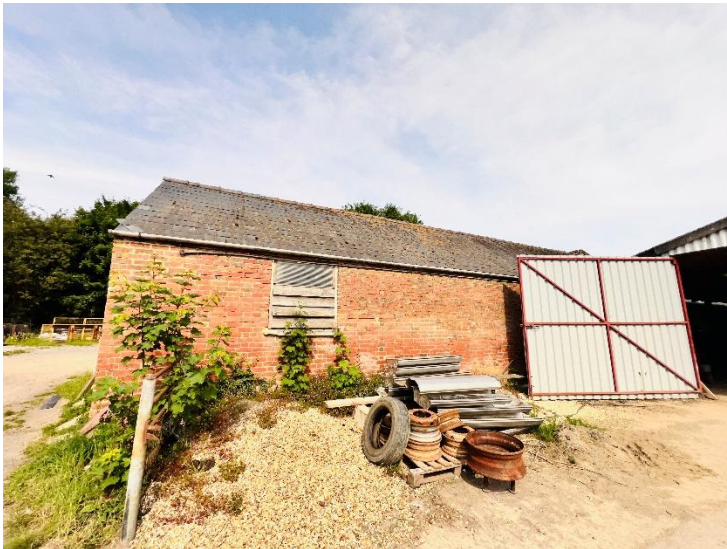
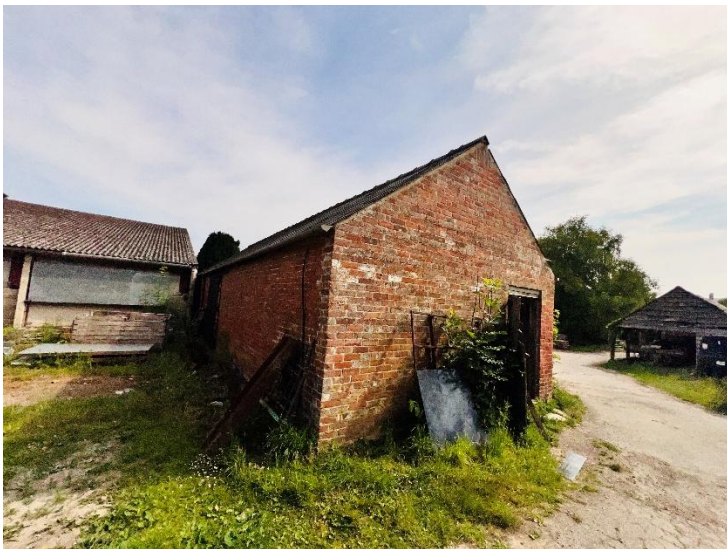
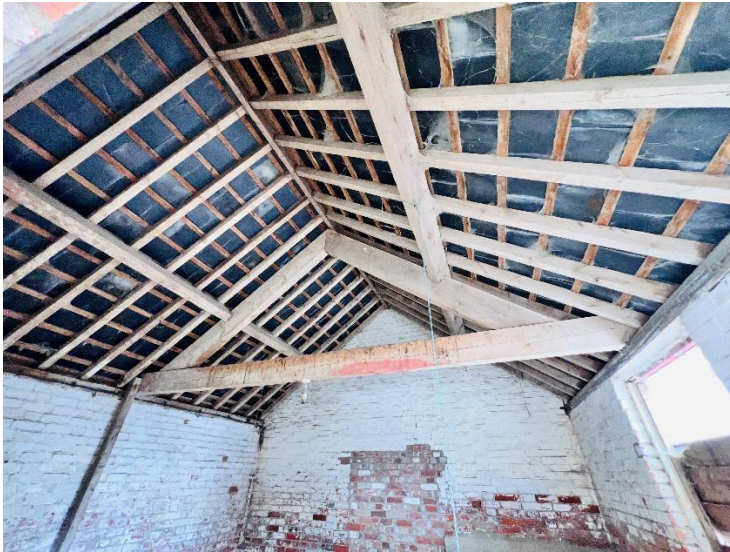
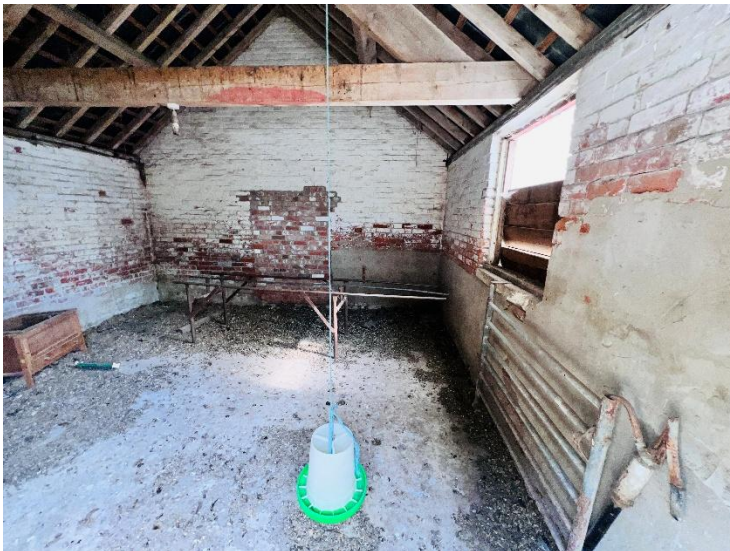
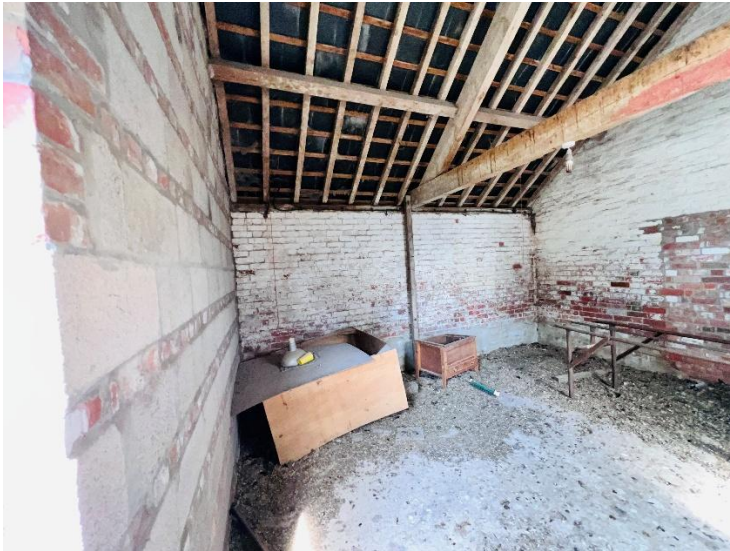
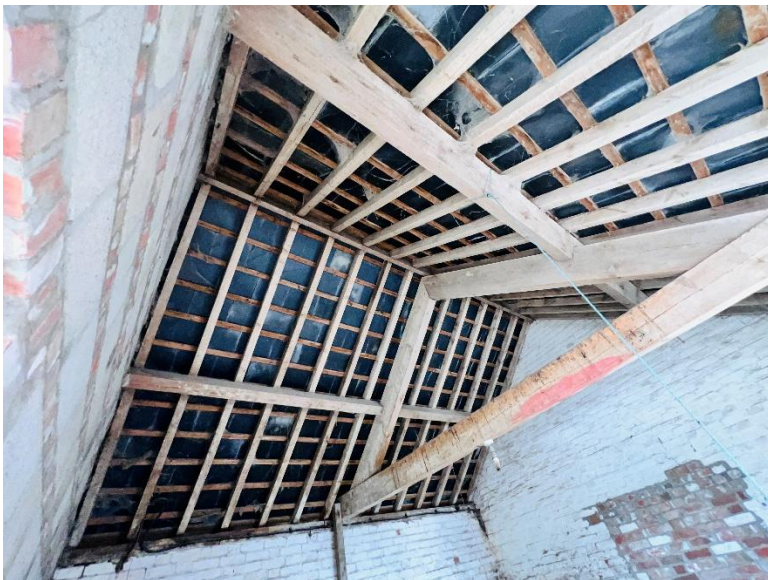
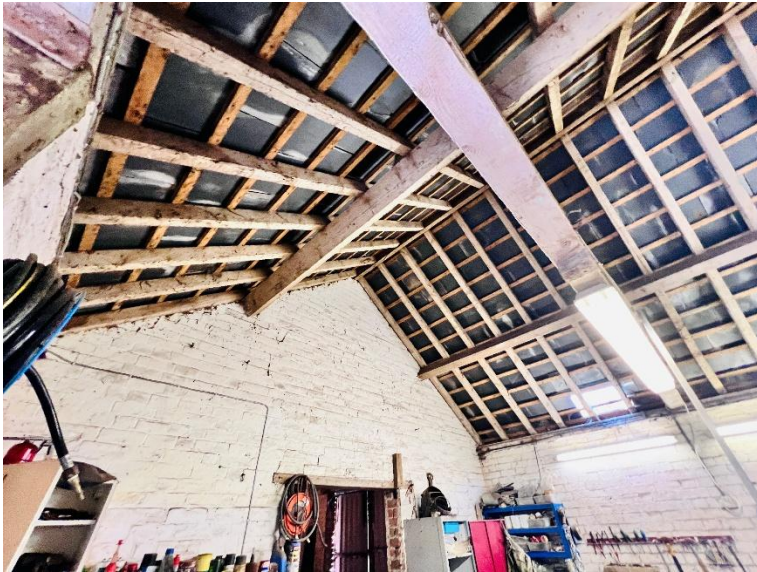
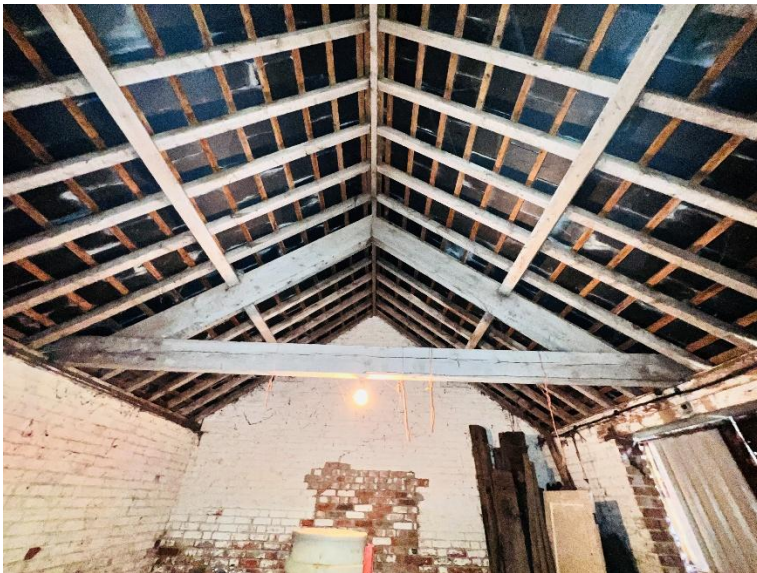
The existing building structure is an agricultural barn consisting of a duo-pitched roof, supported on masonry load-bearing walls, with a concrete floor slab at the ground level. The roof is formed using common rafters on each pitch, spanning between the eaves level and the ridge point, and is supported by intermediate steel purlins on each roof slope. The purlins are of solid timber sections spanning between the gable end walls of the barn. The walls (flank and gable) are of solid brickwork construction. The ground floor is a concrete ground-bearing slab, which appears to be of adequate construction to sustain the loadings associated with heavy-duty agricultural loadings.

*There were no structural defects that could be seen during the structural inspection, and it is therefore our professional opinion that the existing building is in good condition and requires no structural remedial work for the purposes of accommodating a residential dwelling within the existing building envelope.*
