# STAGE 1 PRELIMINARY UXO RISK ASSESSMENT

**Client:** WSP  
**Project:** Bulford Camp, Salisbury  
**Date:** 29/09/2025

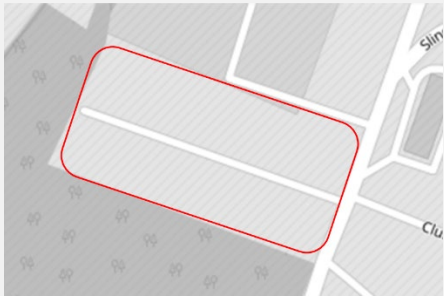
| <b>National Grid Ref:</b> SU 18885 44410 | <b>What3Words:</b> atlas.tilting.rant | |
| <b>Location:</b> Situated in Bulford, within the county of Wiltshire, within the confines of Bulford Camp. | | |
| <b>Site Composition:</b> Recent satellite imagery indicates Site predominantly comprises undeveloped land. Hardstanding accessway intersects central extent. Vegetation present sporadically. | | |
| <b>Surroundings:</b> Bound to the north by residential properties on an unnamed accessway, to the east by Sling Road and to the south and west by mature vegetation. | | |
