**Design & Access Statement**

**Listed Building Consent Application**

**Roof Structure & Associated Repairs**

**The Old Rectory, Church Lane, Wingfield, Wiltshire, BA14 9LW**

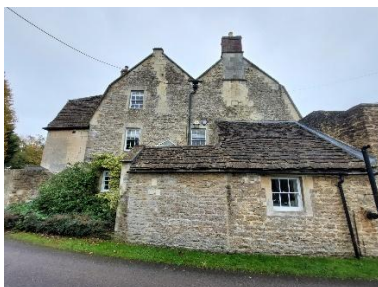
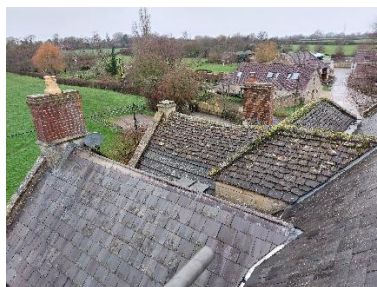
The work includes the essential structural repair of the gabled roofs set to the north west road side elevation, which are subject to structural movement (Mann Willams report dated 19 3 25) resulting in significant cracking and damage to internal ceiling and wall finishes beneath the roof structure.

*The timber members in both roof spaces appear overall in reasonable condition (as far as the limited access enabled to view). However, slippage/shrinkage of timber members from their wall pockets has resulted in notable deformations. Isolated areas of water ingress are also suspected. The timber beam over the headboard of NW bedroom, despite not showing recent signs of distress, would be prudent to be provided with a holding repair. Inaccessible roof spaces associated with the inspected sections of roof should also be reviewed and repair requirements considered as part of this exercise.*

The current gabled roof structure(s) over the north west road side are subject to some structural movement (Mann Williams report). The sympathetic repair of the existing roof structure in accordance with Mann Williams repair details will support the old and ailing roof structure, with minimal harm and intervention to the existing old roof timbers.
