## DESIGN AND ACCESS STATEMENT

### REPLACEMENT ROOF COVERING AND STRUCTURAL REMEDIAL WORKS TO THE ORANGERY AT GRITTLETON HOUSE

**Proposals:** Listed Building Consent for replacement roof covering and structural remedial works

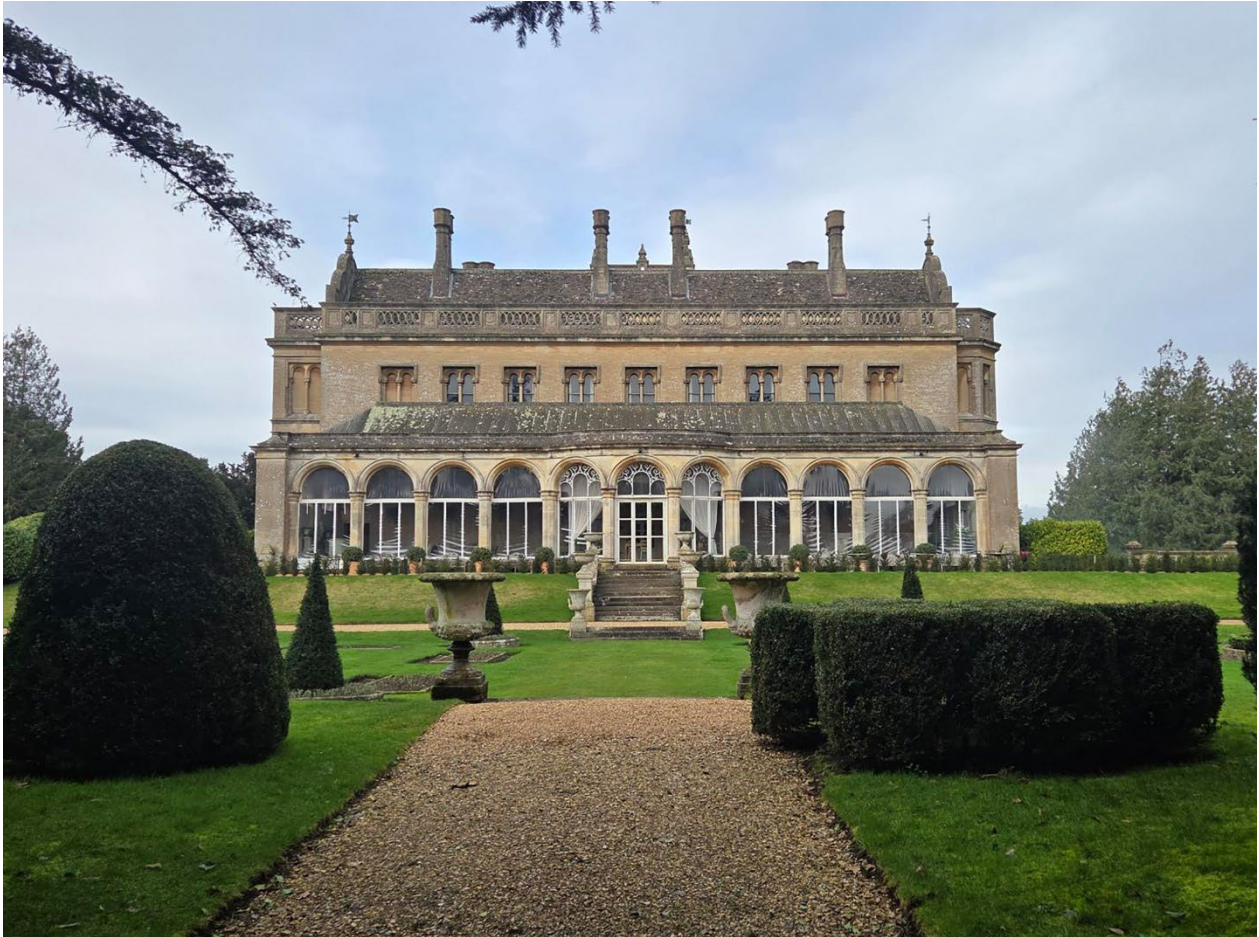
*The Orangery at Grittleton House*

- Hipped roof profile
- Corrugated fibreglass roof covering (opaque, weathered, lichen-covered, visually tired and deteriorated)
- Masonry columns and arched features visible on south, east, and west elevations
- Integration with the main house's south elevation
