## The Old Rectory, SN14 6HN

Heritage Design and Access Statement

February 2026

## 1 Introduction

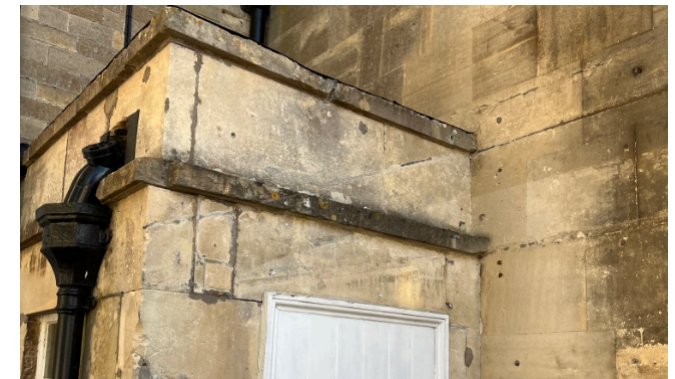
Fig 2. Single storey rear addition with historic evidence of lean-to structure.

The 1844 - 1888 map also indicates the addition of the small rear extension that originally provided secondary access into the west extension, rather than into the kitchen as currently used. It is understood that this element was constructed after the 1856 extension as is evident from a visual inspection of the stonework quality, design and coursing. Further inspection indicates a lean-to roof was connected to this access point, providing a simple external shelter (*fig. 2*).

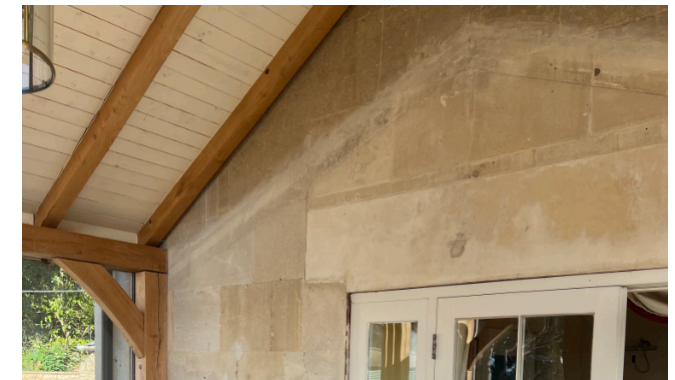
Fig 3. Existing conservatory with historic evidence of pitched roof structure.

The 1898 - 1939 map indicates a further extension was constructed to the west. A visual inspection of this elevation shows historic evidence of a pitched roof structure in this location (*fig. 3*). This extension was replaced at an unknown date with a smaller, modern oak conservatory now situated in this location.

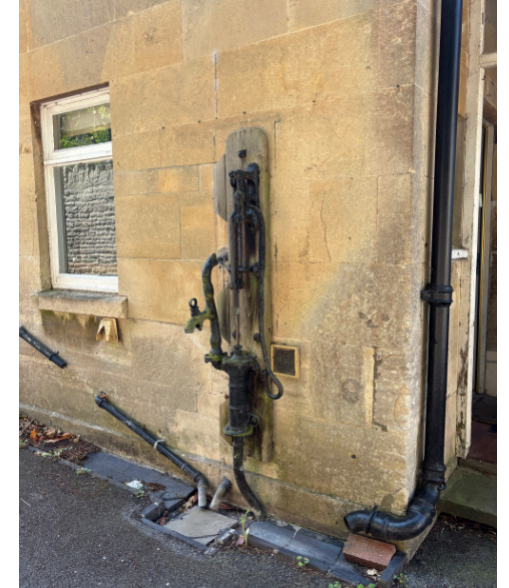
External water pump (north elevation) - to be retained.

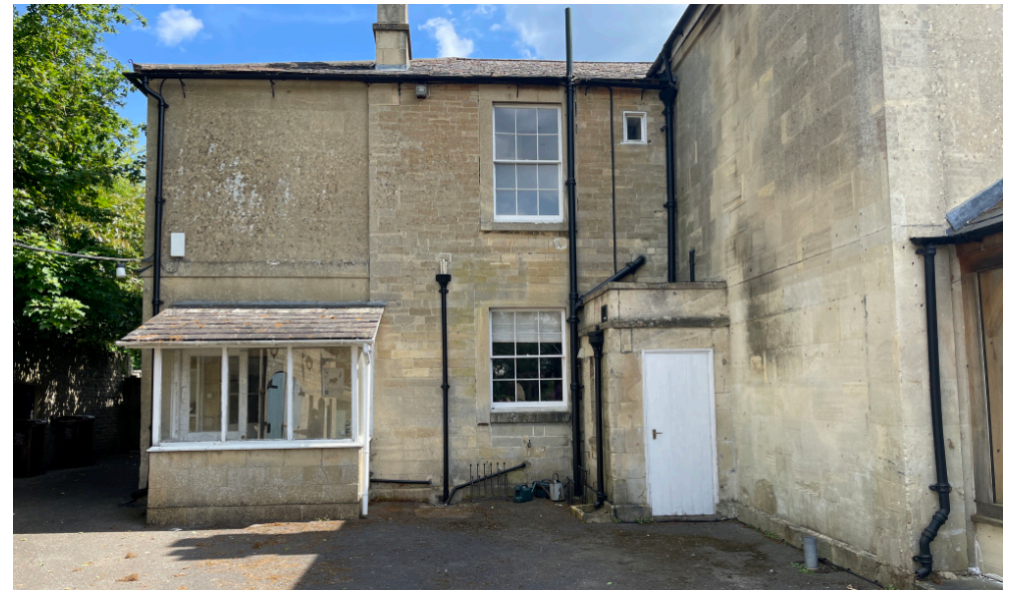
Section of west elevation showing the late C19 addition, early C20 two-storey extension and 1970s lean-to.

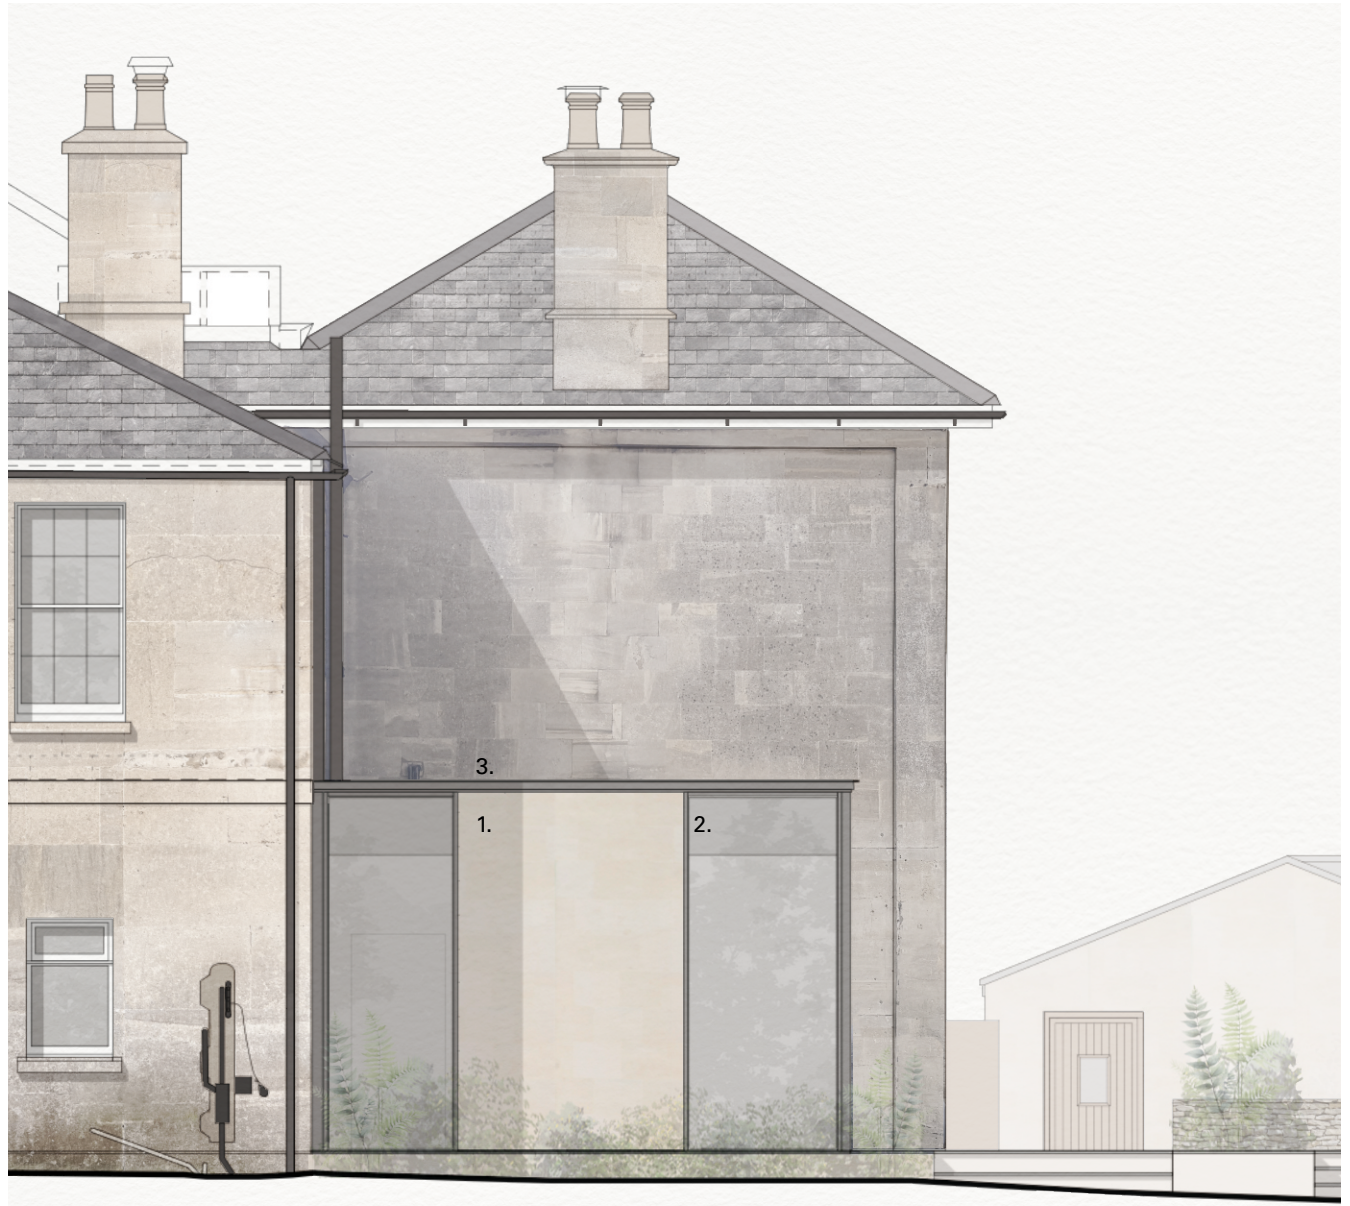
The material palette for the proposed extension has been purposely kept minimal and complementary to the existing dwelling.

1. Ashlar stone is to be used for the solid elements of the extension, matching that of the original house.
2. Metal framed windows and doors will be used to reflect the contemporary nature of the addition and will be of a high thermal standard. The design of the extension utilises glazing at the points where it meets the existing dwelling - a 'light touch' approach, helping to visually separate it from the host structure.
3. Metal coping, colour matched to the metal frames of the windows and doors, will form a thin band to link the wall and glazing elements. The coping has been designed to line through with the existing stone detail to the north elevation.
