# REPAIR METHODOLOGY

at The Weighbridge, Old Road,  
Chippenham SN15 1HW

PROJECT: 4580

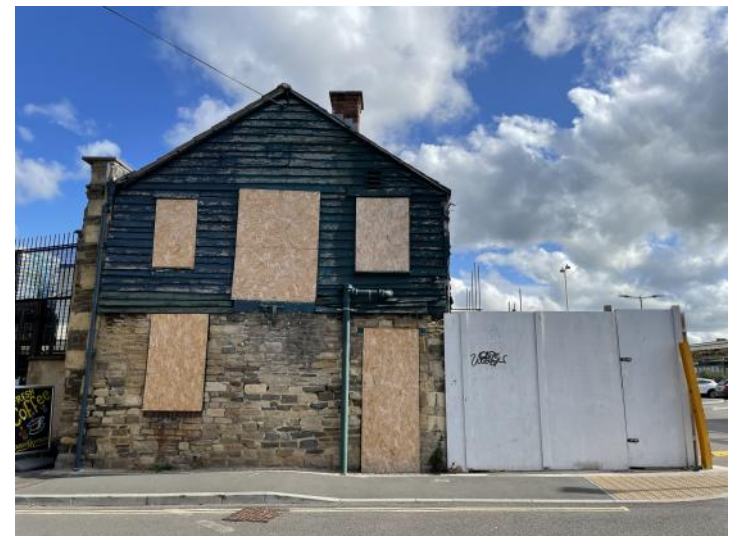
### Removing biological growth:

Biological growth, including moss, algae and lichen growth is to be brushed off from area around downpipes, flaunching, quoins, coping stones, and areas where stonework repairs (both piecing in and plastic mortar) are to be undertaken.

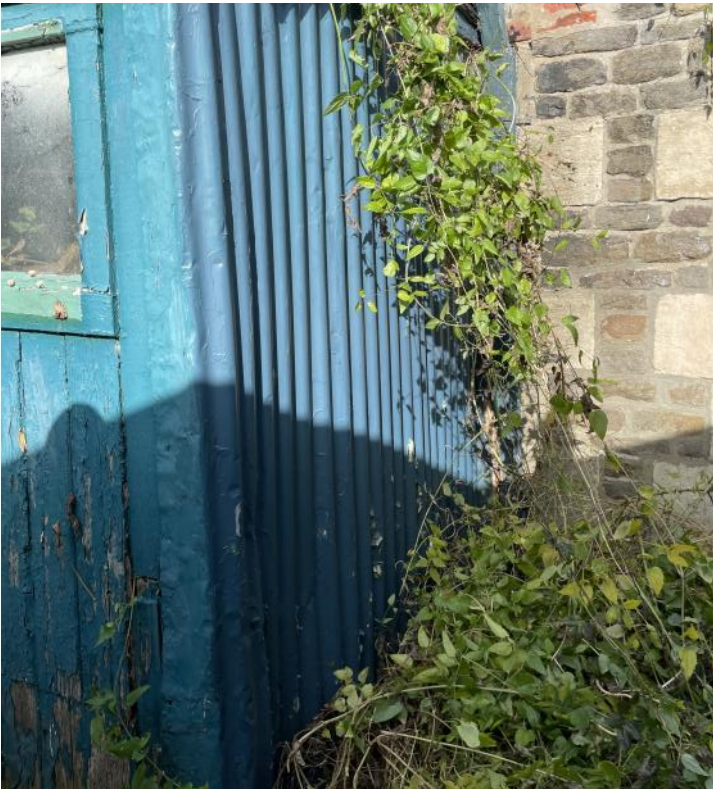
### Plastic mortar repairs:

Where mortar is applied it is to be finely controlled so that it does not smear onto adjacent surfaces. Repairs are to be applied to reflect the shape, form and texture of the stone to which they are applied. Where repairs are applied to mouldings of other vulnerable areas, ceramic reinforcement should be used.

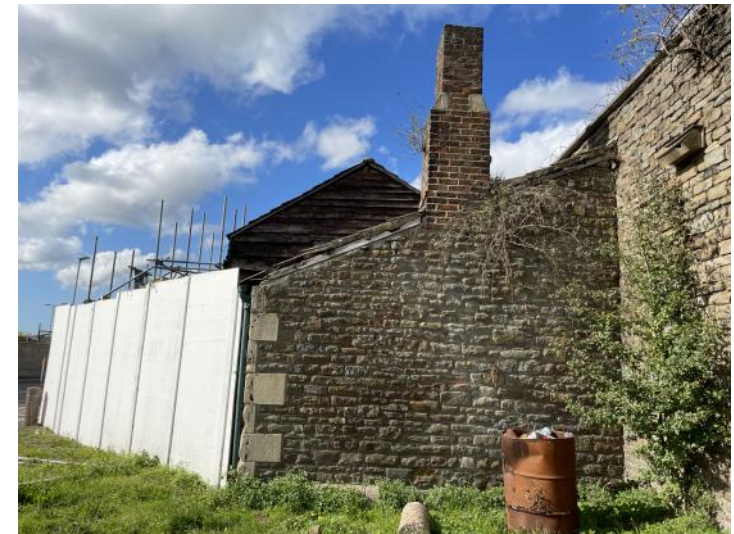
**Repointing:**

Working from the top of the wall downwards, any failed (i.e. cracked or missing) mortar joints are to be raked out to a depth of at least 20mm to give a sufficient key. Chisels, fine blades, hooks or plugging chisels can be used, but on no account shall power tools be used.

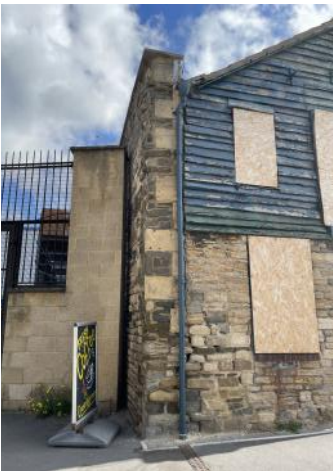
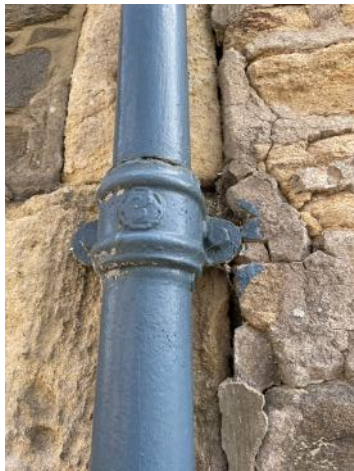
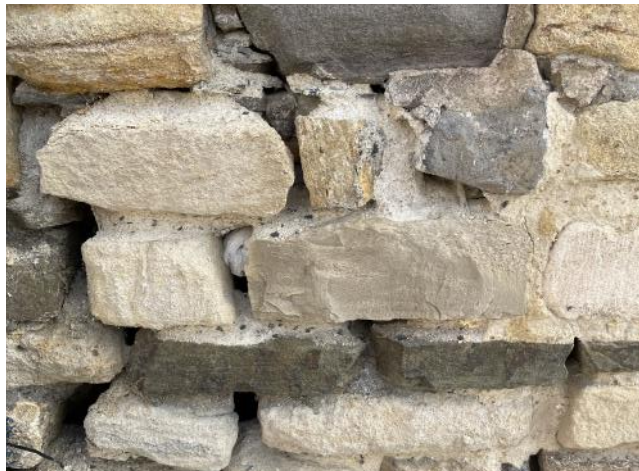
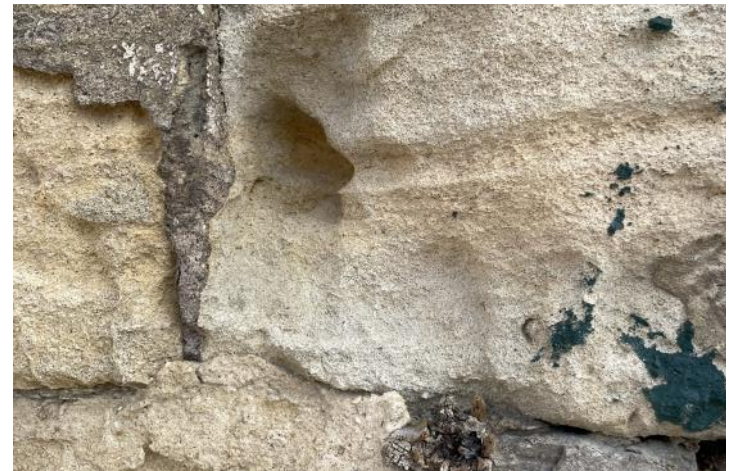
Sections of stone identified for replacement should be cut out and replaced using new stone that is closely matched to the original. Stone should be replaced to a minimum of 150mm or to a full depth if the original stone is thinner. All stone should be fully bedded (i.e. top, bottom, sides and rear face with no voids) with lime mortar to match the existing. Stainless steel fixing dowels can be used where deemed necessary such as with thin sections.

Where new stone is required for projections i.e. cills, the entire decayed length of stone (but not necessarily the whole piece of stone) and its recess into the wall is to be renewed. This is because the stone projects and is prone to decay and weathering; the risk of small stone projections fracturing and falling must be avoided. The new stone is to be cut to the original (and not the eroded) profile of the stone.

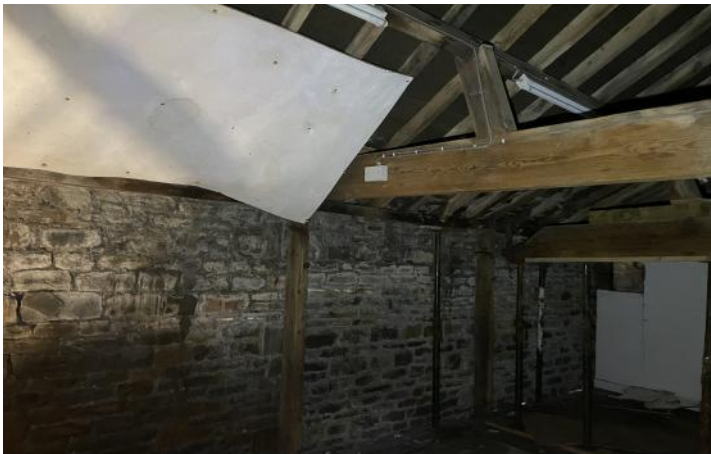
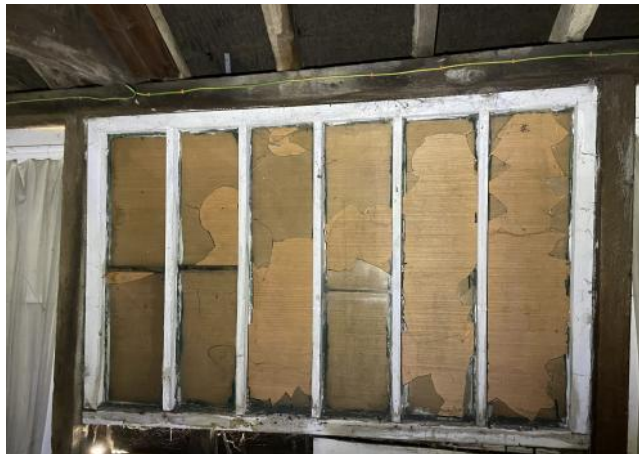
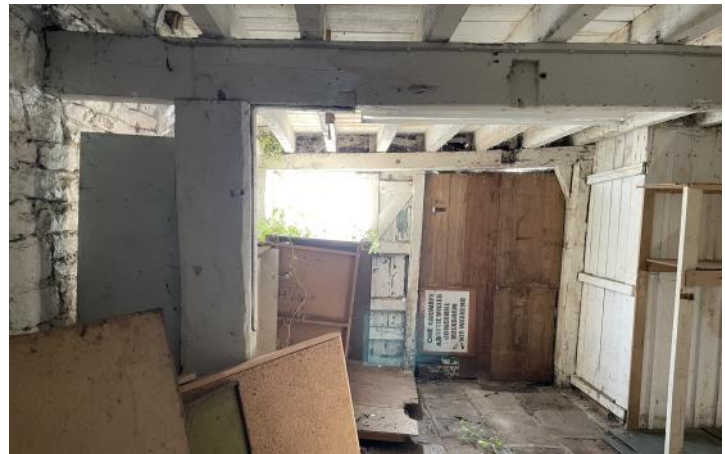
### Timber cladding

All existing decayed timber cladding is proposed to be removed. If the timber battens behind the cladding is also deteriorated this should also be removed or timber cut back 150mm back from any decay. New softwood timber battens should then be spliced in with a minimum 3 times width of the batten. New timber cladding should be installed with the size and lapping to match the original design.

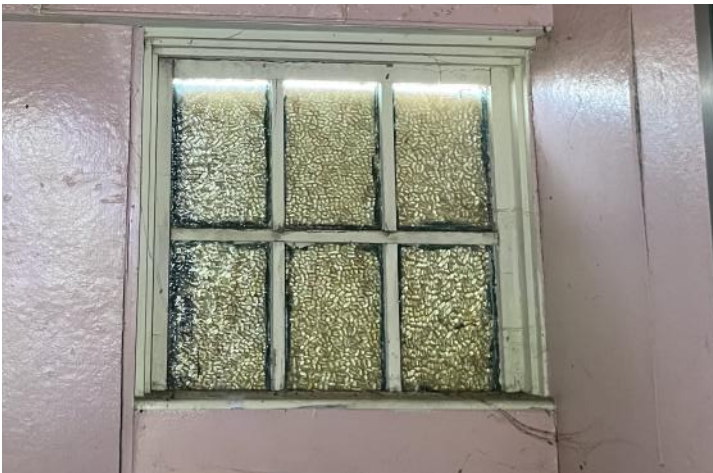
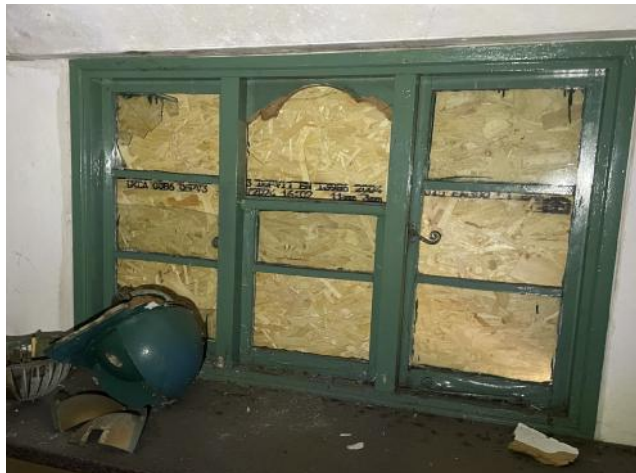
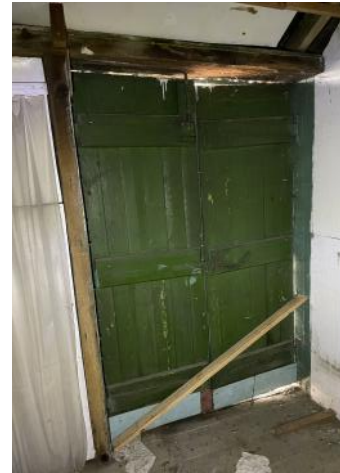
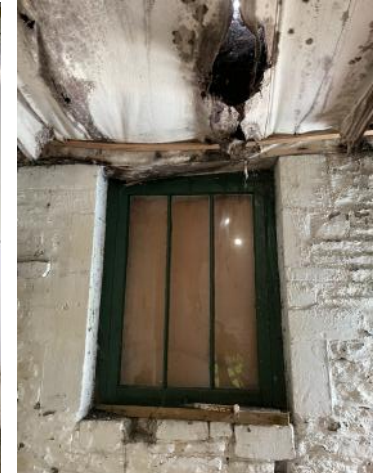
**Slide section:** Wiper brush seals are to be installed and are to be pinned not glued.

**Decoration:** All coatings must be applied to a clean, dry surface. Remove areas of loose paint and any rust, deal with areas of decay as above, do not use heat strippers, lightly sand surfaces, clean areas with sugar soap, leave to fully dry. Apply primer, undercoat and 2 finishing coats all to manufacturers recommendations. Ensure all new putty is fully cured before any decorations.

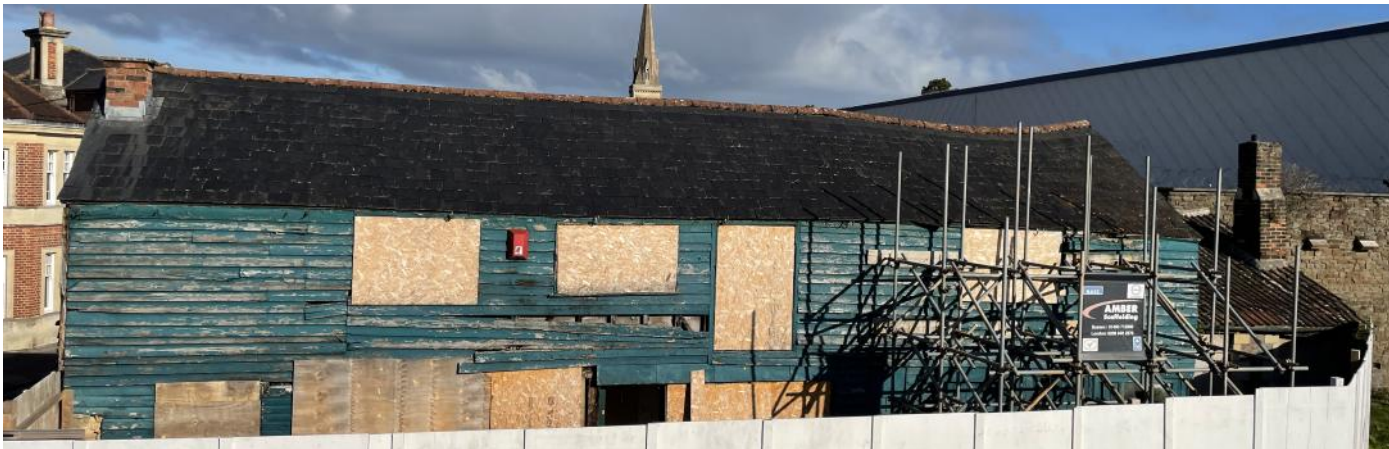
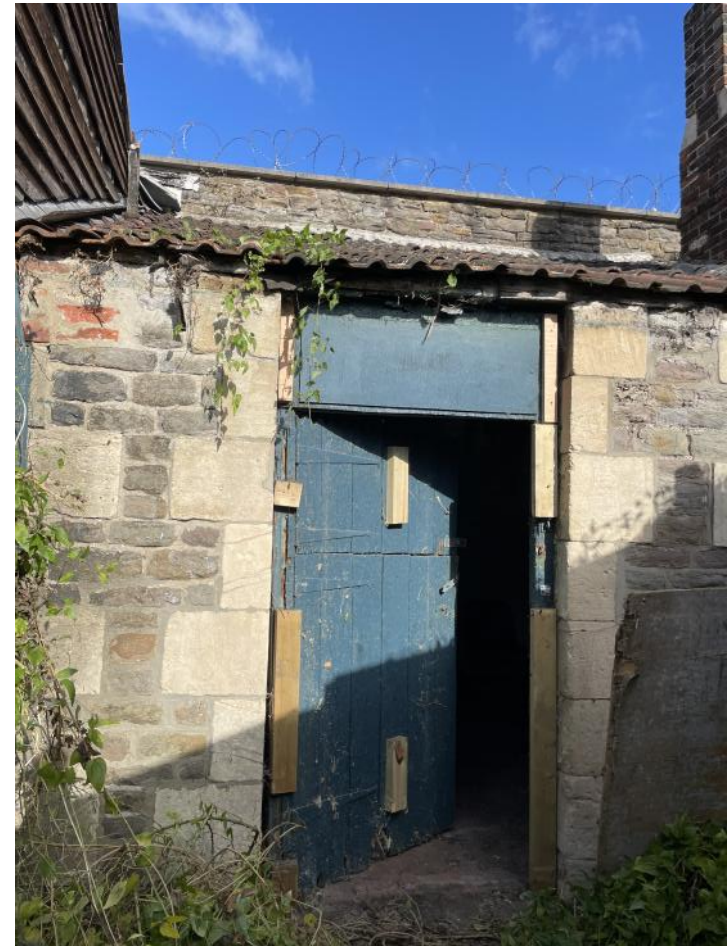
### Ridge tiles:

Stone ridge tiles are to be replaced with new stone ridge and 'back' bedded on a base of lime mortar. No mortar should show along the ridge line.
