# **PLANNING, DESIGN AND ACCESS STATEMENT**

**PROPOSED WORKS TO  
ST PATRICKS GARRISON CHURCH  
1 ST PATRICKS AVENUE  
TIDWORTH  
WILTSHIRE, SP9 7BS**

**MARCH 2026 REF: F1870/ DAS**

**DELLA VALLE ARCHITECTS LTD  
LAKE VIEW, CHARLTON ESTATE  
SHEPTON MALLET  
SOMERSET, BA4 5QE  
01749 330672**

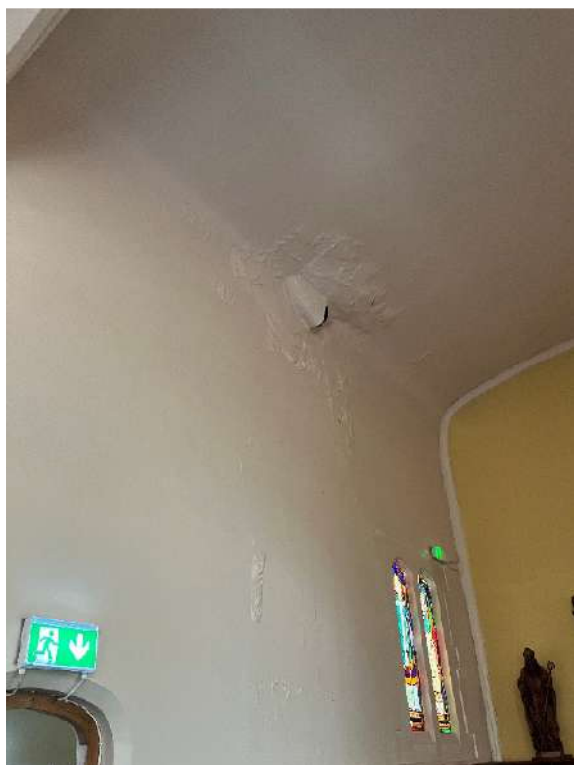
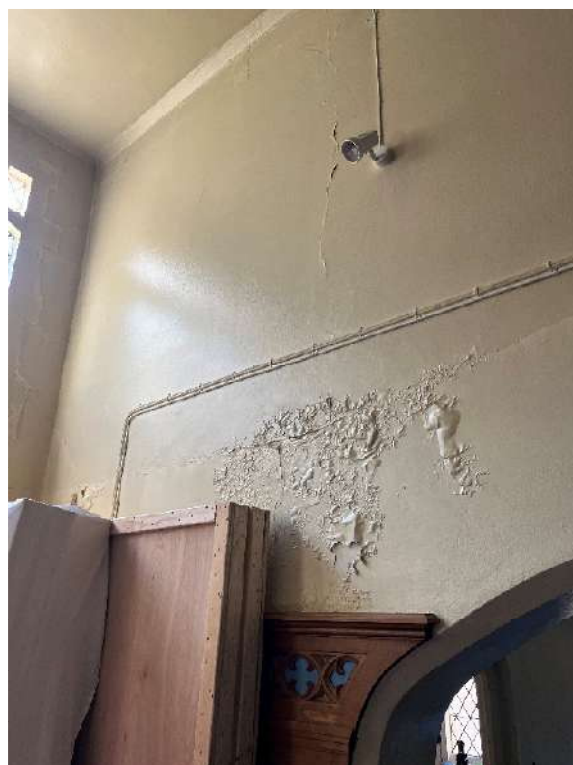
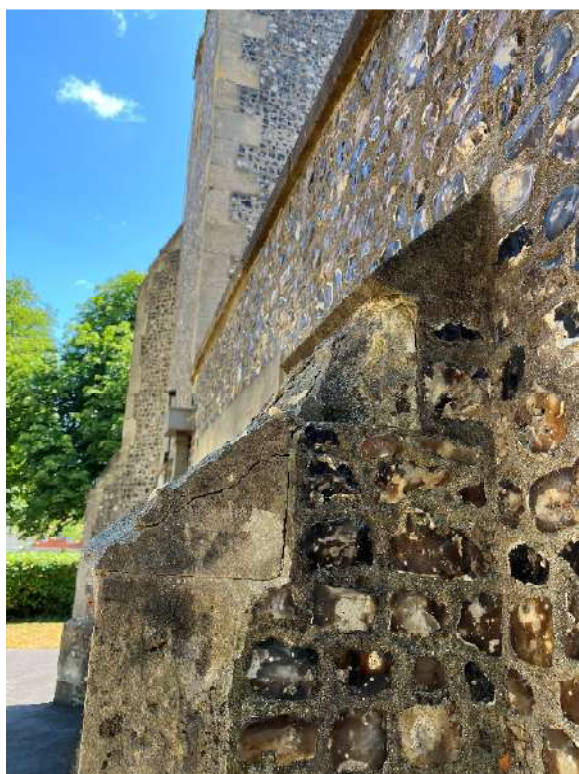
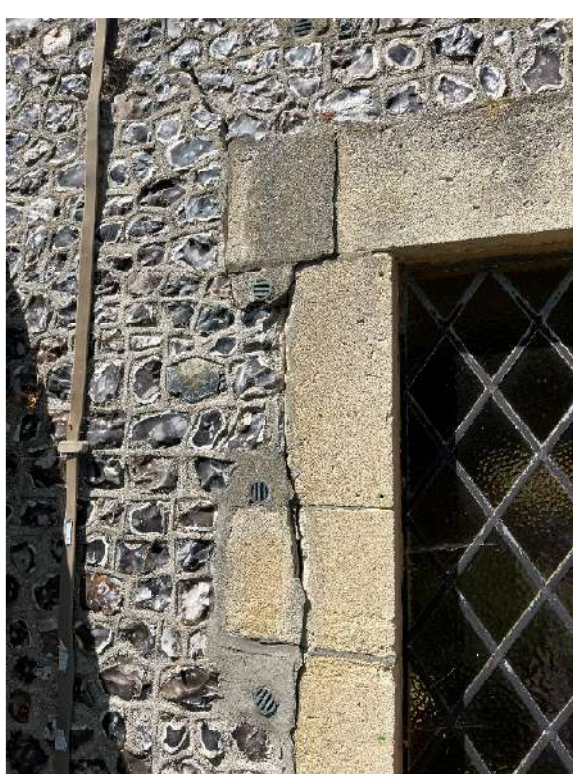
Figure 3, 4, 5 & 6 – Photographs of example damaged stonework, and internal water ingress.

The application is accompanied by a Quinquennial inspection by Bennington Green, that provides a detailed examination of the condition of the building and supported by building condition drawings that demonstrate the extent of the works required. A significant issue is the state of the flat and low pitch roof coverings which have reached the end of their serviceable life. There are also concerns about water ingress from defective flashings, stonework and slate roof coverings throughout. These have caused damage throughout the building, that requires immediate attention to prevent further deterioration of the building fabric.

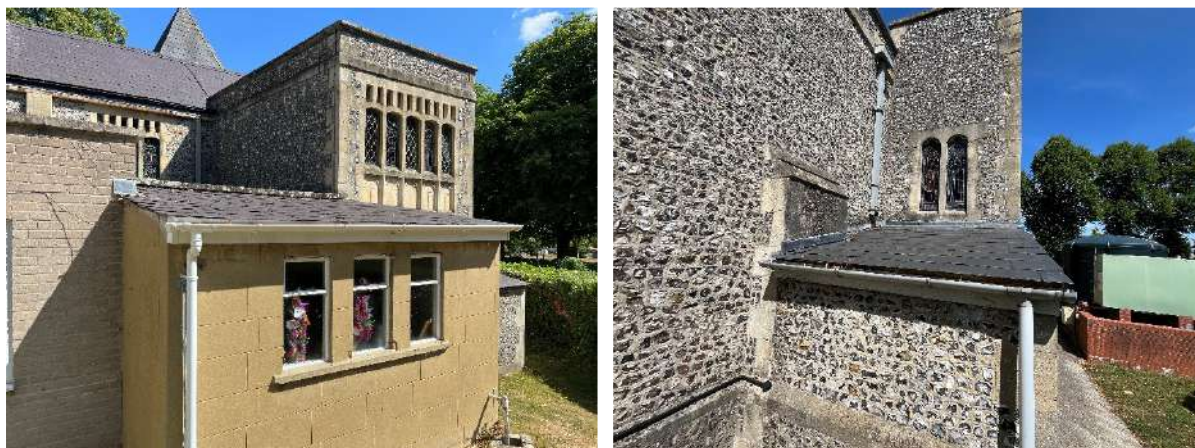
*Figure 7 & 8 – Photographs of low pitch vestry roof (left) & store roof (right)*

**Standing Seam Roofing** - The low pitch roofs will be replaced and recovered with standing seam zinc roofing, that is more suitable for the low pitch of the roof and avoids rain penetrating the building fabric. The standing seam zinc/ steel has a similar appearance to a leaded roof but is safer to work with and preferable for more accessible roofs, because it is less likely to be stolen.

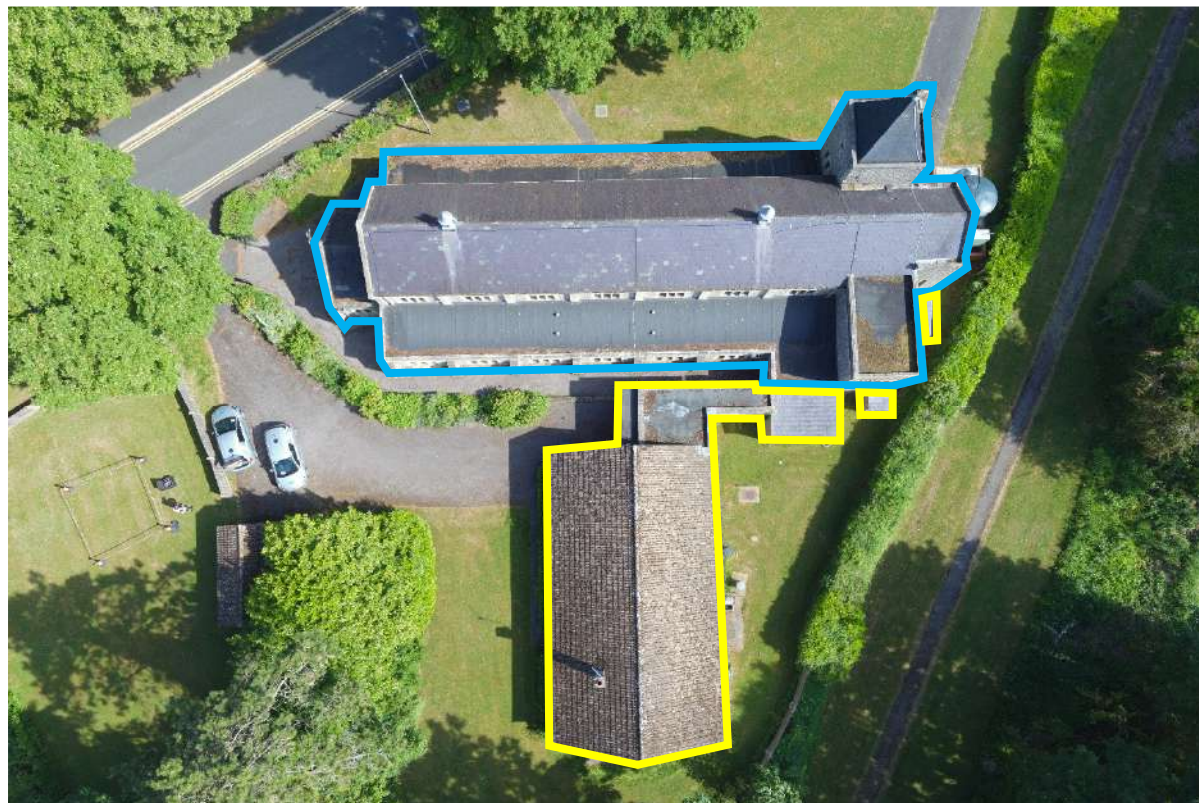
Figure 10 – The Main Church (Blue), and the Presbytery, Vestry & External Stores (Yellow)

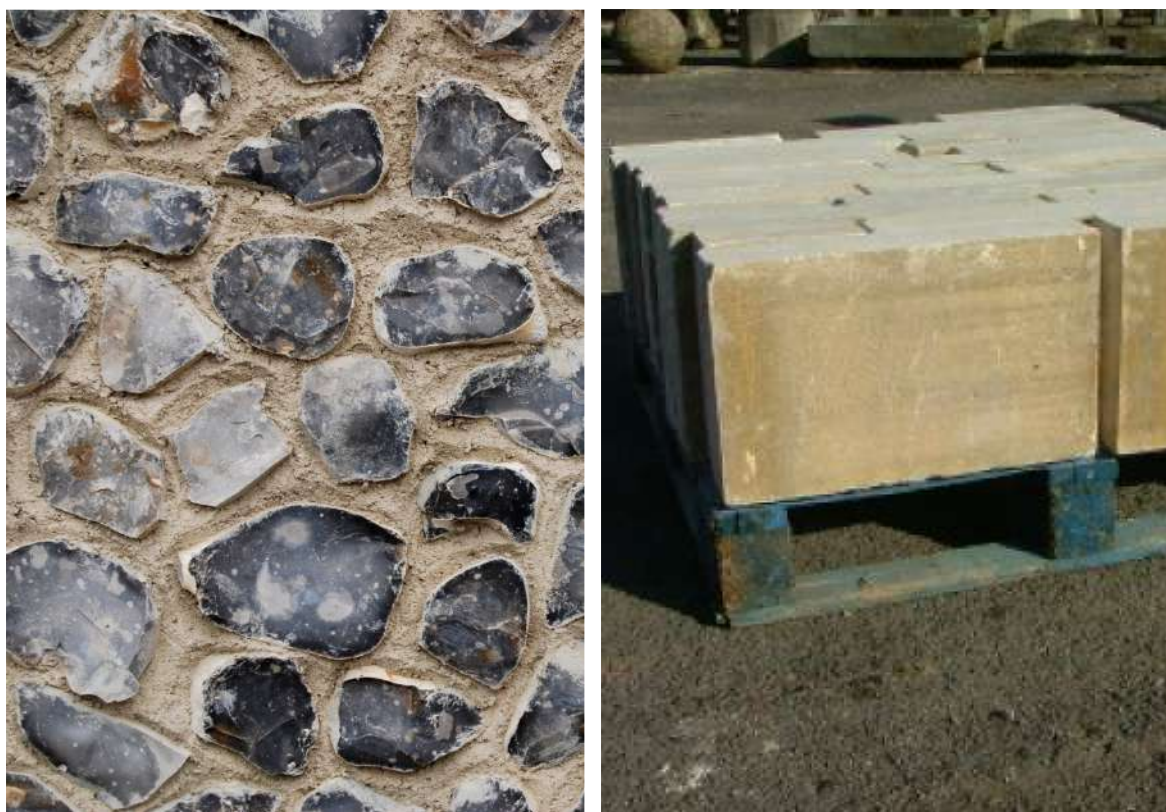
Figure 11 & 12 – Example of knapped flint and bath stone

**Stonework** - The building is faced with knapped flint, with bath stone quoins, window surrounds and parapet cappings. The building is pointed and originally constructed throughout with cement-based mortars, and whilst the harder flintwork appears to be in good condition generally, the softer bath dressed stone to the quoining, capping and window surrounds is damaged significantly and extensively across the building. Where feasible, the proposals aim to repair the stonework using a lime mortar mix, colour matched by the Lime Centre. Where stone has to be replaced, locally sourced knapped flint and bath stone will be used to match the existing materials.

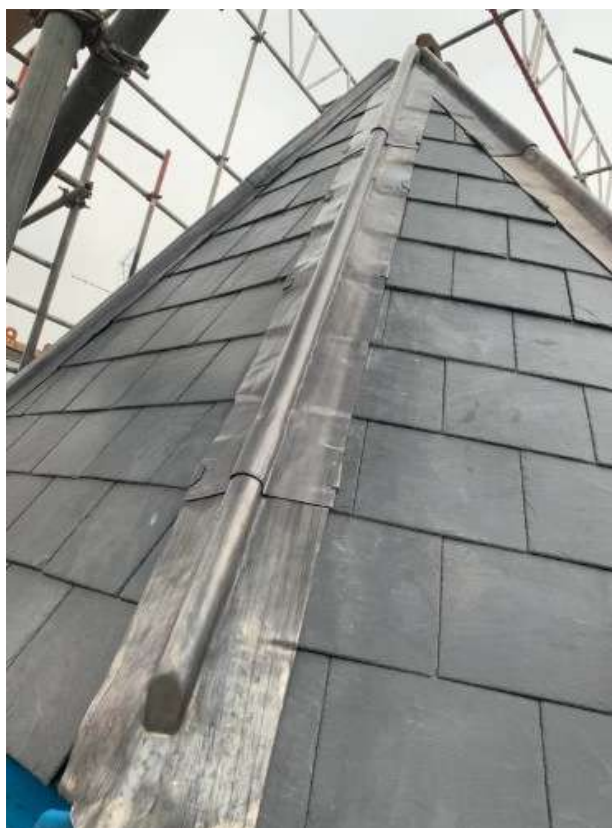
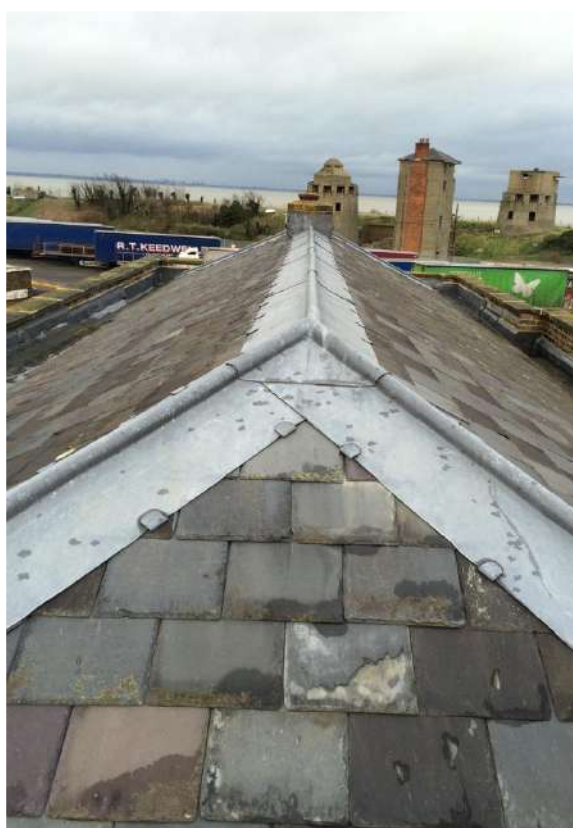
Figure 13 & 14– Example of rolled leaded hips

The tower roof is covered in fibre cement tiles, which are to be replaced with natural slate and a rolled lead hip detail to be more in keeping with the historic structure. All lead will be treated with patination oil.

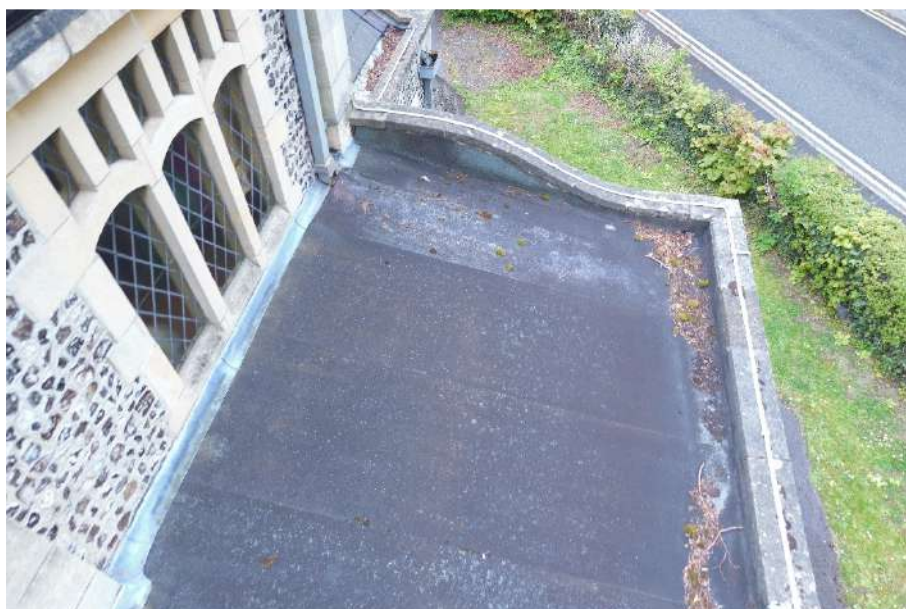
Figure 15 – Existing Mineral Felt Aisle Roofs

**Mineral Felt Roofing** - The existing flat roofs will be renewed with a dark grey 3 ply bituminous felt on a like for like replacement basis.

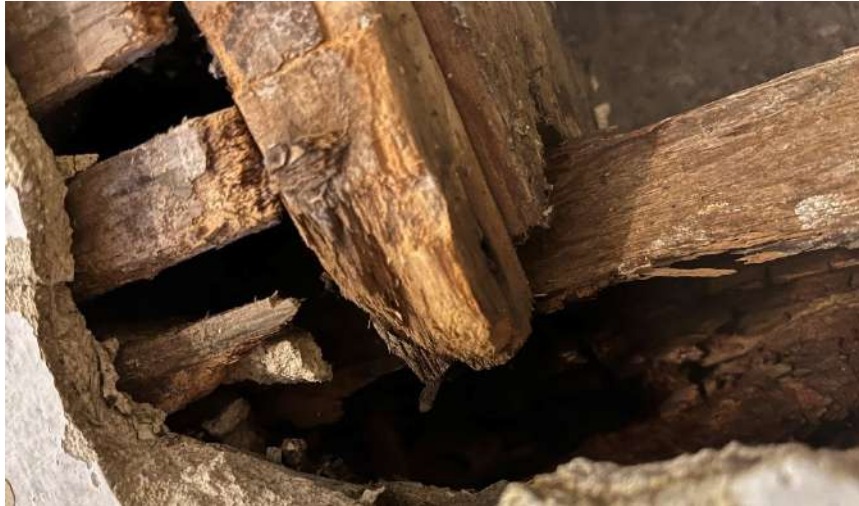
*Figure 16 – Evidence of degraded roof timbers due to water ingress*

**Timber Roof Structure** - Significant degradation of the timber roof structure has been identified in the Sanctuary, and will require extensive repair/ replacement work.

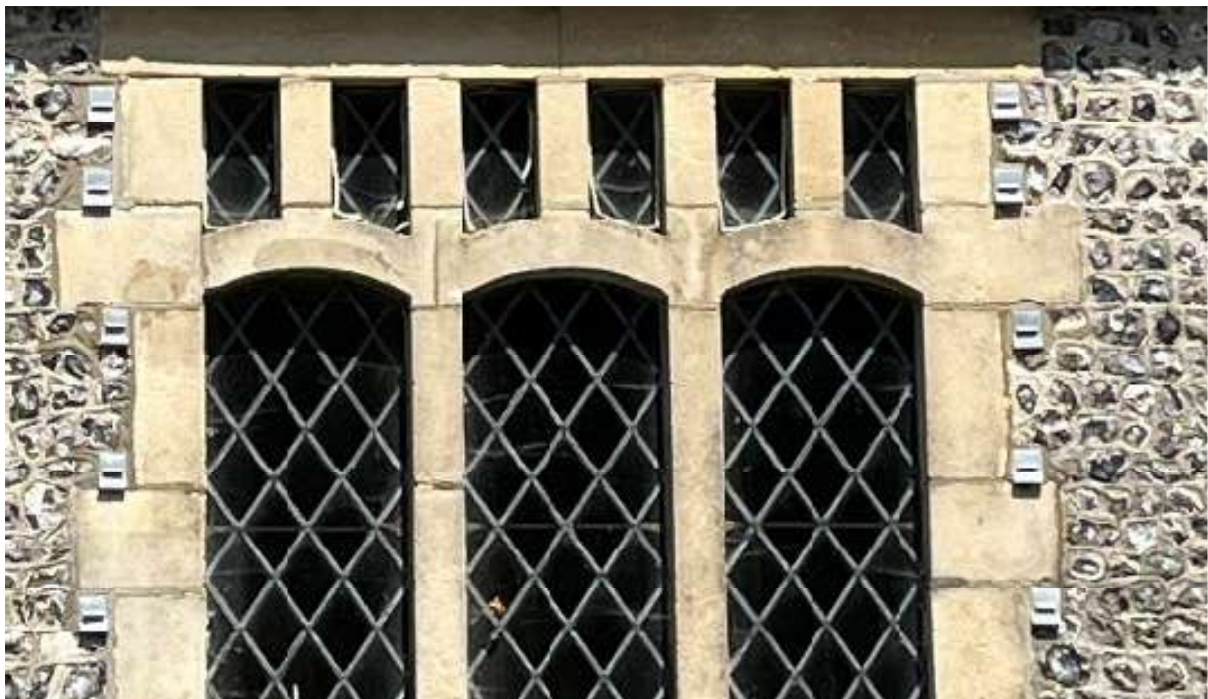
*Figure 17 – Example of knapen vent caps installed to other areas of the building*

**Knapen Vents** - The building features a system of Knapen vents to the building façade, primarily on the East, South and West elevations. These are ineffective, and a potential point of water ingress into the structure. As they are noted in the listing, the proposals allow for their retention, and the installation of a leaded cap similar to what has already been installed to other parts of the building to prevent potential water ingress.

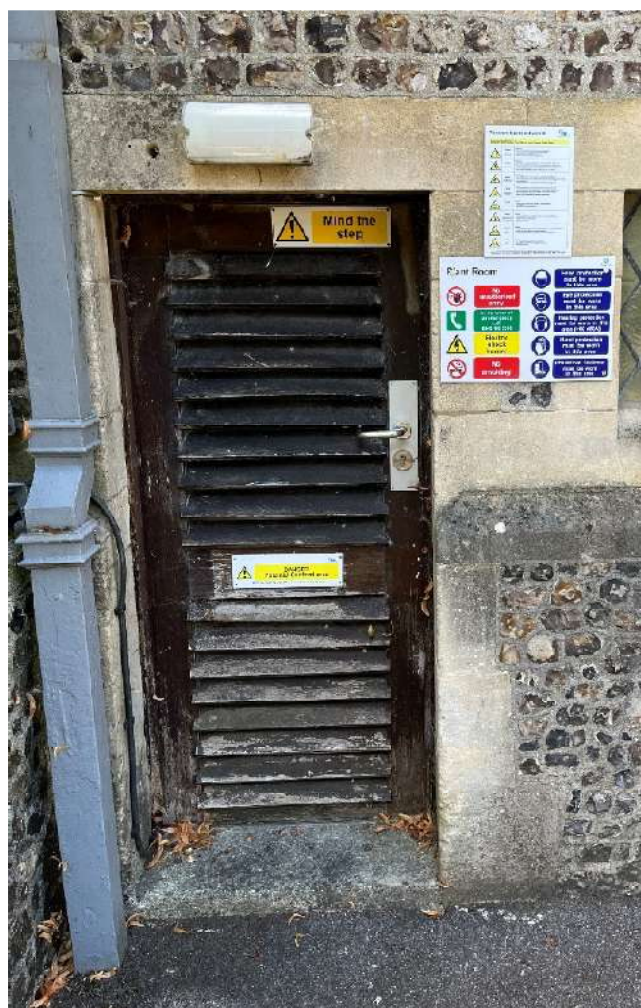
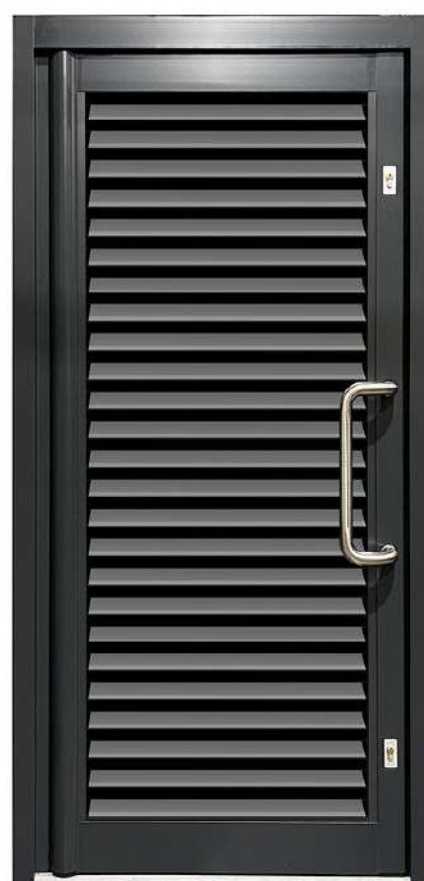
Figure 18 & 19 – Rotten plant door and more robust PPC aluminium door

**External Doors** – The existing historical doors will be refurbished throughout. This will include repainting the ironmongery to match existing and refinishing the timber, with replacement door sweeps where required. The more modern plant room door to the tower will be replaced with a PPC aluminium plant door.

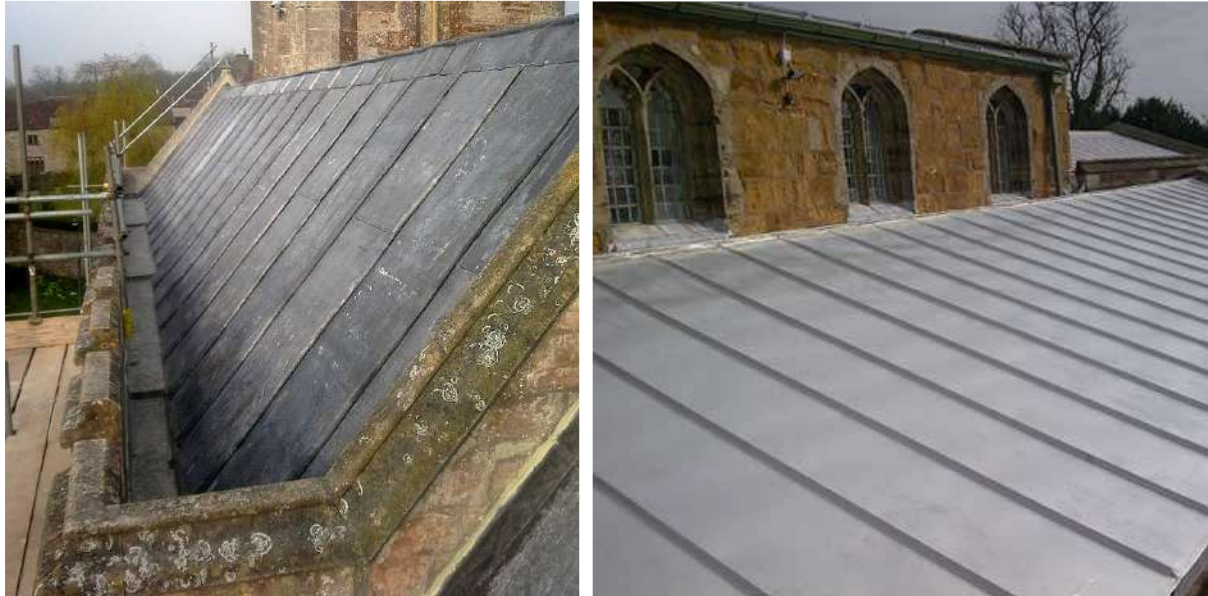
Figure 20 & 21 – Example of lead standing seam on church (left), Example of zinc/steel standing seam (right)

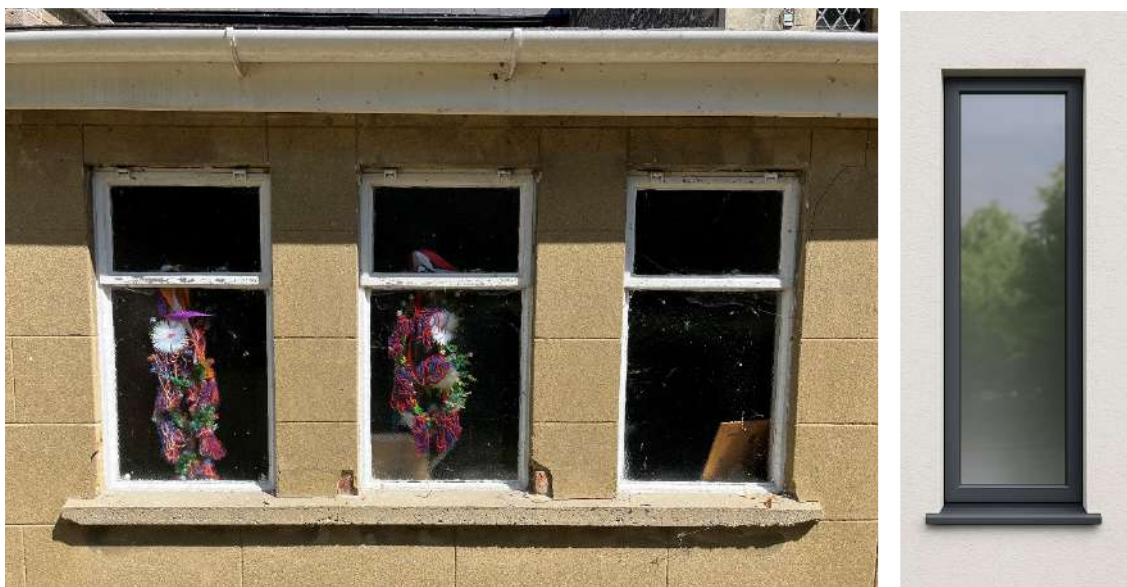
Figure 22 & 23– More modern single glazed windows and concrete cill (left), proposed replacement (right)

**Windows** - The single glazed timber windows to the Vestry are failing, and will be replaced with grey PPC aluminium windows, to meet modern standards. The concrete cill to the Vestry will also be replaced with a bath stone cill for a more sensitive appearance.

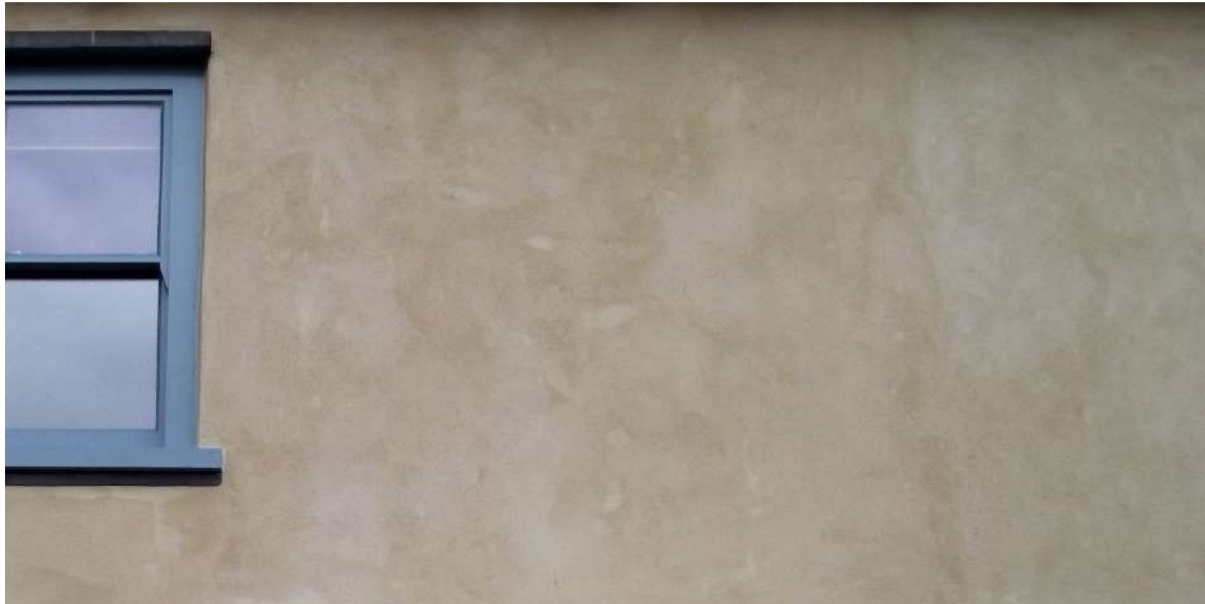
*Figure 24 – Example of proposed Lime render finish to Vestry*

**Render Finishes** – The render finish to the Vestry will be removed and replaced with a lime render finish to match the colour of the existing stone. This will enable the solid brickwork to breathe, and the appearance will be more sensitive to the church.

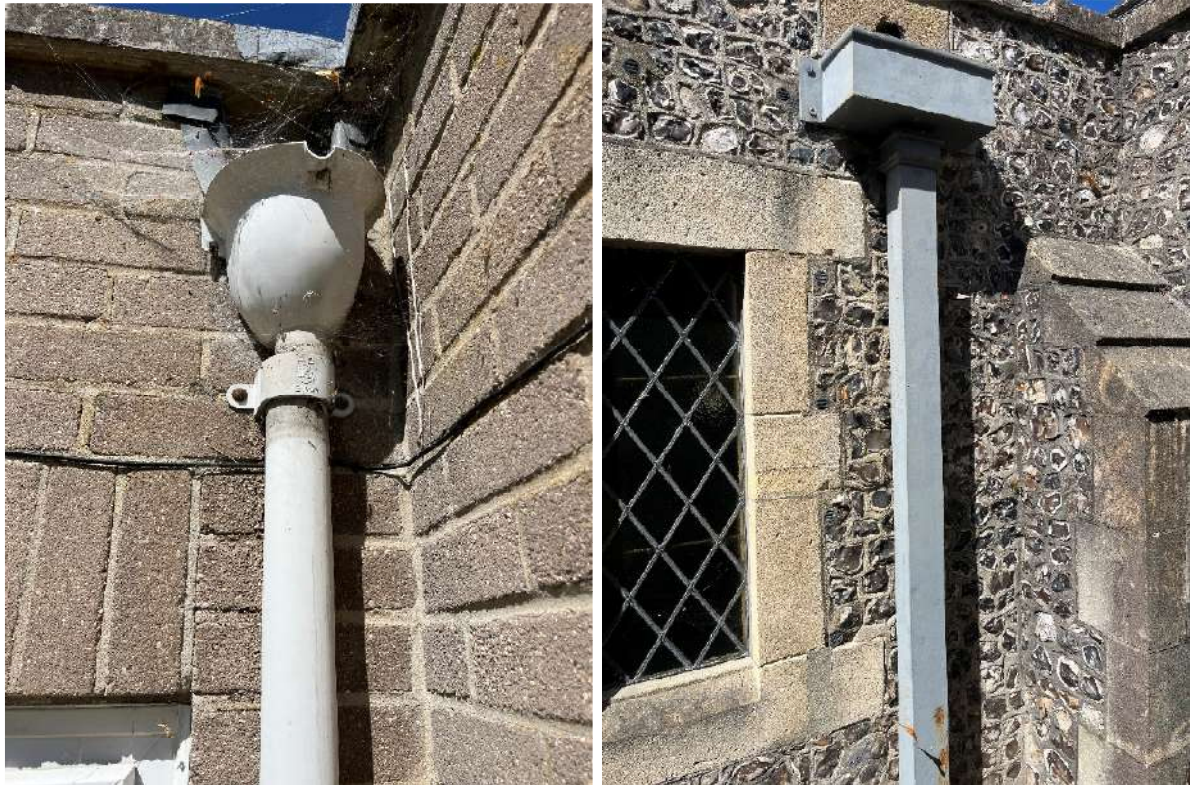
Figure 25 & 26 – Existing uPVC rainwater goods (left) to be replaced with cast iron to match existing profiles (right)

**Rainwater Goods** - The existing uPVC rainwater goods will be replaced with cast iron to match the profiles of the existing cast iron goods and painted to match the existing colour. A new cast iron gutter and downpipe will be installed on the smaller store to prevent further water ingress. Several new gullies connecting to a surface water disposal system will be installed to control the discharge of water and prevent damage to the building fabric.

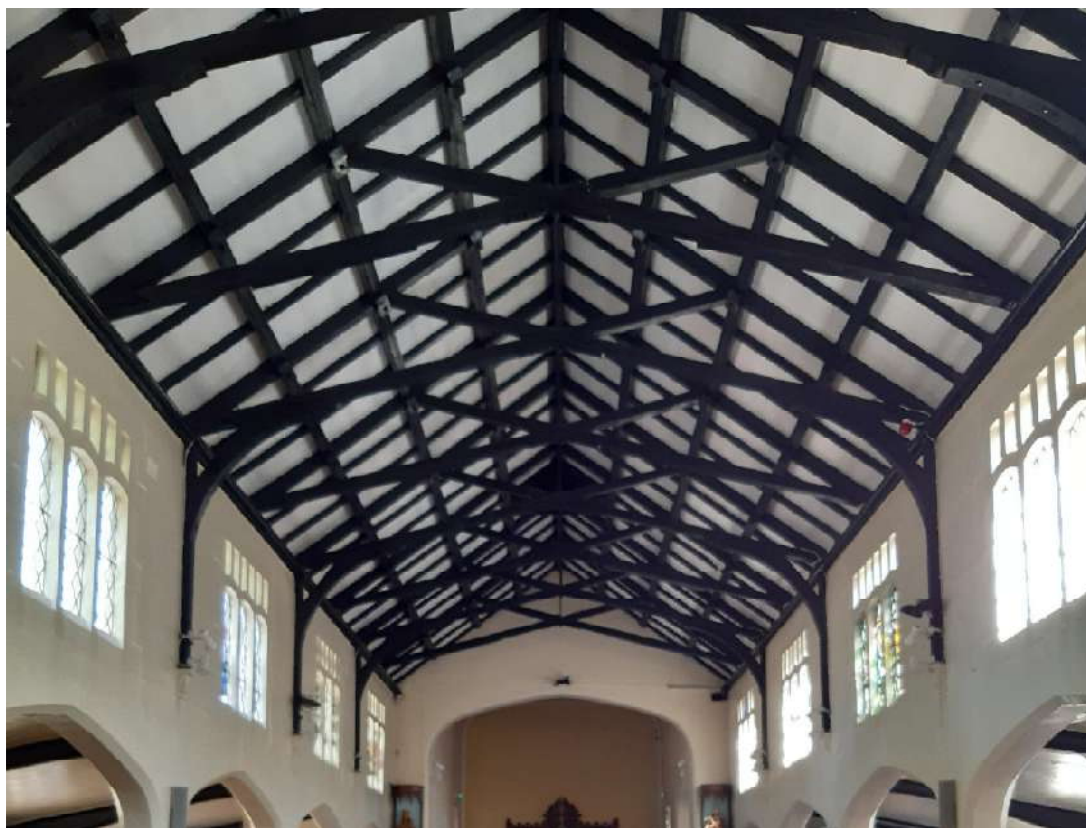
*Figure 28 – Asbestos soffit tiles above the scissor trusses to the Nave*

The asbestos soffit tiles to the Nave ceiling will be removed and replaced with a skimmed plasterboard finish to match the existing visual appearance. The tiles to the Narthex will also be replaced with a similar finish.

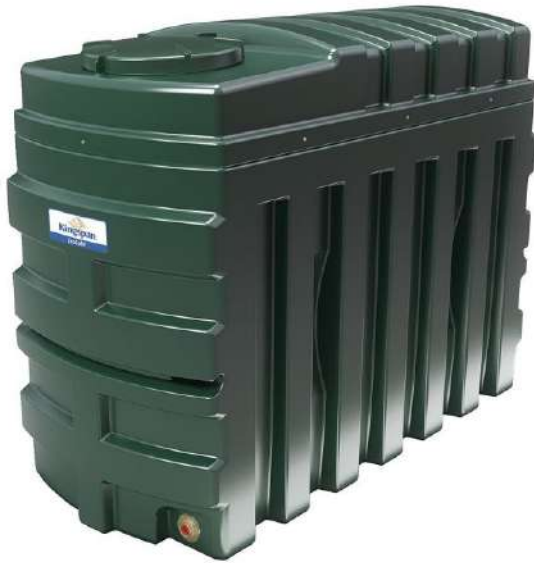
Figure 29 - Example of Modern bunded oil tank

**Heating** - All emitters and pipework will be replaced back to the plant room. The single skin metal oil tank will also be replaced with a modern bunded tank to ensure the safe storage of oil in line with current regulations.

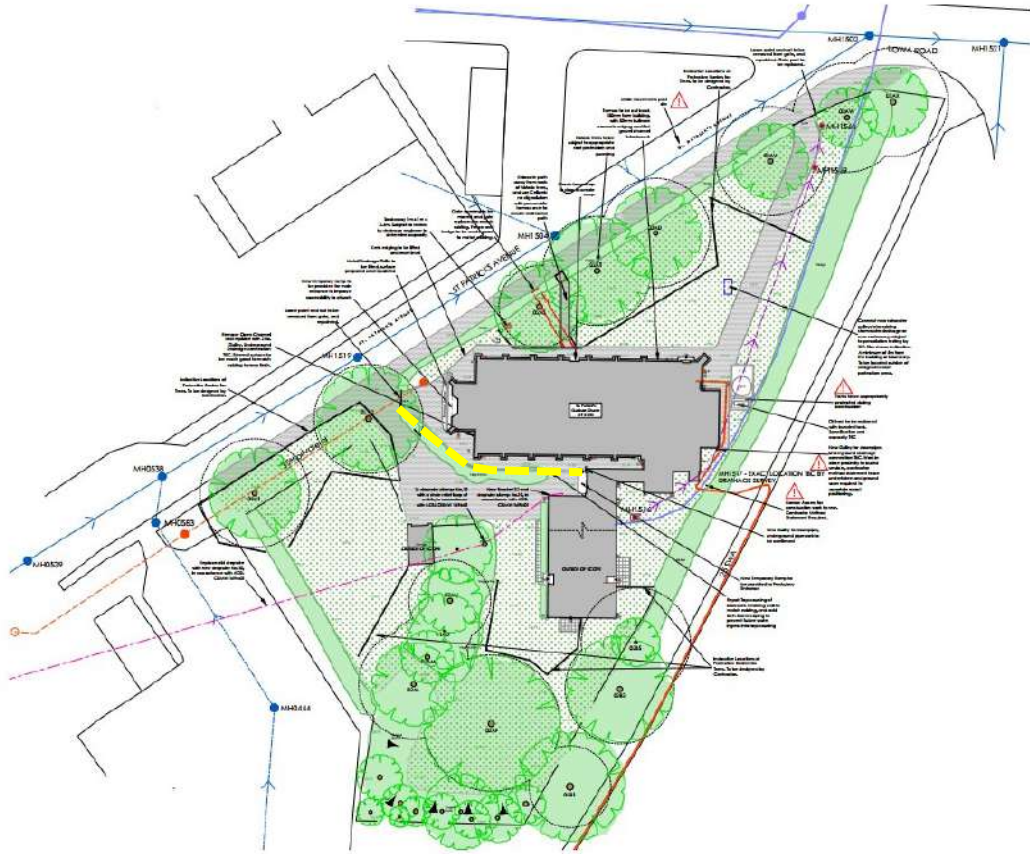
Figure 30 – Proposed Site Plan (retaining wall shown in yellow)

A new bath stone capping will be installed to the top of the small retaining wall, where the top courses have degraded.

The footpath from St Patricks Avenue will be redirected to avoid the tree roots that are causing it to bulge. A Cell web no dig system will be installed with a permeable tarmac finish to protect the tree roots.

The tarmac will be cut back from the perimeter of the building where it is causing erosion of the stone, and a new flint gravel channel with concrete edging will be installed.

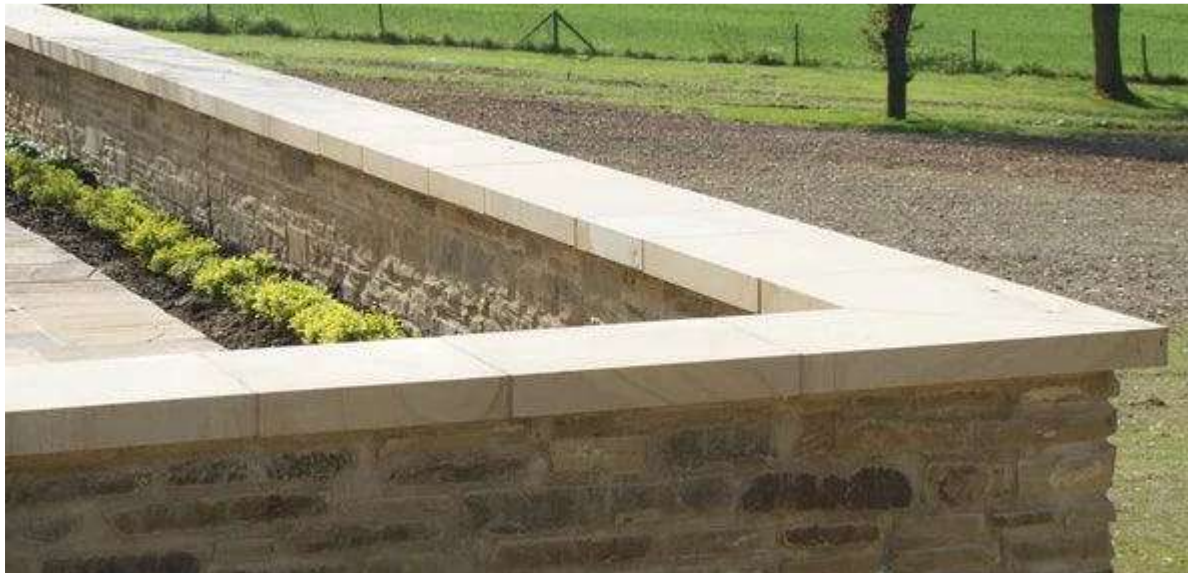
Figure 31 – Bath Stone Capping Example for retaining wall

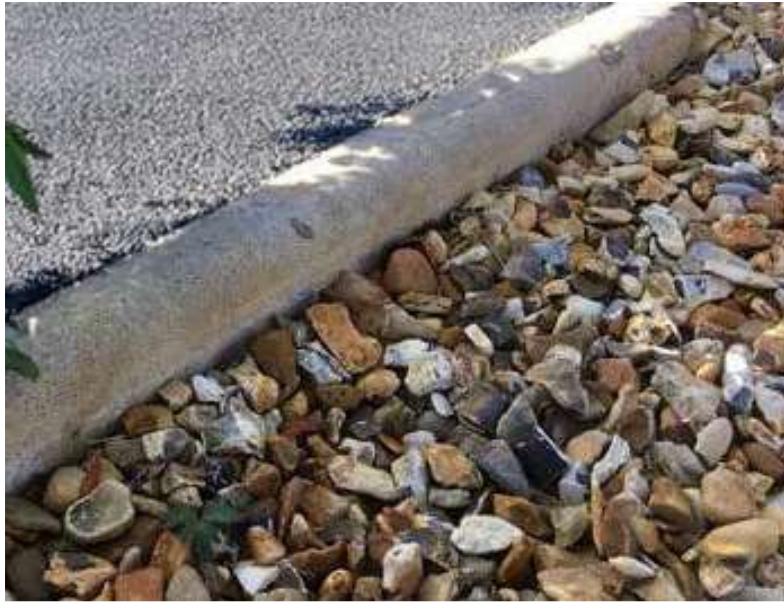
Figure 32 – Pin kerbing and flint gravel

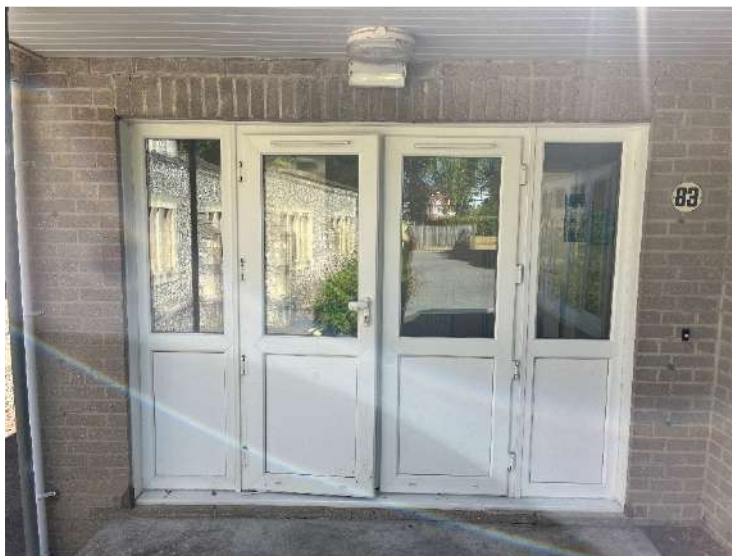
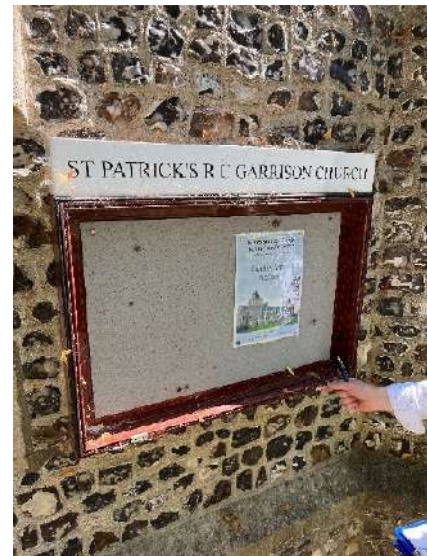
Figure 33 & 34 – Existing stepped access to the Presbytery (left) and existing noticeboard (right)

The proposals include a range of measures intended to improve access for wheelchair users and ambulant persons. This includes a new removable ramp to the Presbytery and main entrance and a grading of the floor finish up to the side entrance to the Nave. The scheme also allows for an improvement to the overall lighting of the spaces with LED lights. A new lit noticeboard designed to be more inclusive to visually impaired and dyslexic persons will also be installed.
