# HERITAGE STATEMENT

PROPOSED WORKS TO  
ST PATRICKS GARRISON CHURCH  
1 ST PATRICKS AVENUE  
TIDWORTH  
WILTSHIRE, SP9 7BS

**REVISION C**

MARCH 2026 REF: F1870/ HS

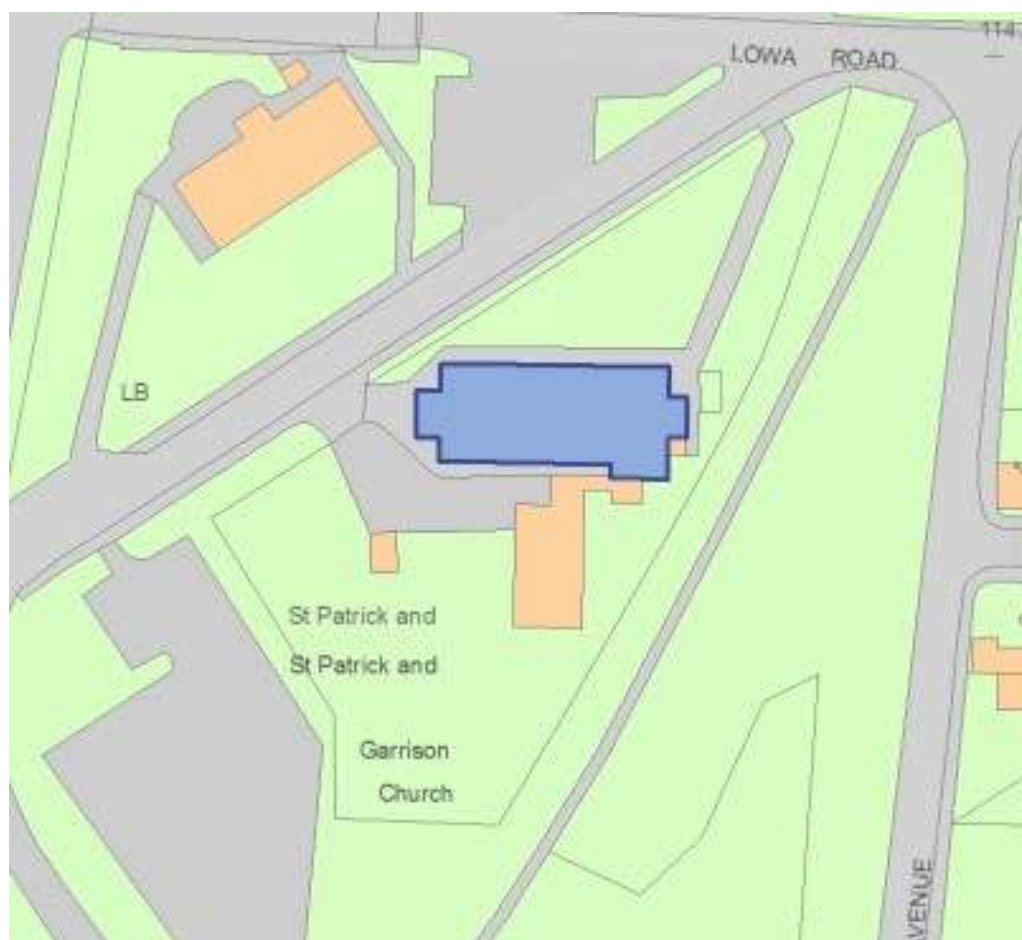
Figure 10 – Extents of Listed Building as shown in Historic England Listing

The listed building(s) is/are shown coloured blue on the attached map. Pursuant to s.1 (5A) of the Planning (Listed Buildings and Conservation Areas) Act 1990 ('the Act'), structures attached to or within the curtilage of the listed building (save those coloured blue on the map) are not to be treated as part of the listed building for the purposes of the Act.

The blue line drawing accompanying the official list entry (Figure 10) excludes these later additions from the listing (External Stores, Vestry and Presbytery). As a result, these are not considered curtilage listed and are excluded from the requirements of listed building consent as per The Historic England Advice Note 10 'Listed Buildings and Curtilage'. The listing also notes that the Vestry is not of special interest. However, due to the close proximity of these building elements, they may be considered to have an impact on the character of the listed building and all proposals have been carefully considered to complement the heritage asset.

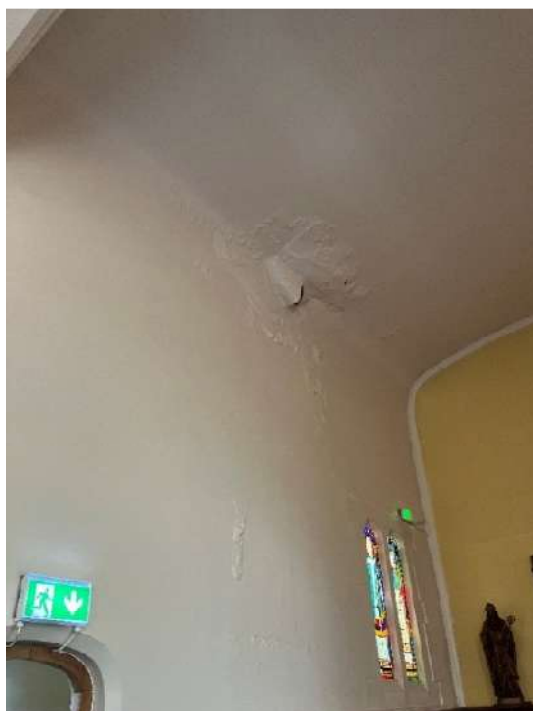
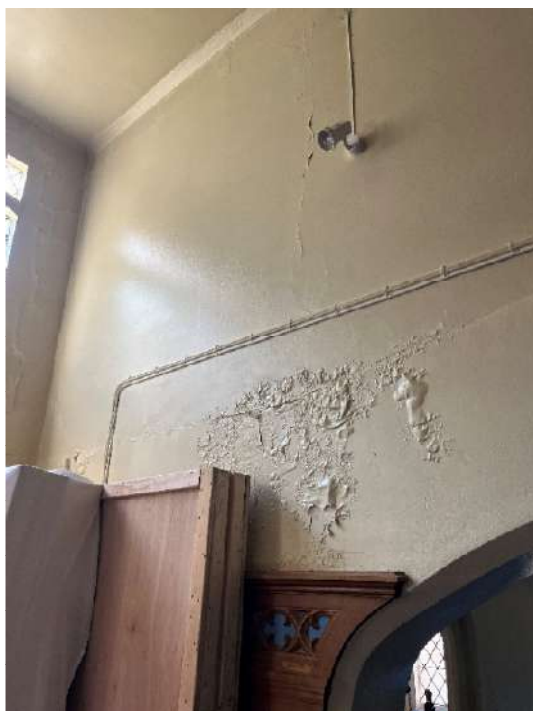
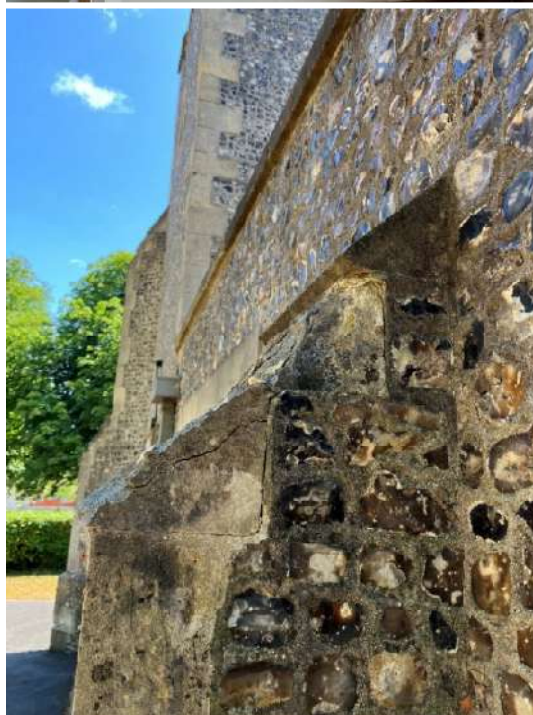
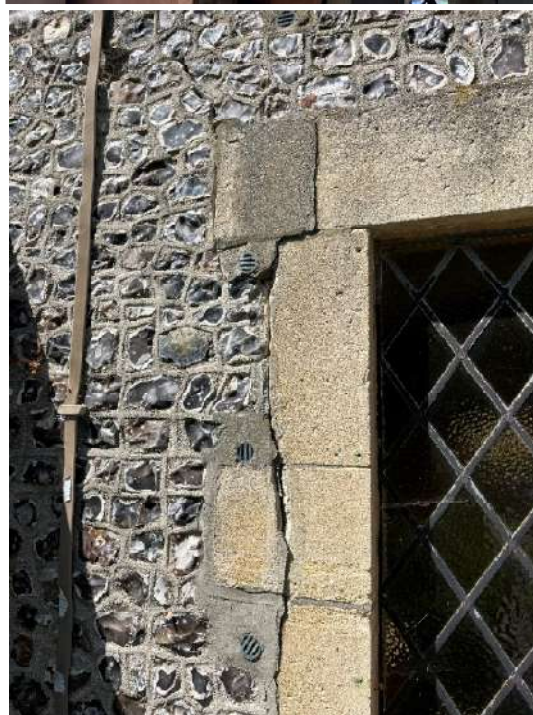
Figure 16, 17, 18, 19 – Photographs of example damaged stonework, and internal water ingress.

The application is accompanied by a Quinquennial inspection by Bennington Green, that provides a detailed examination of the condition of the building, and building condition drawings that demonstrate the extent of the works required. A significant issue is the state of the flat and low pitch roof coverings which have reached the end of their serviceable life. There are also concerns about water ingress from defective flashings, stonework and slate roof coverings throughout. There is also evidence of less sensitive repair and maintenance work to the building. The Tower roof features cement fibre tiles, and some asbestos tiles have historically been used to patch a small area of the lobby roof. Poorly colour matched hard cement mortar to the quoining has contributed to the damage of the softer ashlar stonework quoins and window surrounds. The poor quality repairs and degradation of the building fabric are both detrimental to the heritage significance of the building.

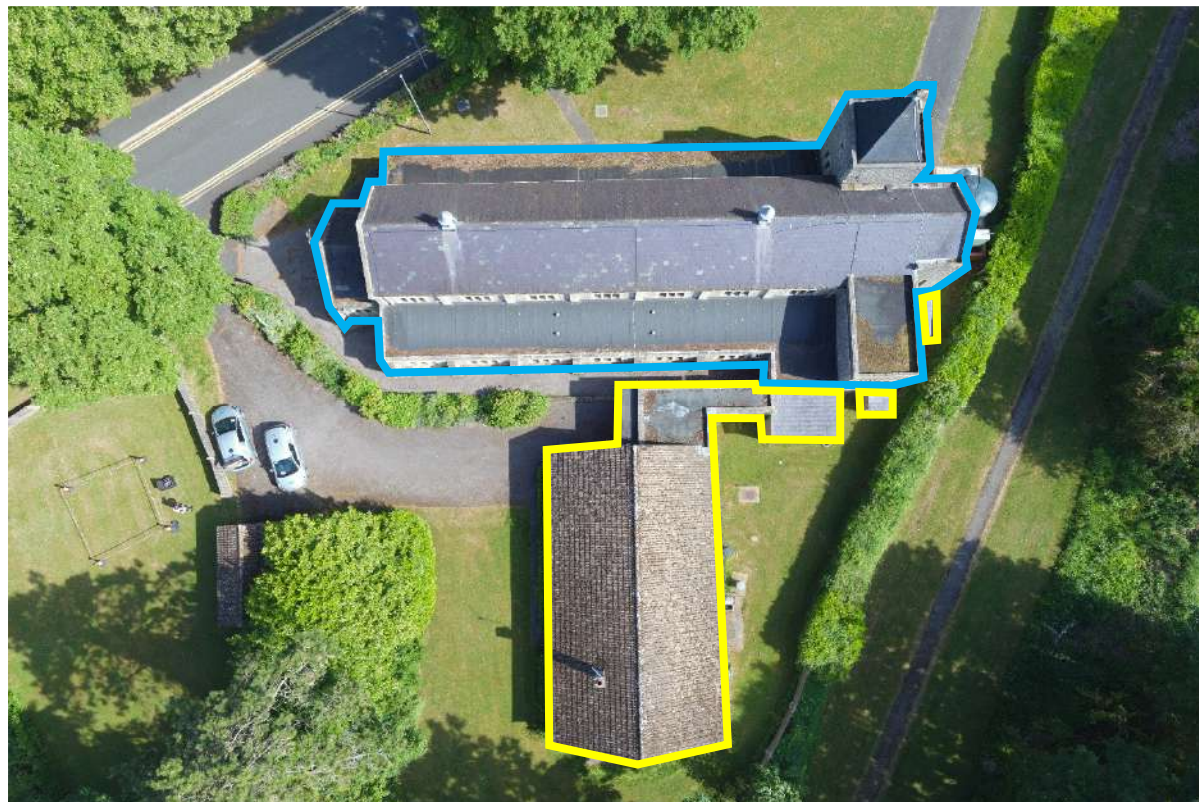
Figure 17 – The Main Church (Blue), and the Presbytery, Vestry & External Stores (Yellow)

The heritage statement has clearly identified that the main church (outlined in blue, figure 17) is covered by the listing, and that the later additions of the Presbytery, Vestry and External Stores (outline in yellow, figure 17) are excluded from the listing.

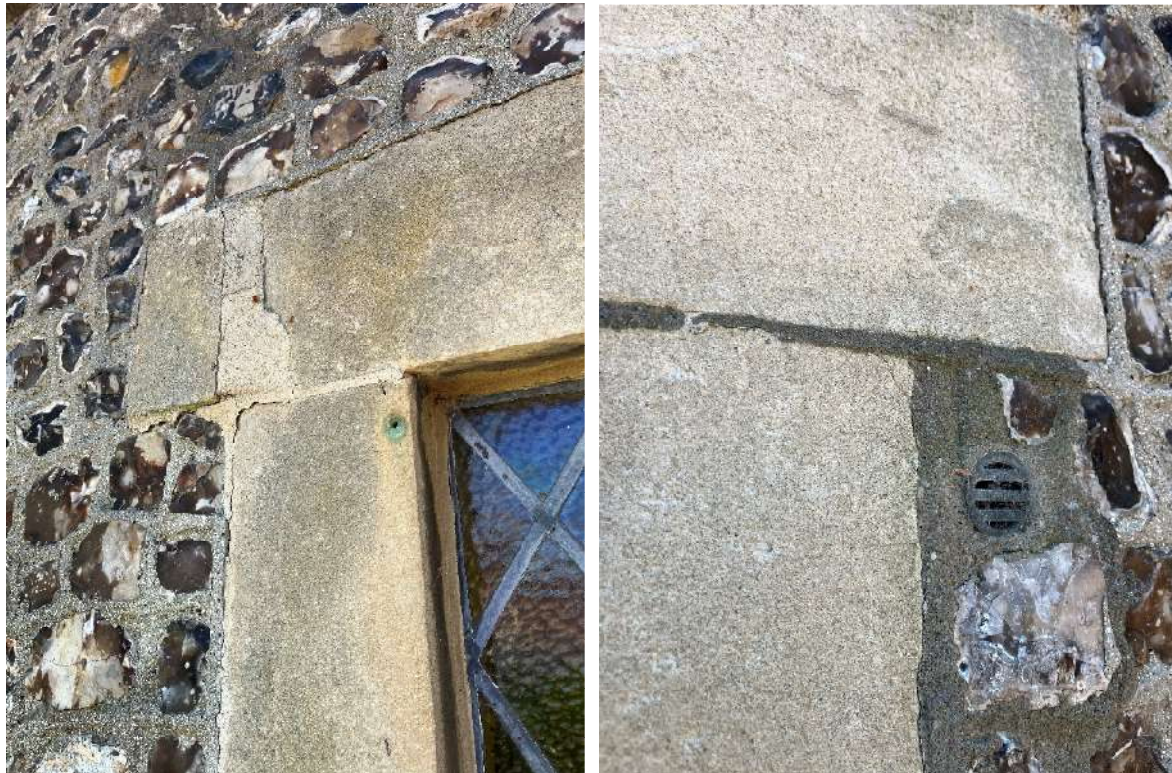
Figure 18 & 19 – Example of poor-quality repairs to stonework (left) and badly matched cement pointing (right)

**Stonework** - The building is faced with knapped flint, with bath stone quoins, window surrounds and parapet cappings. The building is pointed and originally constructed throughout with cement-based mortars, and whilst the harder flintwork appears to be in good condition generally, the softer bath dressed stone to the quoining, capping and window surrounds is damaged significantly and extensively across the building. Where feasible, the proposals aim to repair the stonework using a lime mortar mix, colour matched by the Lime Centre. Where stone has to be replaced, locally sourced knapped flint and bath stone will be used to match the existing materials.

**Mortar Pointing** - The softer ashlar stonework will also be repointed in another lime mortar mix for a more sensitive appearance, and with the aim of improving the longevity of the stonework. The majority of the original cement-based mortars to the flintwork are in good condition, and where required, a cement mortar mix will be matched to the existing for localised repairs and repointing.

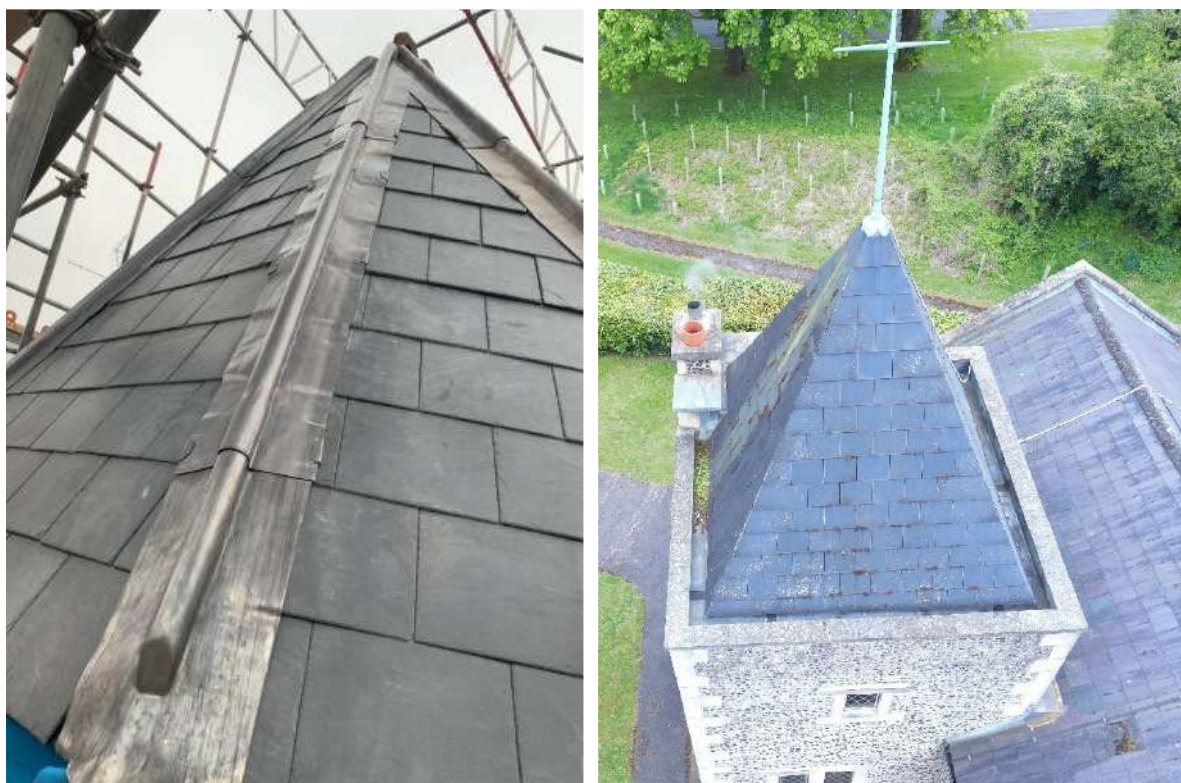
Figure 20 & 21 – Example of rolled leaded hip(left), and existing fibre cement tiles and concrete hip to Nave (right)

The tower roof is covered in fibre cement tiles, which are to be replaced with natural slate and a rolled lead hip detail to be more in keeping with the historic structure. All lead will be treated with patination oil.

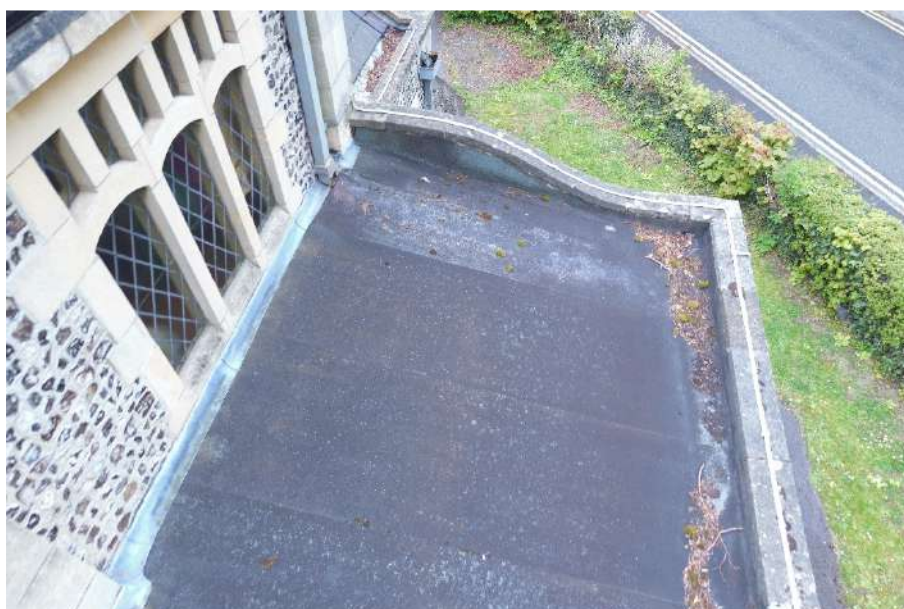
Figure 22 – Existing Mineral Felt Aisle Roofs

**Mineral Felt Roofing** - The existing flat roofs will be renewed with a dark grey 3 ply bituminous felt on a like for like replacement basis.

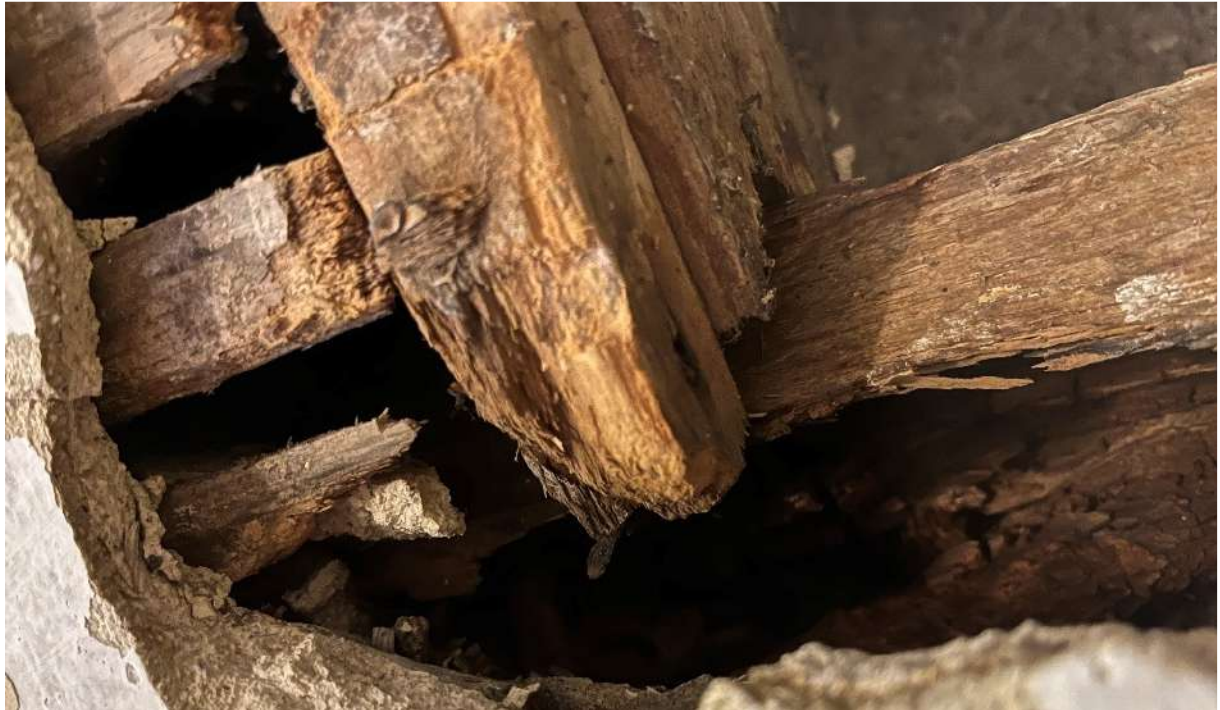
*Figure 23 – Evidence of degraded roof timbers due to water ingress*

**Timber Roof Structure** - Significant degradation of the timber roof structure has been identified in the Sanctuary, and will require extensive repair/ replacement work.

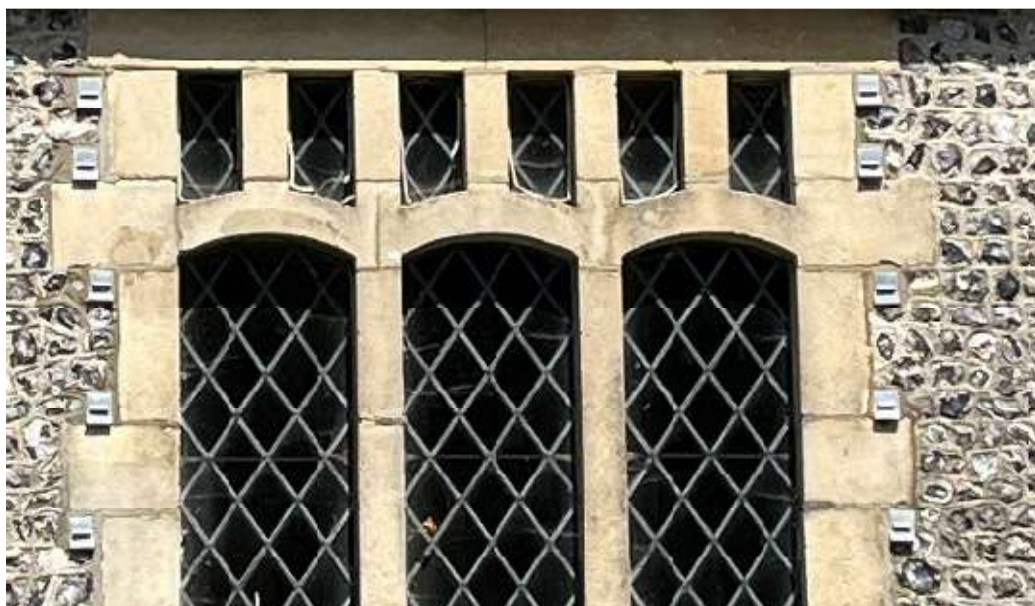
Figure 24 – Example of knapen vent caps installed to other areas of the building

**Knapen Vents** - The building features a system of Knapen vents to the building façade, primarily on the East, South and West elevations. These are ineffective, and a potential point of water ingress into the structure.

As they are noted in the listing, the proposals allow for their retention, and the installation of a leaded cap similar to what has already been installed to other parts of the building to prevent potential water ingress, protecting the historic fabric.

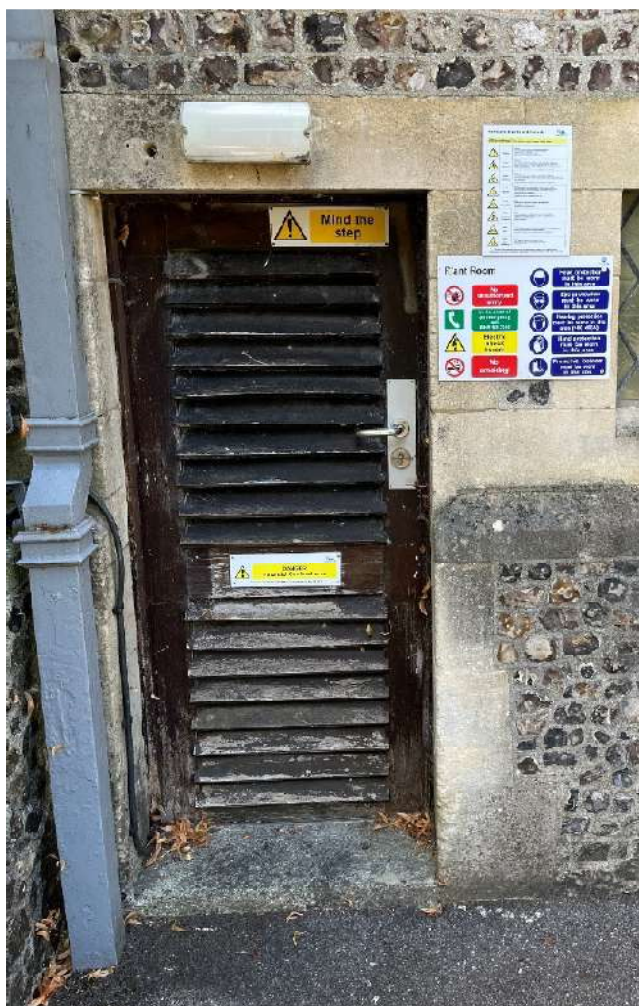
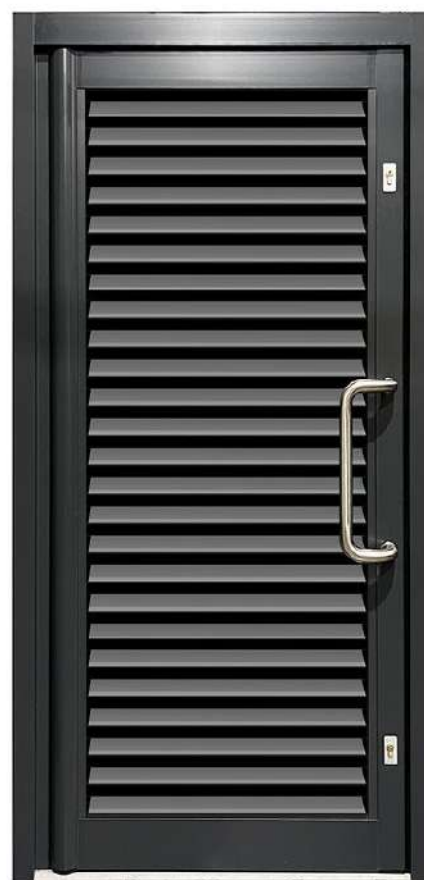
Figure 25 & 26 – Rotten plant door and more robust PPC aluminium door

**External Doors** – The existing historical doors will be refurbished throughout. This will include repainting the ironmongery to match existing and refinishing the timber, with replacement door sweeps where required. The more modern plant room door to the tower will be replaced with a PPC aluminium plant door.

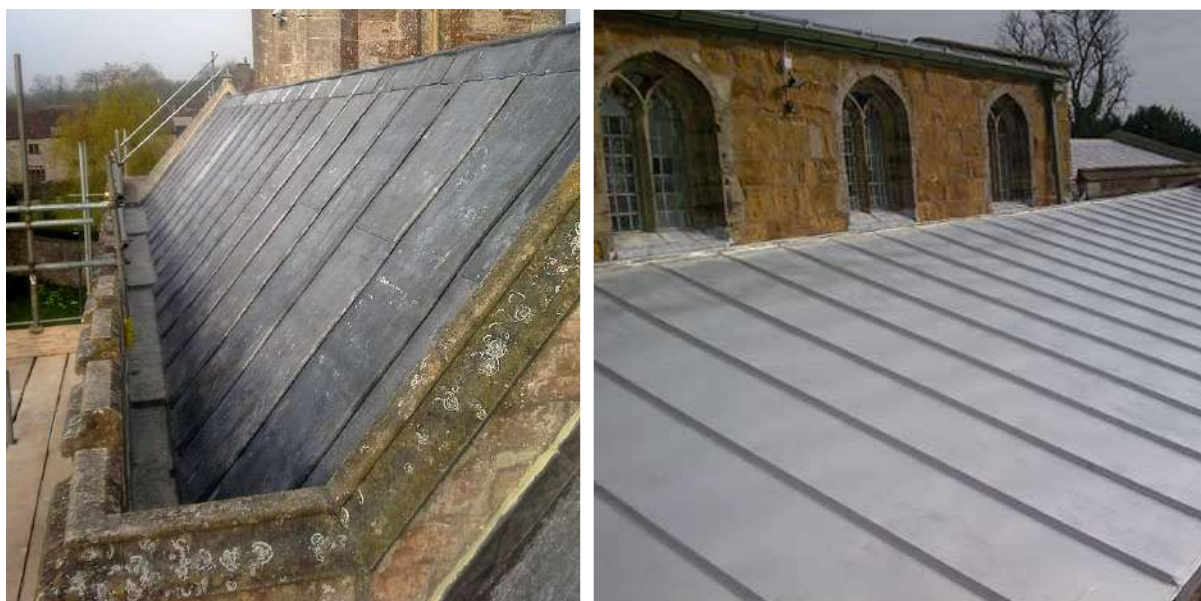
Figure 27 & 28 – Example of lead standing seam on church (left), Example of zinc/steel standing seam (right)

**Standing Seam Roofing** - The low pitch roofs will be replaced and recovered with standing seam zinc roofing, that is more suitable for the low pitch of the roof and avoids rain penetrating the building fabric. The standing seam zinc/ steel has a similar appearance to a leaded roof but is safer to work with and preferable for more accessible roofs, because it is less likely to be stolen.

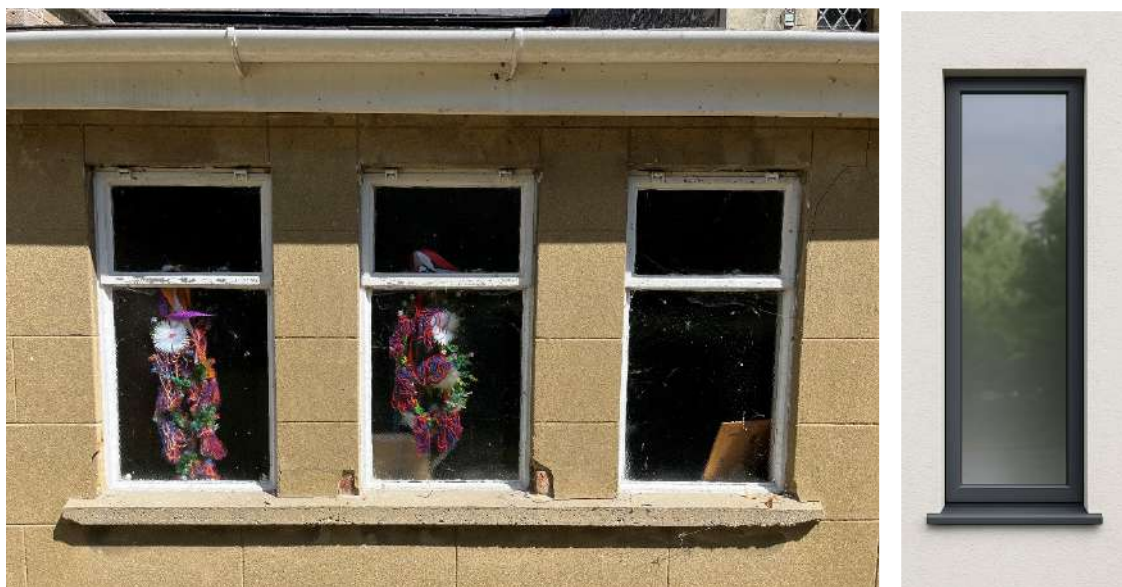
Figure 29 & 30– More modern single glazed windows and concrete cill (left), proposed replacement (right)

**Windows** - The single glazed timber windows to the Vestry are failing, and will be replaced with grey PPC aluminium windows, to meet modern standards. The concrete cill to the Vestry will also be replaced with a bath stone cill for a more sensitive appearance.

The existing windows have no heritage value, and the replacement of the damaged concrete cill with a natural stone cill will be more sensitive and in keeping with the listed asset.

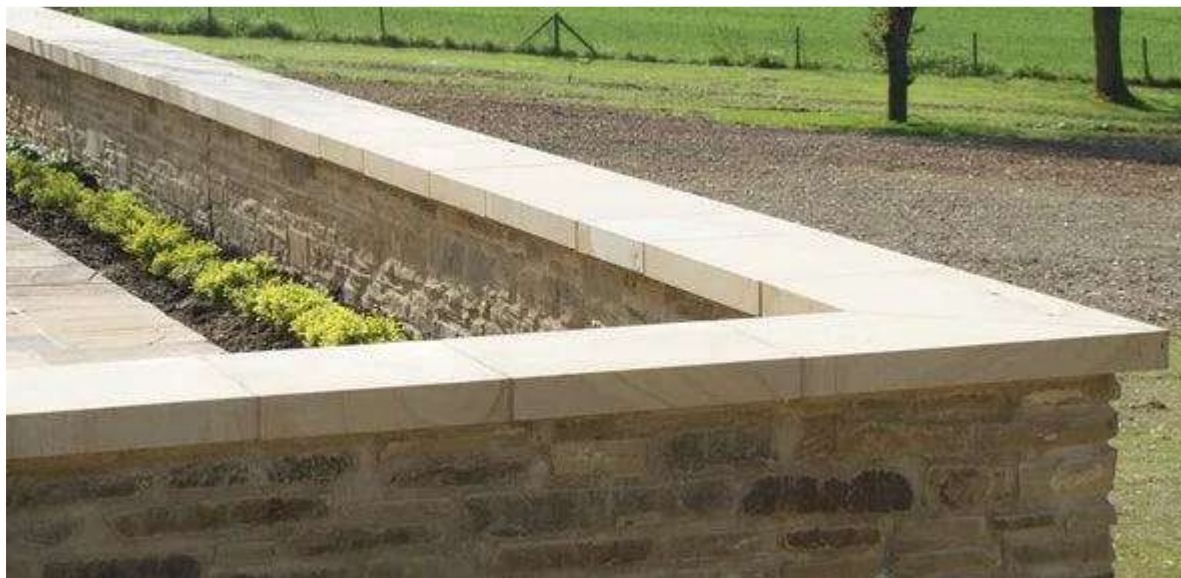
**Retaining Wall** - A new bath stone capping will be installed to the top of the small retaining wall, where the top courses have degraded.

Figure 36 – Bath Stone Capping Example for retaining wall

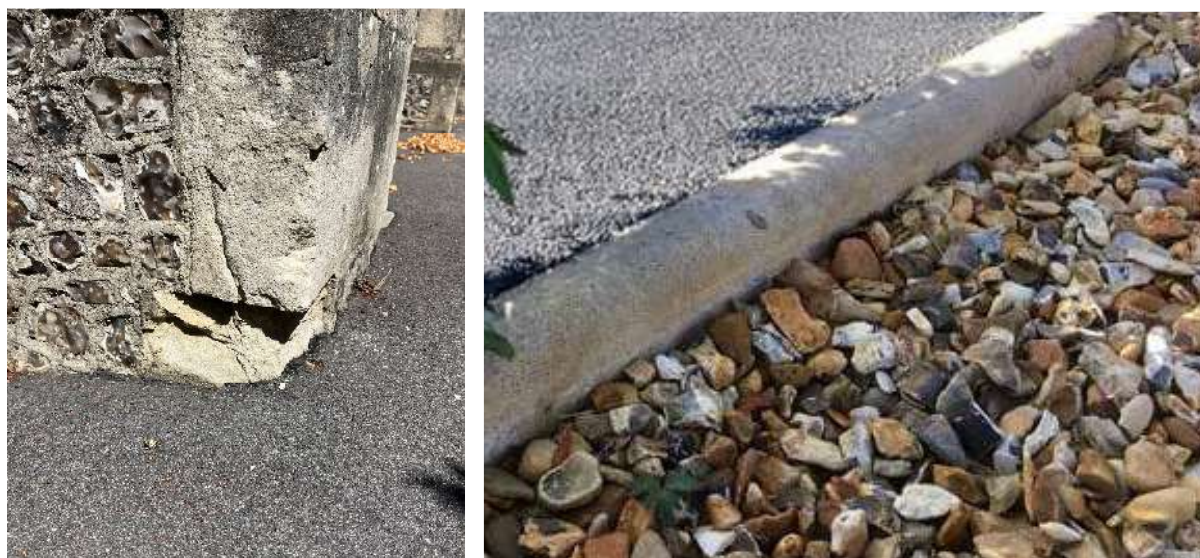
**Hard Landscaping Materials** - The tarmac will be cut back from the perimeter of the building where it is causing erosion of the stone, and a new flint gravel channel with concrete edging will be installed.

This will reduce the damage being caused to the historic stonework by water running on the impermeable surfaces adjacent to the building.

Figure 37 & 38 – Damage caused by impermeable surfaces against building fabric (left), proposed pink kerbing and flint gravel (right)
