# HERITAGE STATEMENT

**Manor Barn, Manor Farm House, Wylve Road, Hanging Langford,  
Salisbury, Wiltshire, SP3 4NW**

**Re-thatching of Manor Barn with water reed**

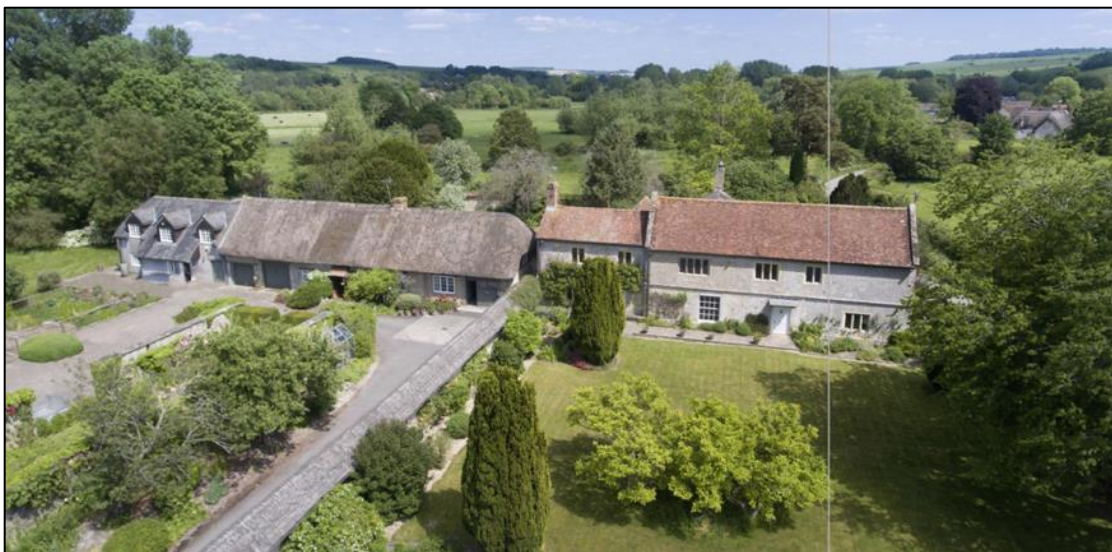
**Bird's-eye view of the principal farmhouse and the former farmstead buildings including Manor Barn (to the left)**

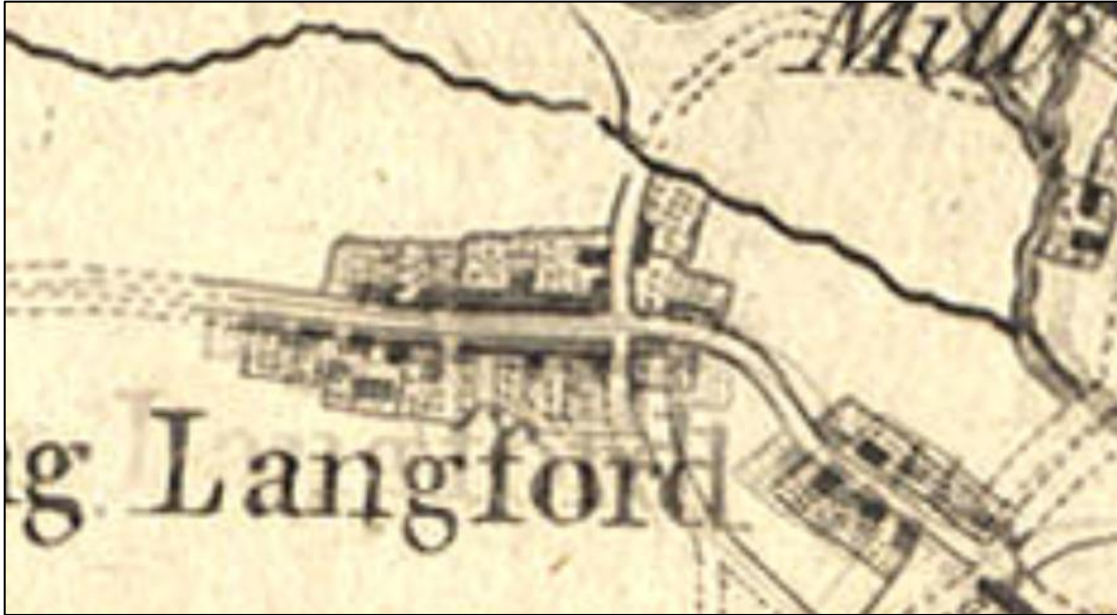
**Andrews' and Dury's Map of Wiltshire, 1773**

- 4.3.** Cartographic sources confirm that the extent of the Manor Farm plot has remained broadly consistent since at least the late 18th century. Andrews’ and Dury’s Map of Wiltshire (1773) indicates the established presence of the farm complex and suggests that the farmstead historically contained structures aligned with the lane (now the farm track/PROW) linking Hanging Langford and Steeple Langford, evidencing the longstanding agricultural function and connectivity of the holding.
-

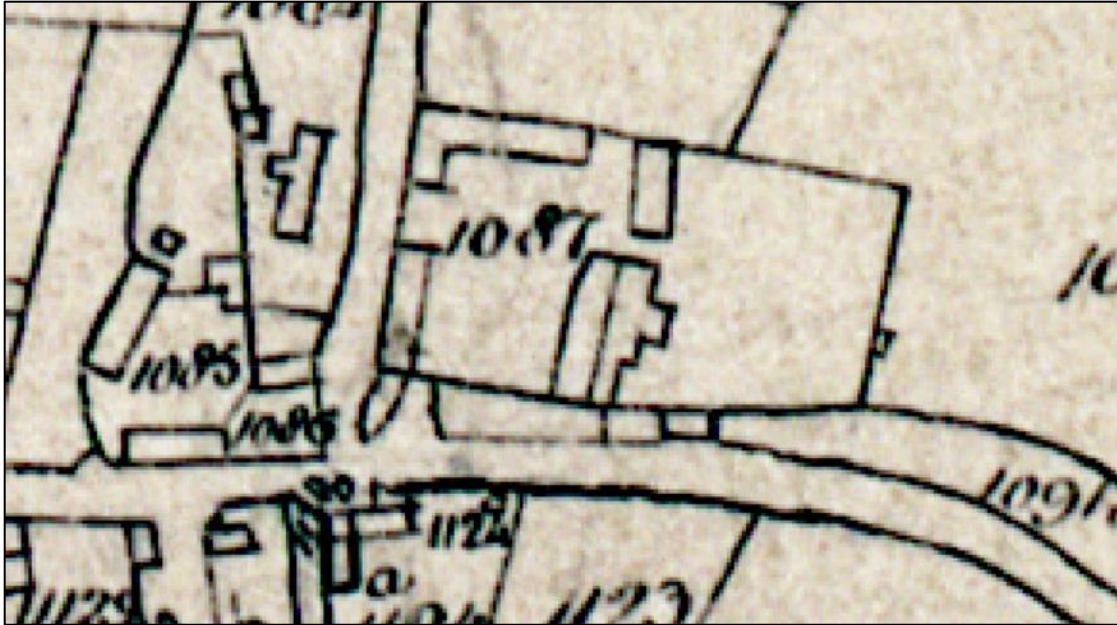
1840s Wiltshire Tithes Map

- 4.4.** By the 1840s, the Wiltshire Tithe Map shows the house in roughly its current position and confirms that the yard already comprised more than just a house and a single barn. At this stage the courtyard form appears more regular, reflecting the broader pattern of farmstead improvement and intensification that occurred in the post-1790 period and particularly during the “High Farming” years of the mid-19th century, when livestock management and manure production drove the reorganisation and investment in farm buildings and yard.

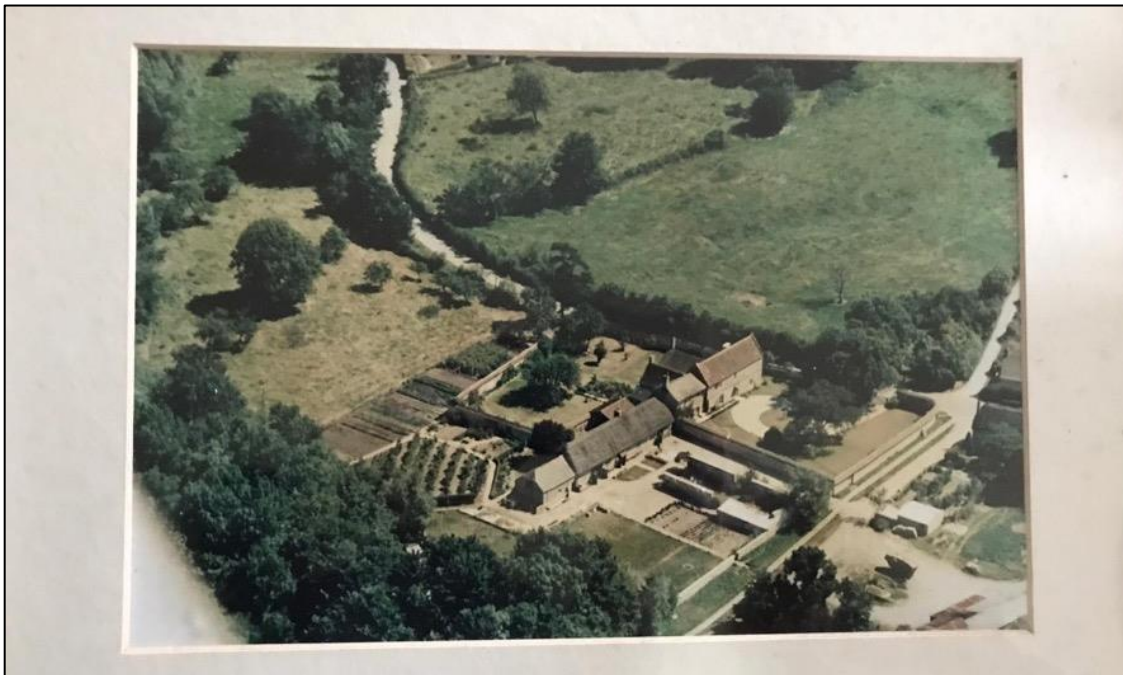
Aerial photo of Manor Farm, June 1959

- 4.8.** Importantly, Building Control records (ref. G11/760/496) indicate that the main barn subject to this application was converted around 1941. This conversion is likely to mark a significant functional transition away from more intensive agricultural use of the yard, and may have coincided with the enclosure and domestication of parts of the former farmyard, including the possible formation of the capped stone wall along the western boundary. This evidence supports the conclusion that the barn's current domestic use and internal configuration represent a relatively modern phase in the building's long history, superimposed upon an earlier agricultural structure of traditional form and materials.
- 4.9.** Late 1950s aerial images of the building confirm the presence of thatch on this former barn.
