West Dean Farm  
Grimstead Road  
Wiltshire SP5 1HP

Design, Access and  
Statement of Heritage  
Significance

Document 200 02 01 Rev 05  
March 2026

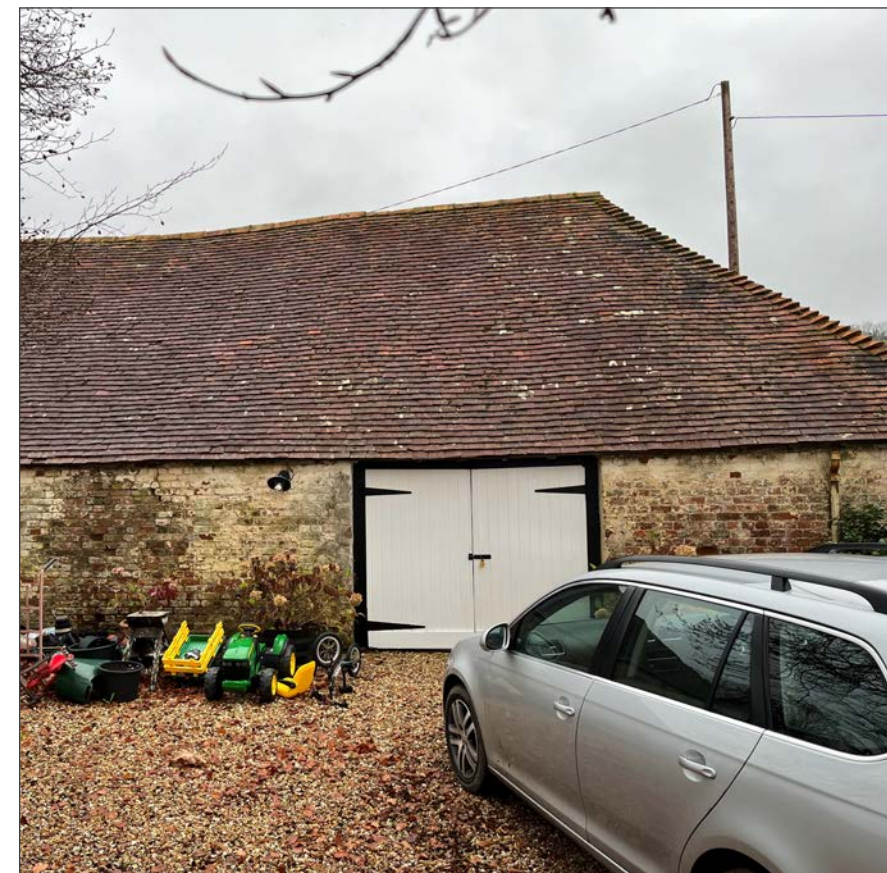
Figure 8: brick building with hip roof is the grade 2 cart-shed

The cart shed to the south-east is internally subdivided with the part nearest the house retained for store. The cart-shed is 18th century and timber framed with 5 bays in brick and timber clad exterior. This building is in need of repair. (See **Figure 8**). The building is listed Grade 2.

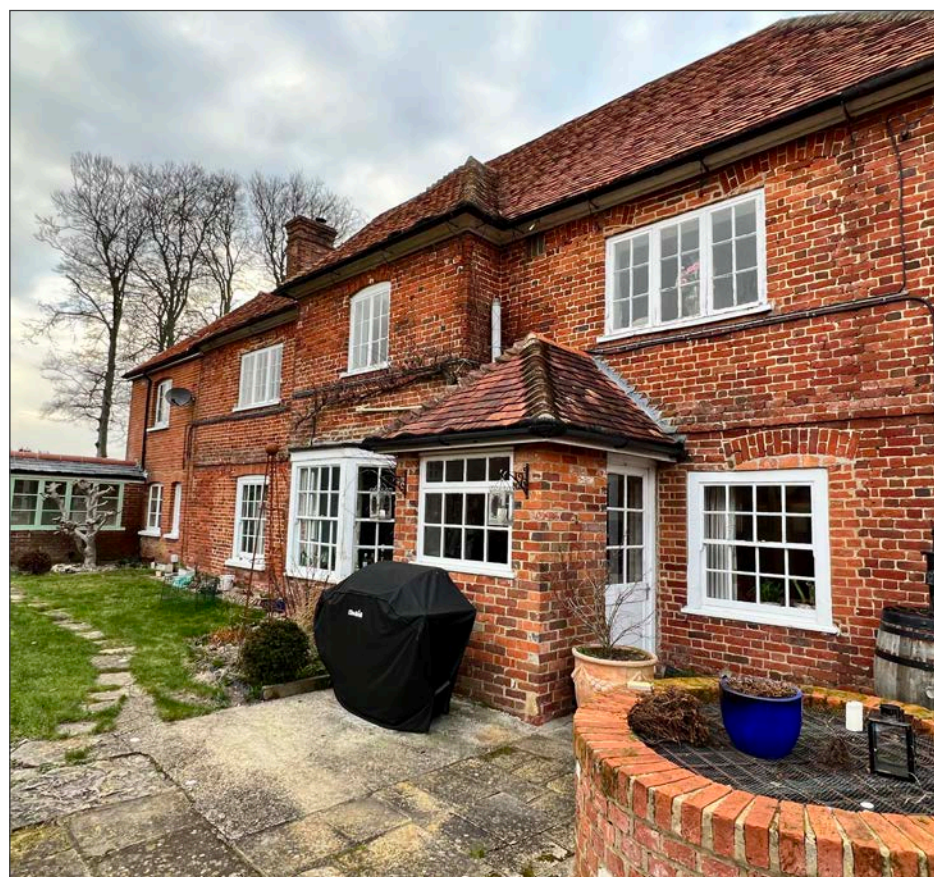
Figure 10: fenestration altered at rear ground floor, brick arch heads with later inserted sashes. Modern small boots room addition.

8. Replace two windows (W29 and W31) to the rear which the joiner reports as beyond reasonable repair (see **Figure 23 and Appendix 3**)
9. Removal of modern boot room extension (See **Figure 10**)

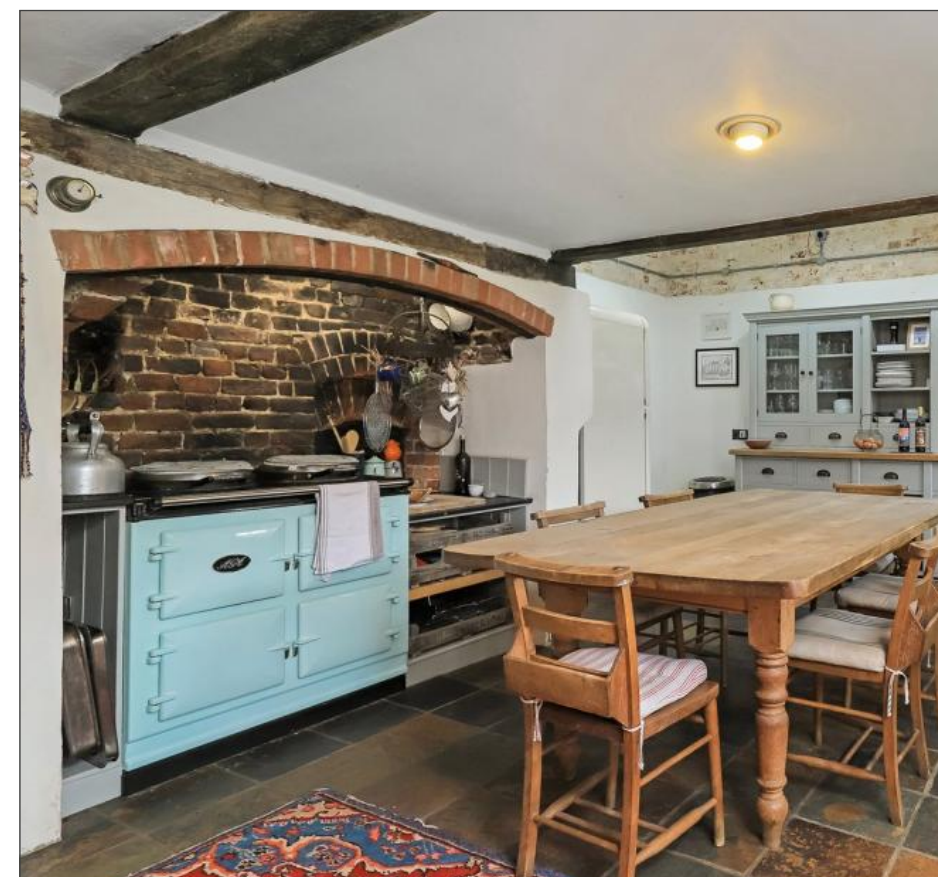
Figure 9: original kitchen fireplace and bread oven in the east end- possibly of 1700 date

The historical stages of development of the farmhouse is reasonably well documented by the RCHME. The east kitchen range is a lower one and half storey build and internally the original bread oven and fireplace opening survives (**Figure 9**). The external brickwork detailing abutting the main house might indicate an older structure of around 1700's rather than attributed to the late 18th century as suggested by the RCHME. Internally the winding stairs, wide plank door (see **Figure 15**) and an element of timber stud-work at first floor above tend to confirm this as a 1700's build.

7. Generally good interior heritage fabric of the 18th century with chamfered ceiling beams and 19th century doors, the main 19th century stairs, front north porch and corridor. The east end of perhaps the 1700's retaining kitchen fireplace, bread oven (see **Figure 9**), stair winder with an early boarded door (see **Figure 15**) and floor beams.

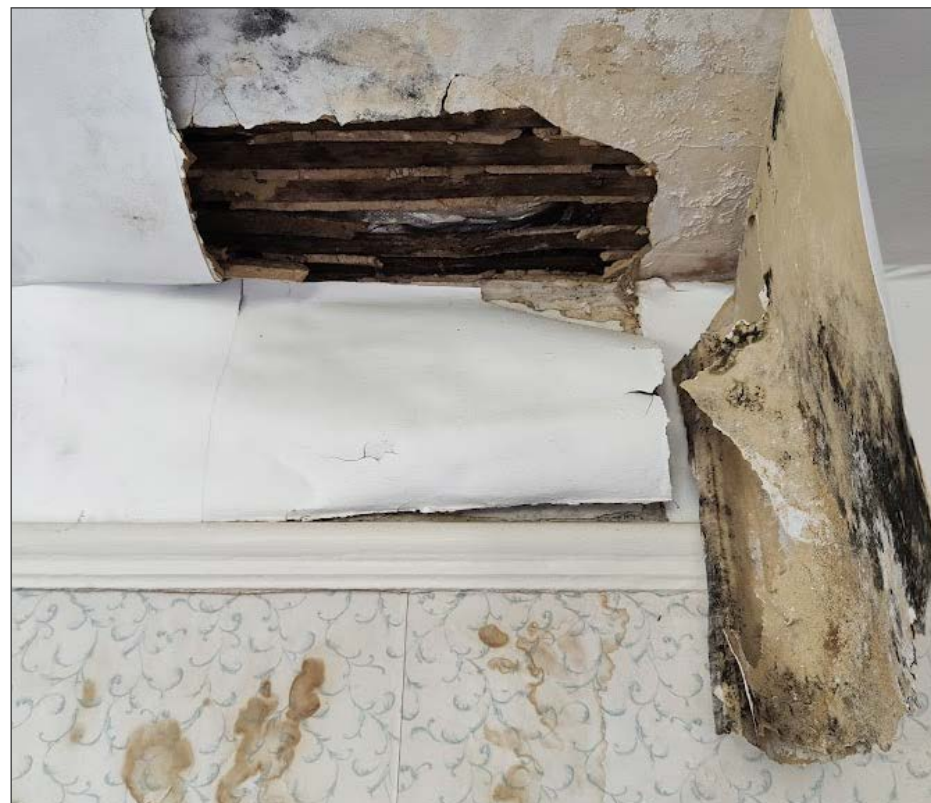
Figure 12: roof leaks causing internal damage

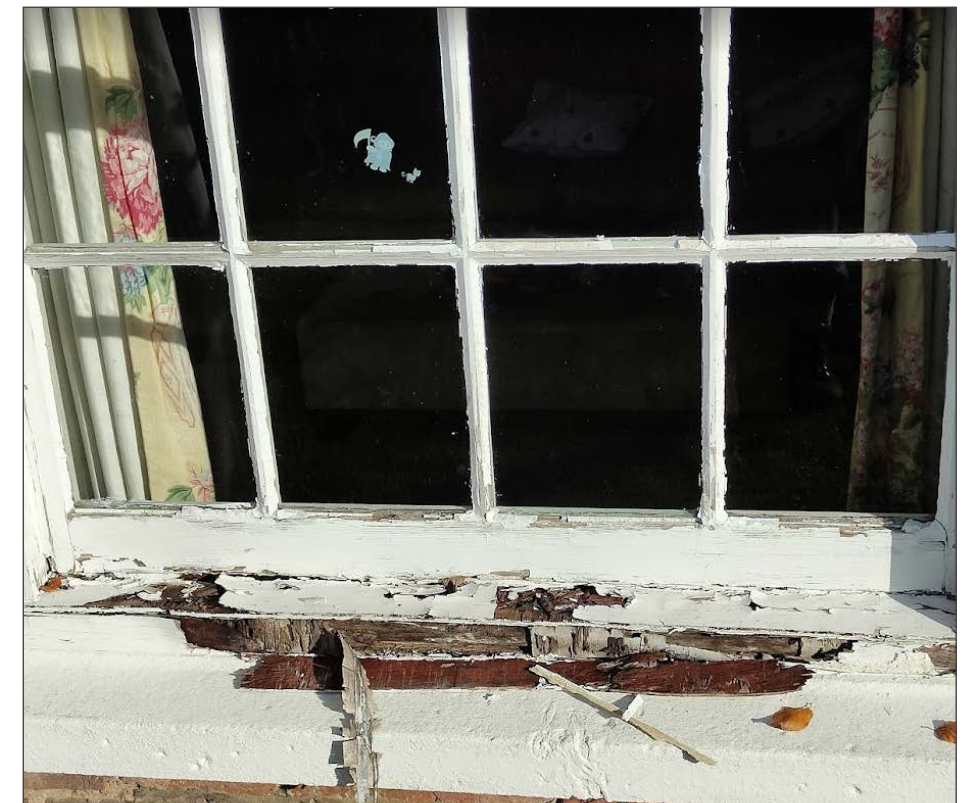
Figure 11: Required joinery repairs

6. Creating pool and garden outbuildings to west end of house/garden, including associated landscaping works
7. General repairs to roof, chimneys and to repair the damage caused to ceiling plasterwork (see **Figures 18 and 19**), restore with lime plasterwork and all external window joinery (see **Figure 11** as an example of the 29 windows which require renovation. See also **Appendix 3** Statement on Heritage Repairs

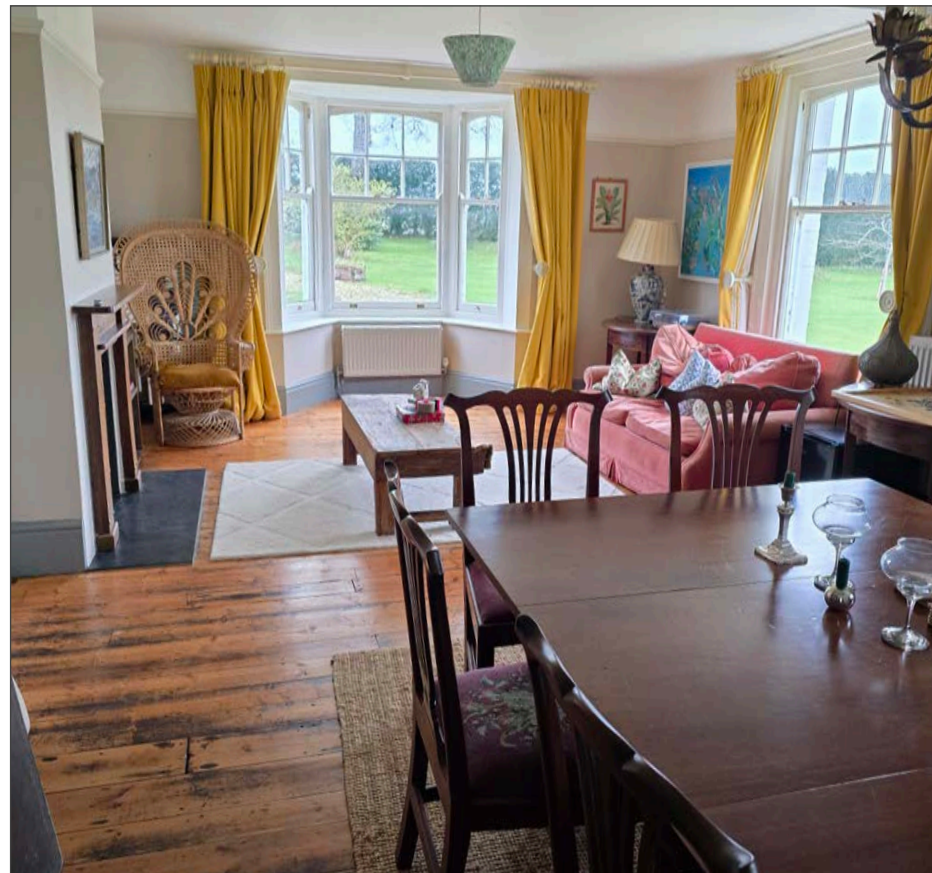
Figure 14: Dining room area with what appears to be a more modern replacement floor which probably took place when dividing wall removed

- New stone flooring to proposed Kitchen in west end and to floors in dining, sitting and hall. The plank floor to the Sitting and Dining Room appears to be more modern than that to the Snug and reception and has weathered badly due to damp. (See **Figure 14**)

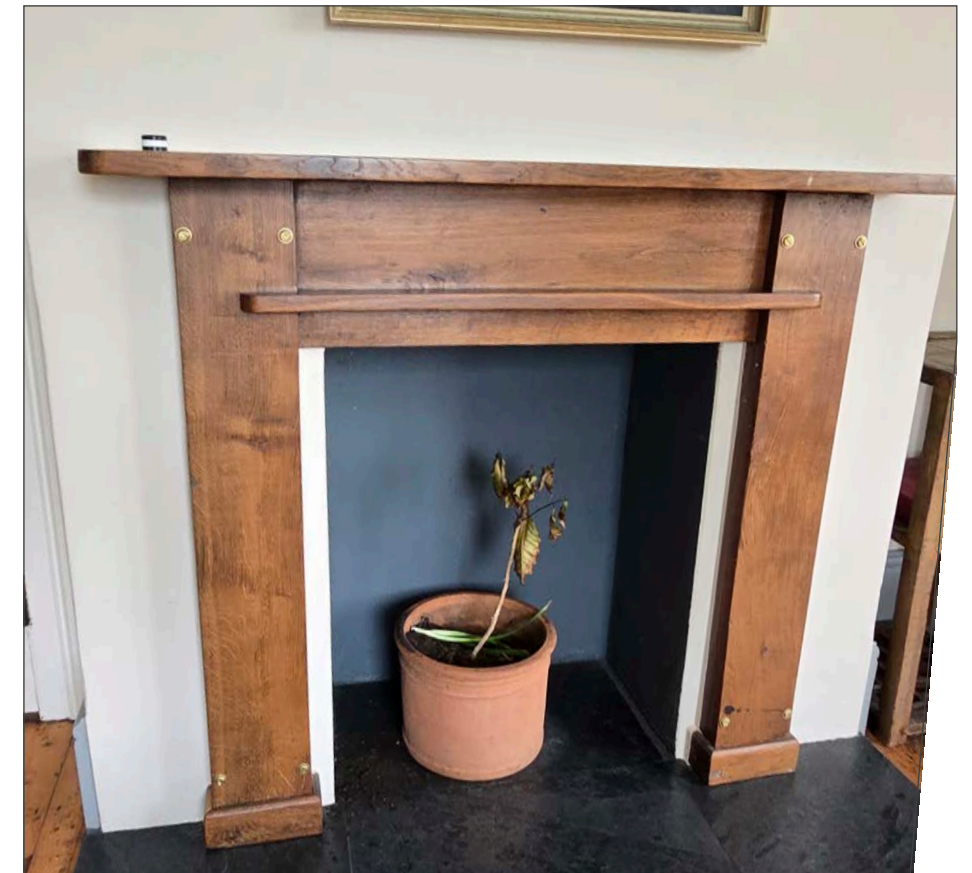
Figure 13: modern fire surround in Dining room

- The removal of the entire wall between the Kitchen and Dining Room, which has the very modern wood fire surround of no heritage value (see **Figure 13**), has some minor impact, but it is already an altered space with the dividing wall removed and bringing the dining area into the functional kitchen area has benefits for the use of space and the restoration works to flooring and joinery.

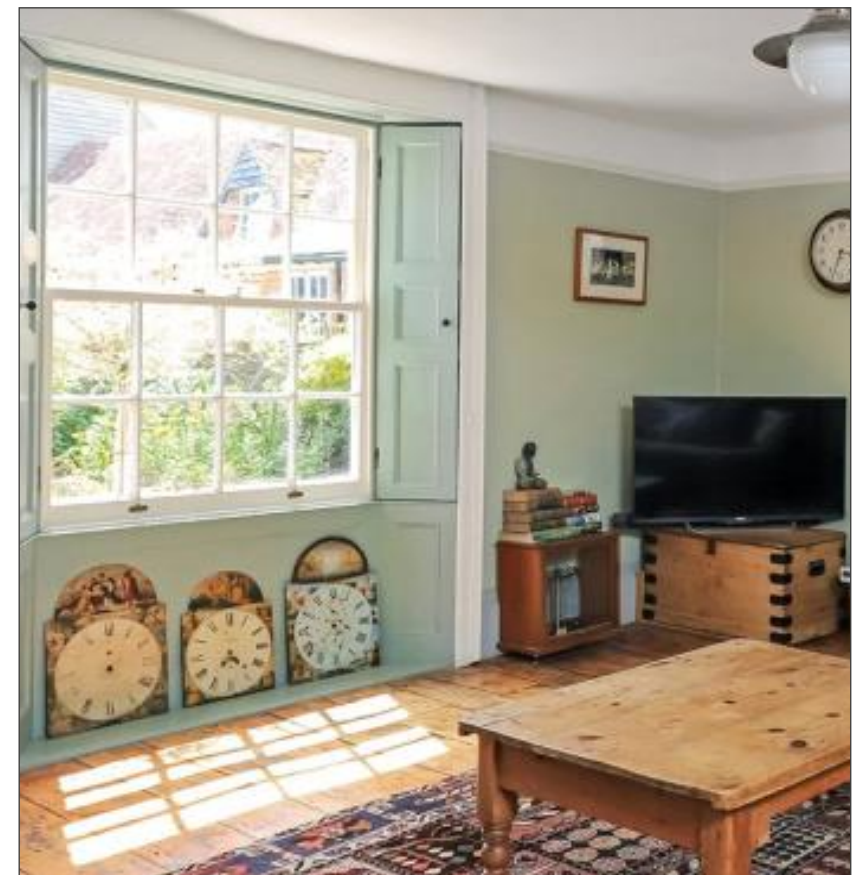
Figure 16: early to mid 19th century joinery and window shutters

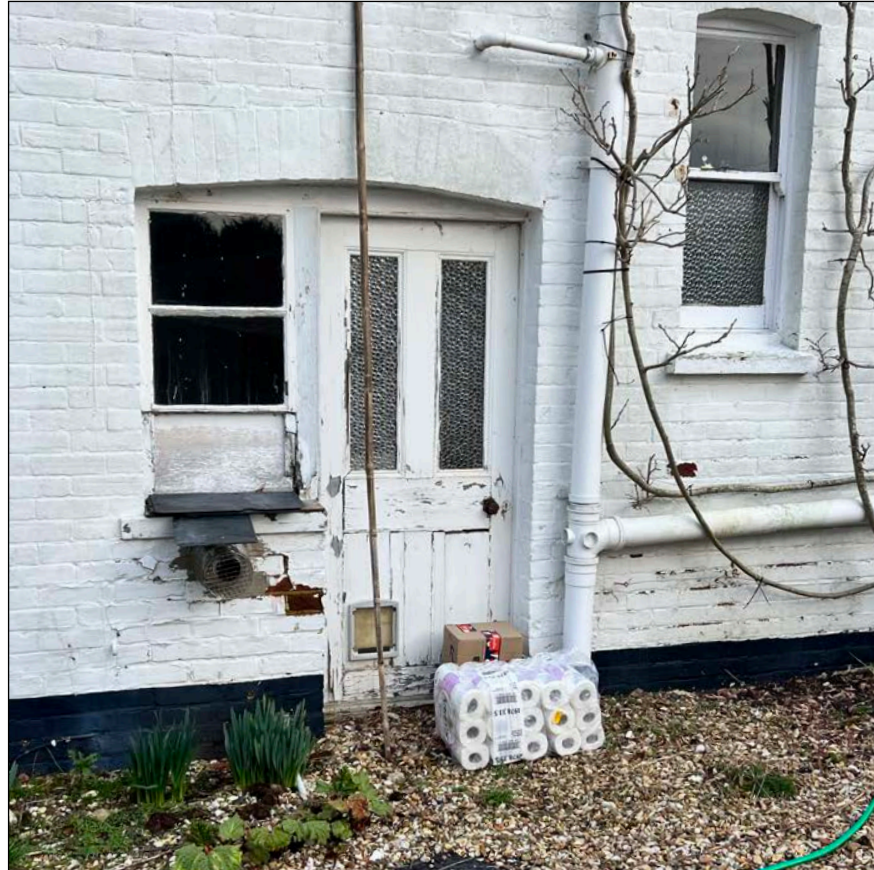
Figure 17: modern joinery to west gable to be replaced

2. Creating an open plan Kitchen and Dining Area with new stone flag flooring
3. Replacing ground floor modern door and side window joinery to west gable end elevation (to the proposed Kitchen) and install French doors within existing opening. (See **Figure 17**)

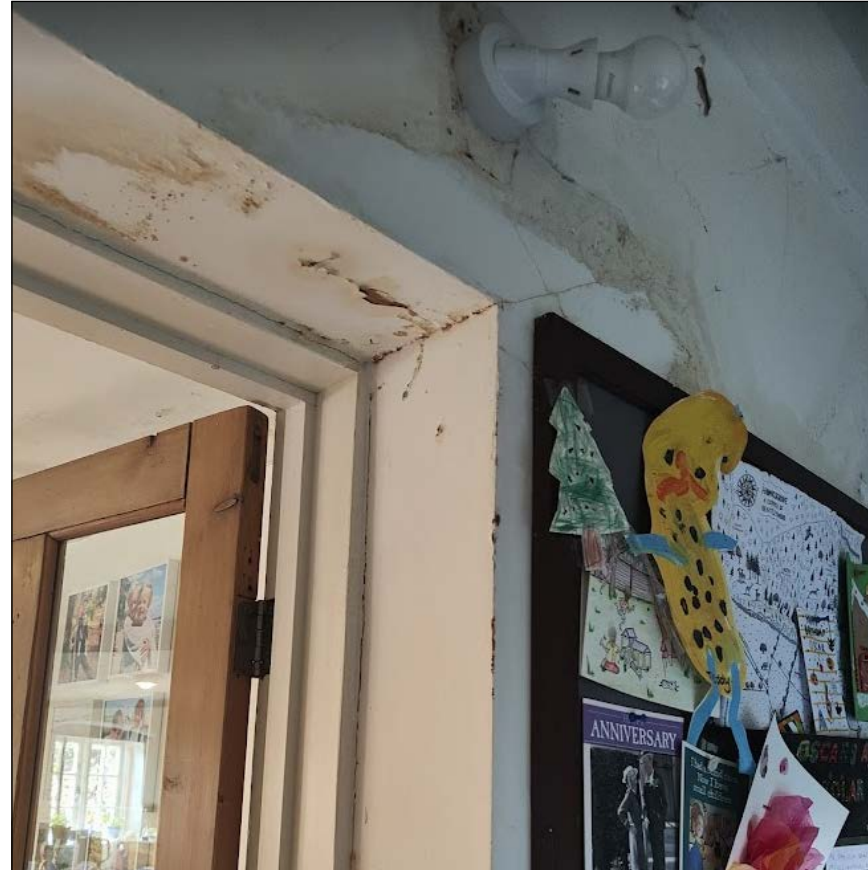
Figure 18: plasterwork damage from roof leaks

- Some essential roof repairs to failing roof lead work has recently taken place to halt the worst of the roof leaks. **Figures 18** and **19** show the damage and **Figure 20** the quality of the work done and replacement in appropriate traditional materials.

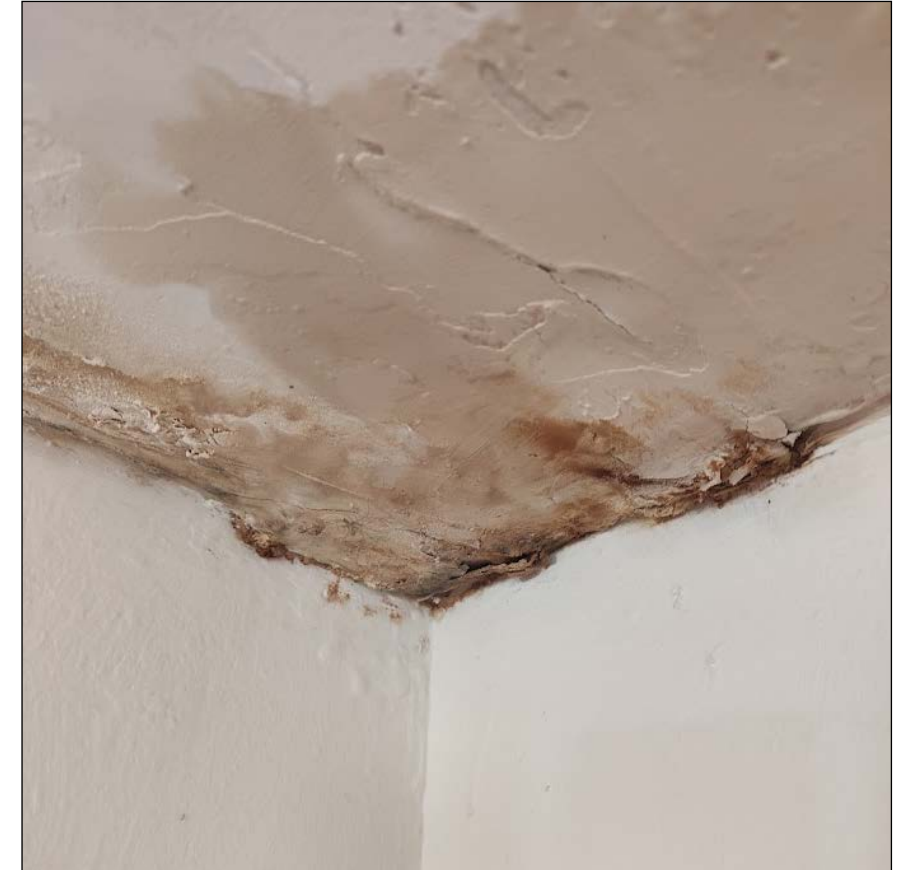
Figure 19: plasterwork damage from roof leaks

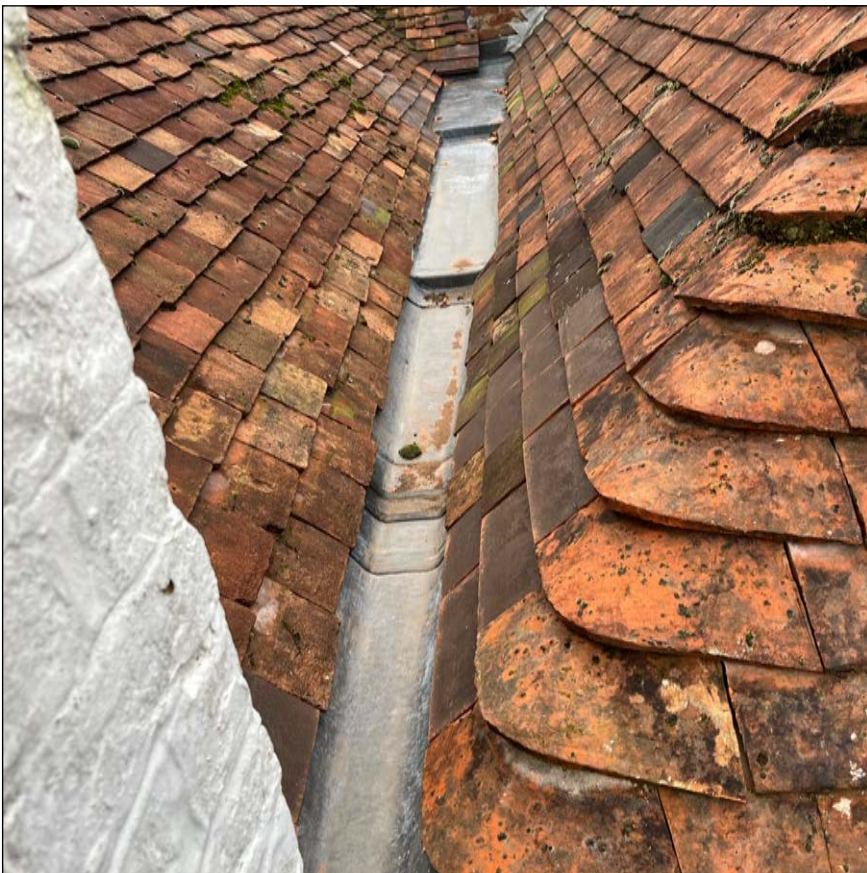
Figure 20: Example of recent roof repairs by the present owner to stop leaking lead gutter and allow ceiling repairs

The proposals have been reviewed over the previous year and some urgent roof repairs carried out (see **Figure 20**) The current revised scheme brief consists of:

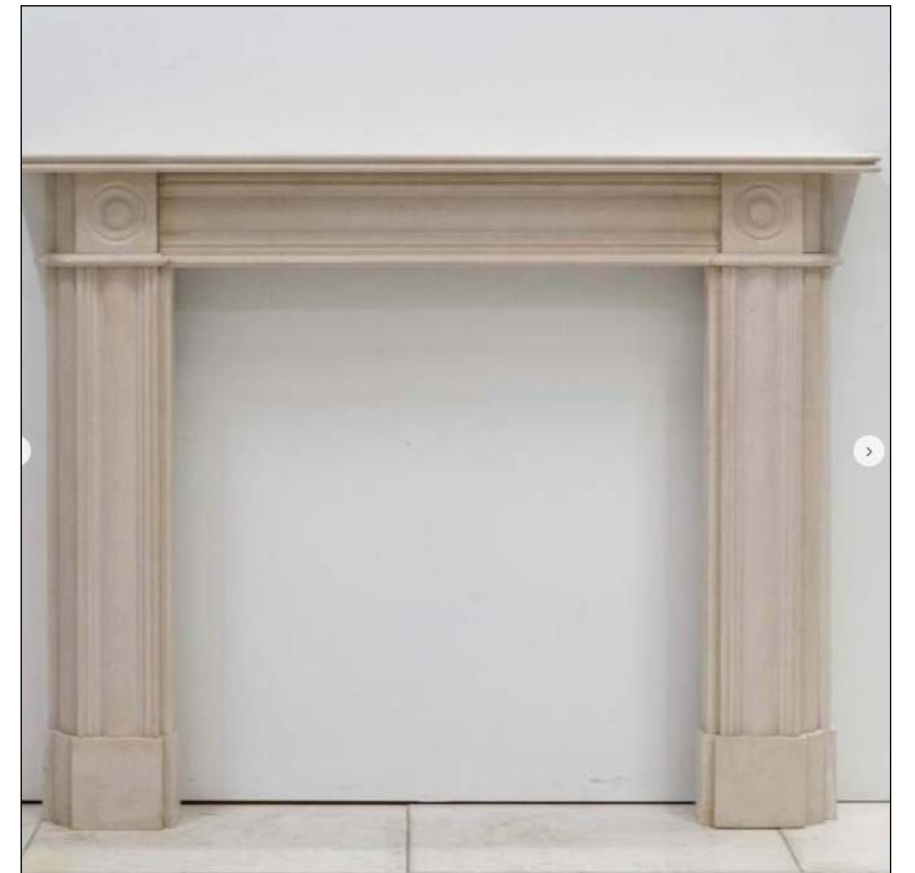
Figure 22: proposed stone fire surround for Snug

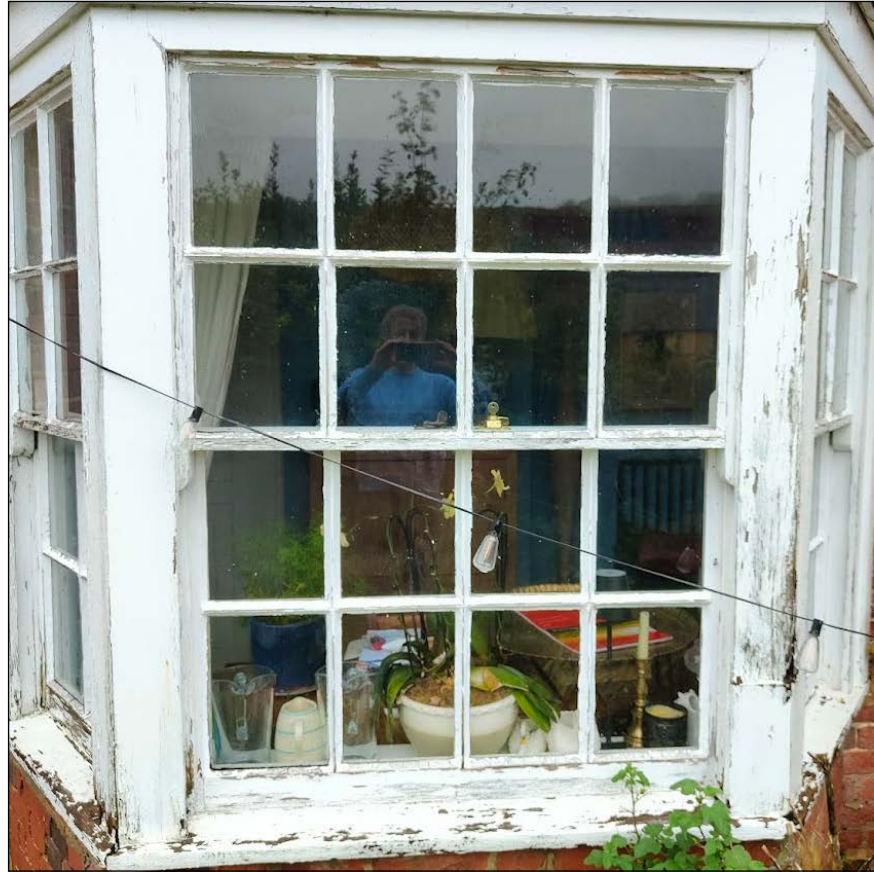
Figure 23: W31 bay which is to be replaced with the exact joinery detail, glazing bar mouldings and salvaging the heritage glass.

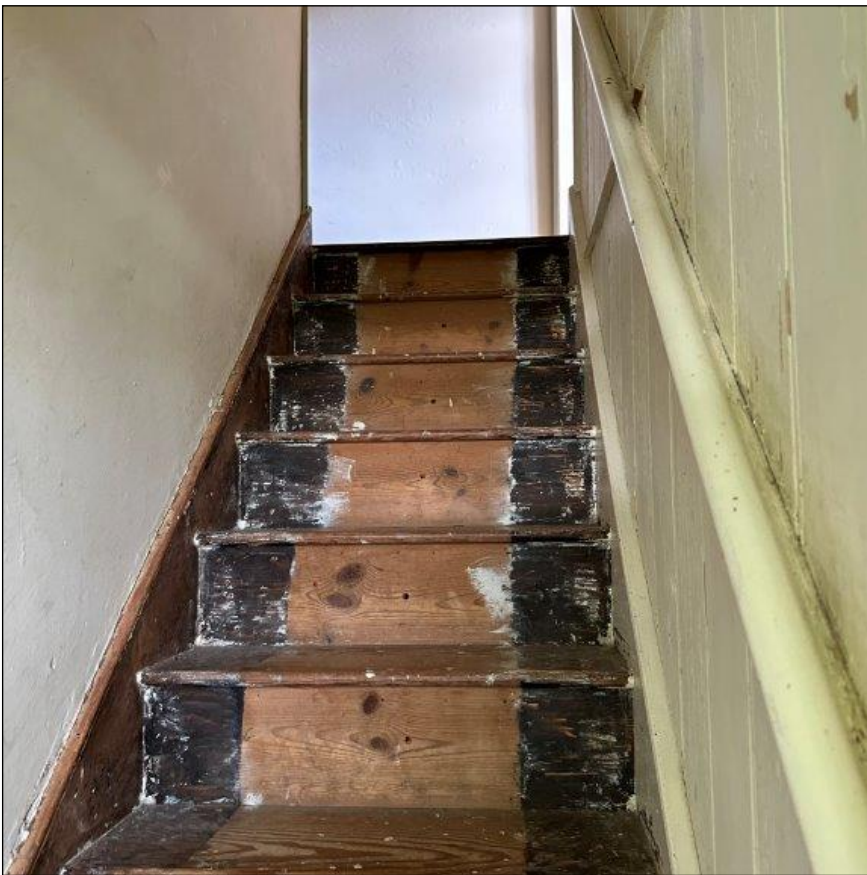
Figure 26: stairs from laundry to first floor

The west end was probably added in the early 20th century to accommodate additional services- laundry room, stores and staff room; probably with two staff bedrooms above (see **Figures 24 & 26**).

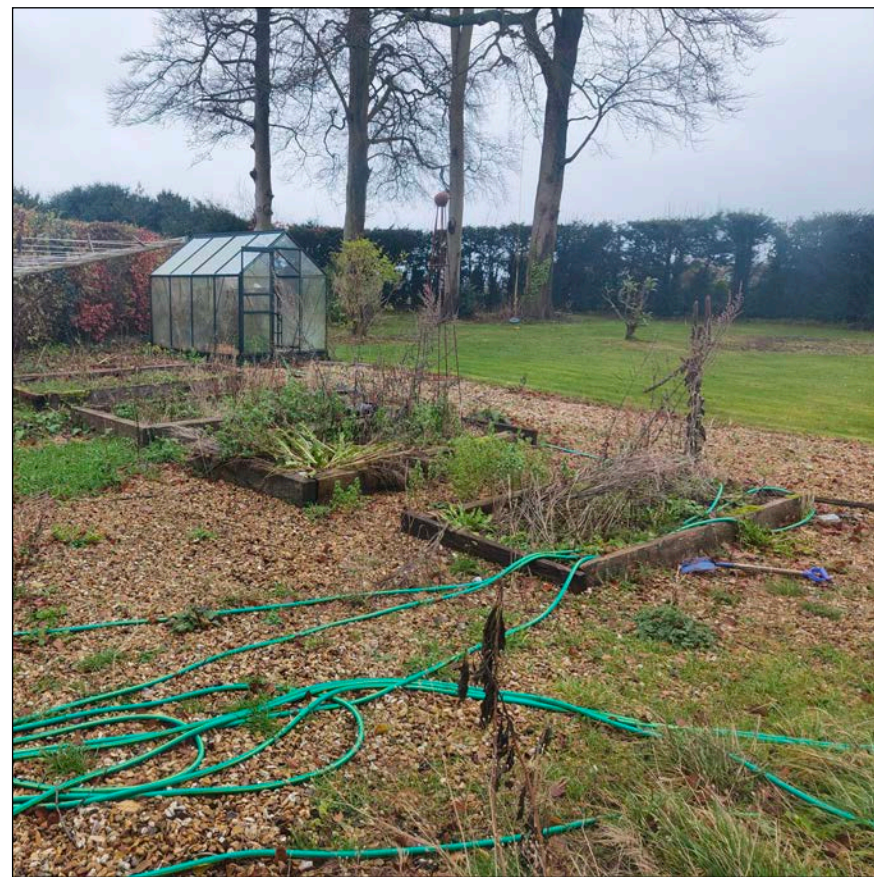
Figure 29: west garden to be replaced with pool and garden building

- The modest exterior addition to the west is the proposed pool which has been adjusted to move it further west away from the farmhouse. It now has no adverse impact on either the National Landscape or the setting of the other heritage assets around the courtyard. The existing gravelled planting area is of no interest and would benefit from removal (see **Figure 29**).

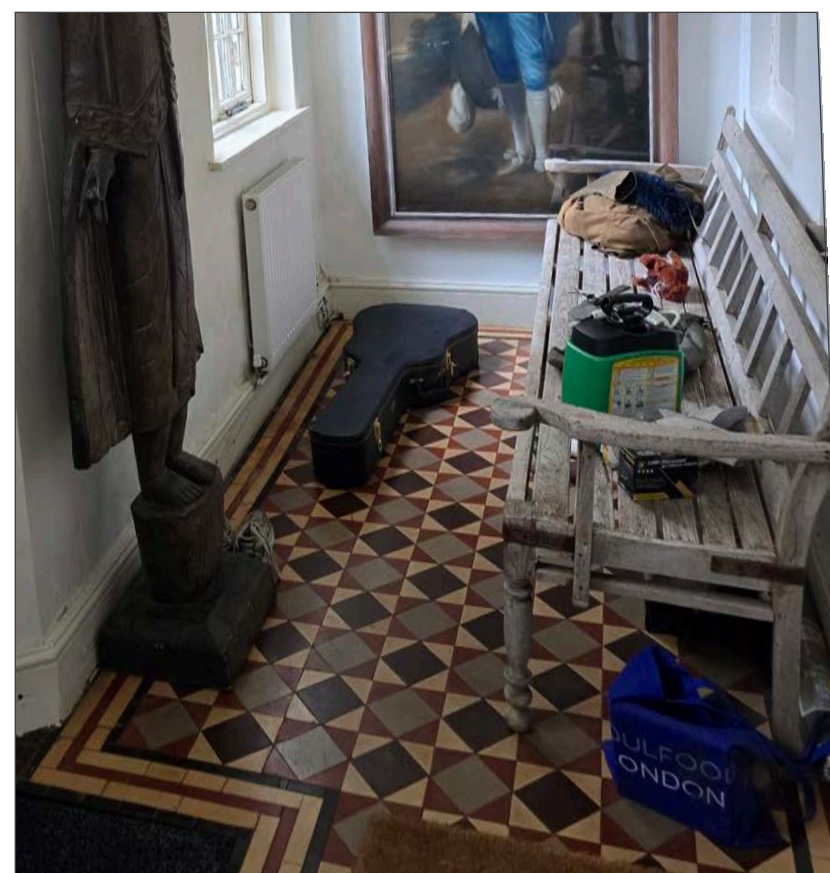
Figure 31: modern tiles floor to be replaced with stone flags

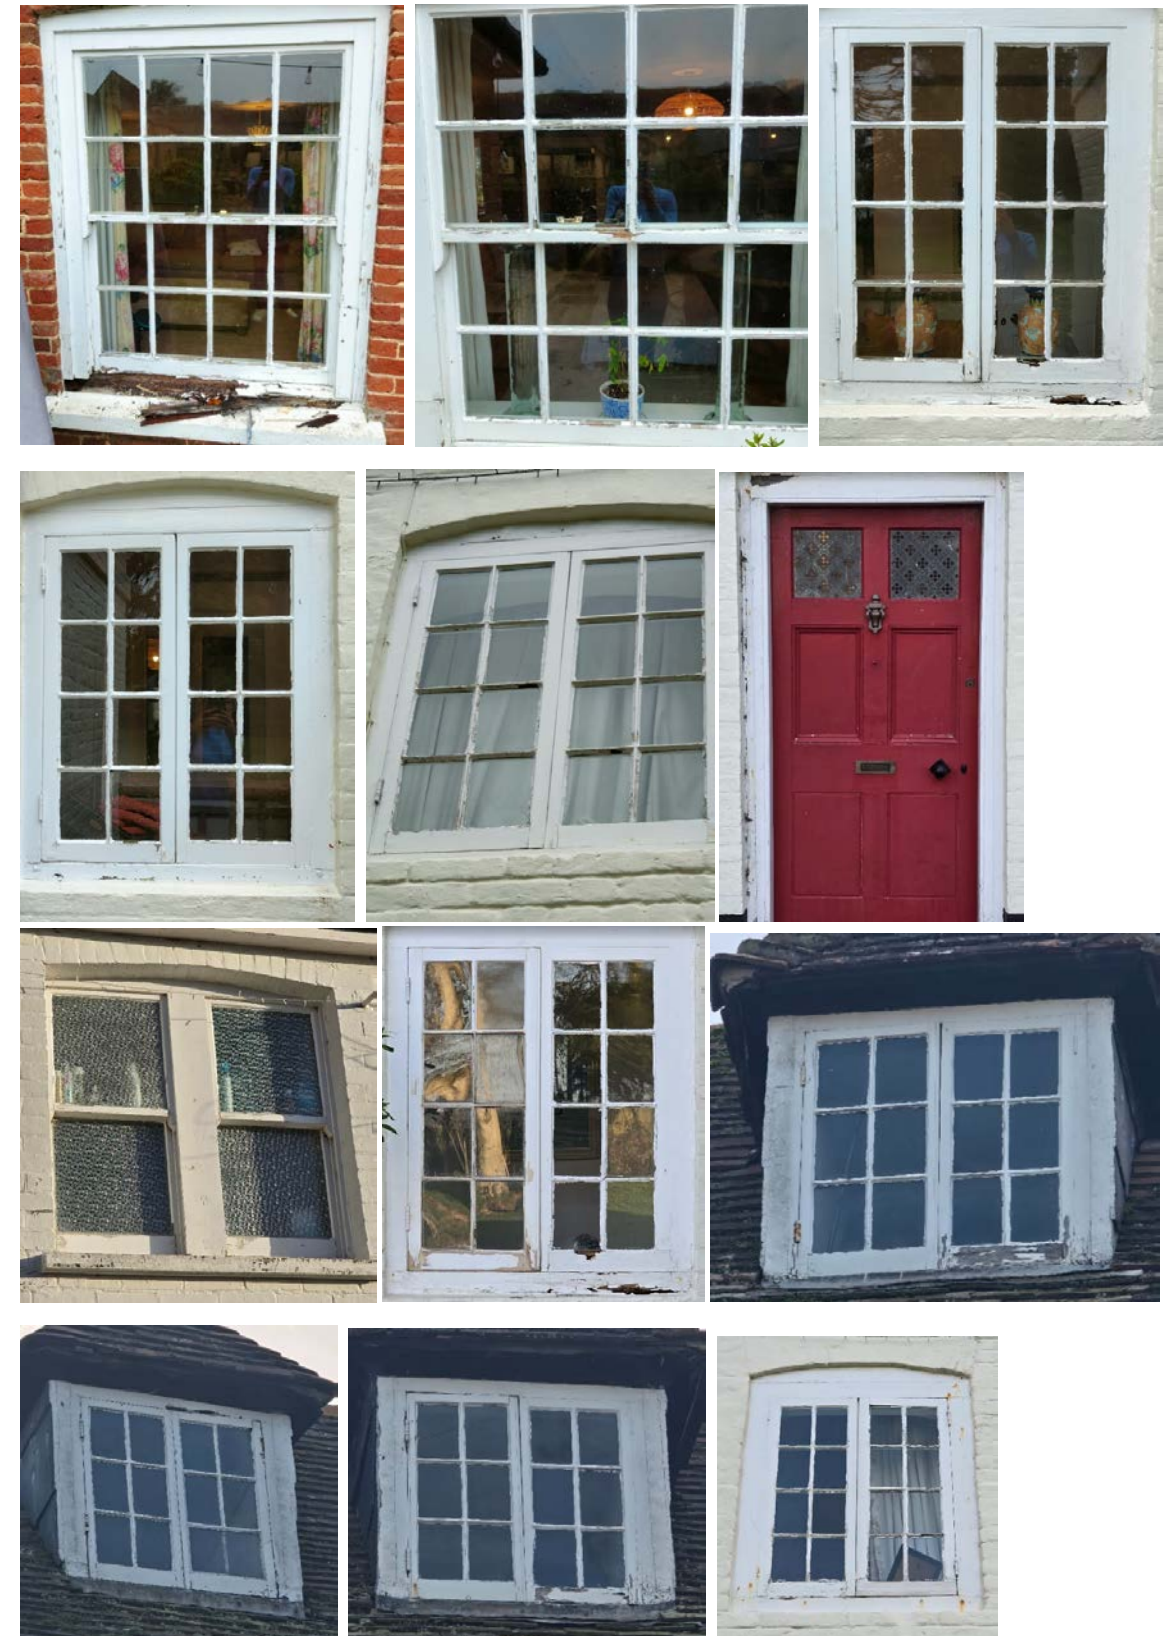
- 3) We will repair and restore all the 29 windows on the property, keeping the original glass and only scarfing in new wood where needed. We will use Ben Broadly, a local Salisbury joiner skilled at working with heritage/listed buildings. The windows we will repair are pictured below

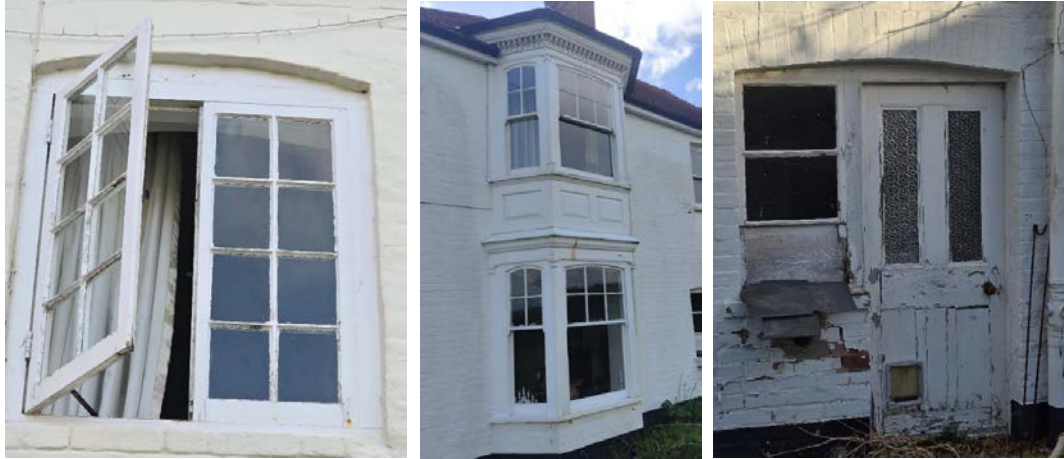
4) Unfortunately the windows (W29 and 31) shown below are beyond economic and practical repair so they will be replaced with like for like windows from Salisbury joinery. The associated drawings accompany the

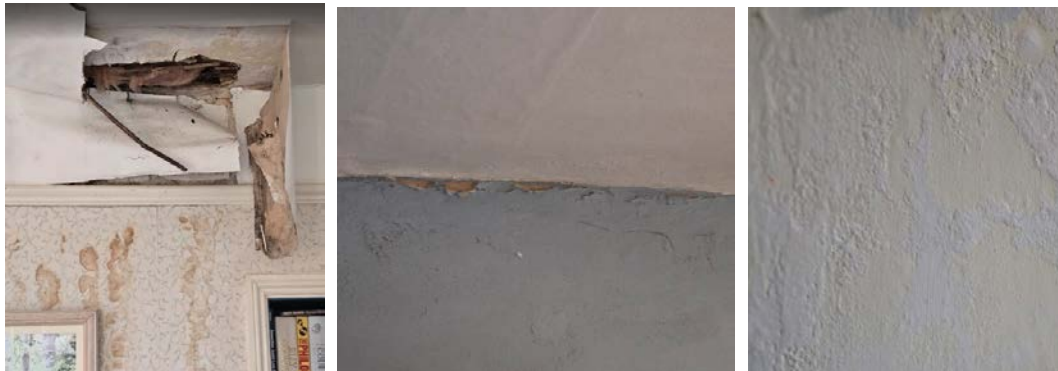
6) Make roof repairs as needed to prevent water ingress and internal saturation.
